SAFETY INVESTIGATION REPORT

REPORT NO.: 21/2013

MV THEOFYLAKTOS Explosions in four cargo holds at Rio Grande Outer Anchorage 22 December 2012

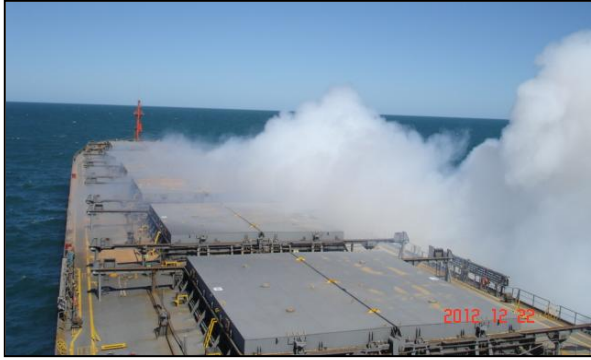
Figure 4: Smoke from cargo hold hatch no. 4

A second less violent explosion in cargo hold no. 4 was reported at 1600, also generating white and grey smoke escaping from the hatch cover joints (Figure 4). More smoke and a violent release of energy were observed on the port side of cargo hold no. 6 at 1620. About two minutes later, a larger explosion occurred in cargo hold no. 2. Crew members observed the hatch covers lift above the deck to an estimated height of between two to three metres and land on the hatch coamings (Figure 5).

As indicated above, the burning of PH₃ gas forms phosphorus pentoxide (P₄O₁₀). P₄O₁₀ is a white gas (Figure 4).

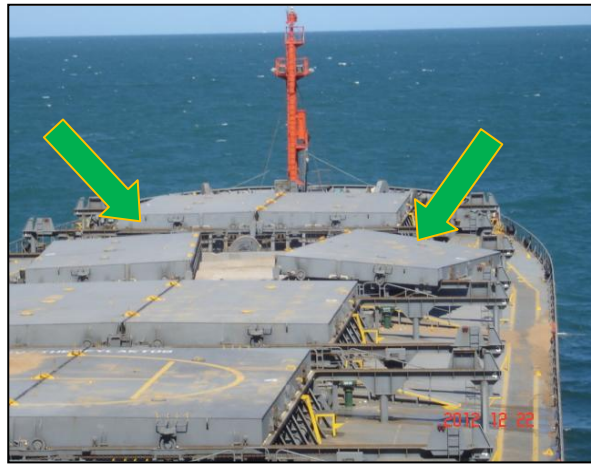
Figure 5: Cargo hold no. 2 with displaced hatch covers

The structural damages were limited to the cargo area. Cargo hold no. 2 was the most affected. Plating in way of the hatch cover and hatch coamings was found buckled and displaced. A number of hatch cover transverse girders were also damaged. Damages were also found in the hatch cover rubber channels, stoppers, chain fittings and compression bars.

The effect of these explosions was more severe in cargo hold no. 2, although the safety investigation could not accurately establish the reasons behind this.

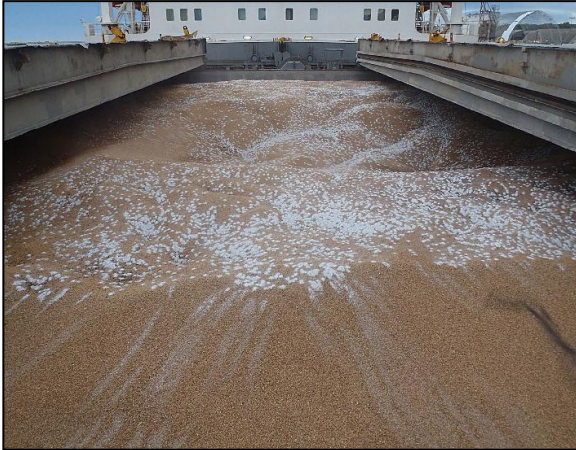
Figure 7: Aluminium phosphide tablets distribution in cargo hold no. 2

One factor that may have contributed to an increase in the temperature in the head space of the cargo hold (and above the auto ignition temperature of PH₃ gas) was the distribution of the aluminium phosphide tablets on the cargo surface. The tablets were in very close proximity within the centre area of the cargo hold rather than spread out evenly⁴ (Figure 7).

It may have been possible that this high concentration of generated PH_3 gas would not have necessarily been a contributing factor to the explosions, had the efficient diffusion of the gas (*via* the ‘J System’) been achieved as intended. It is indeed doubtful whether the ‘J System’ effectively diffused the elevated rate of production of PH_3 gas through the entire stow.
