Danish Maritime Accident
Investigation Board

MARINE ACCIDENT REPORT

AMBER II and SEA WORKER
Loss of tow on 27 January 2016

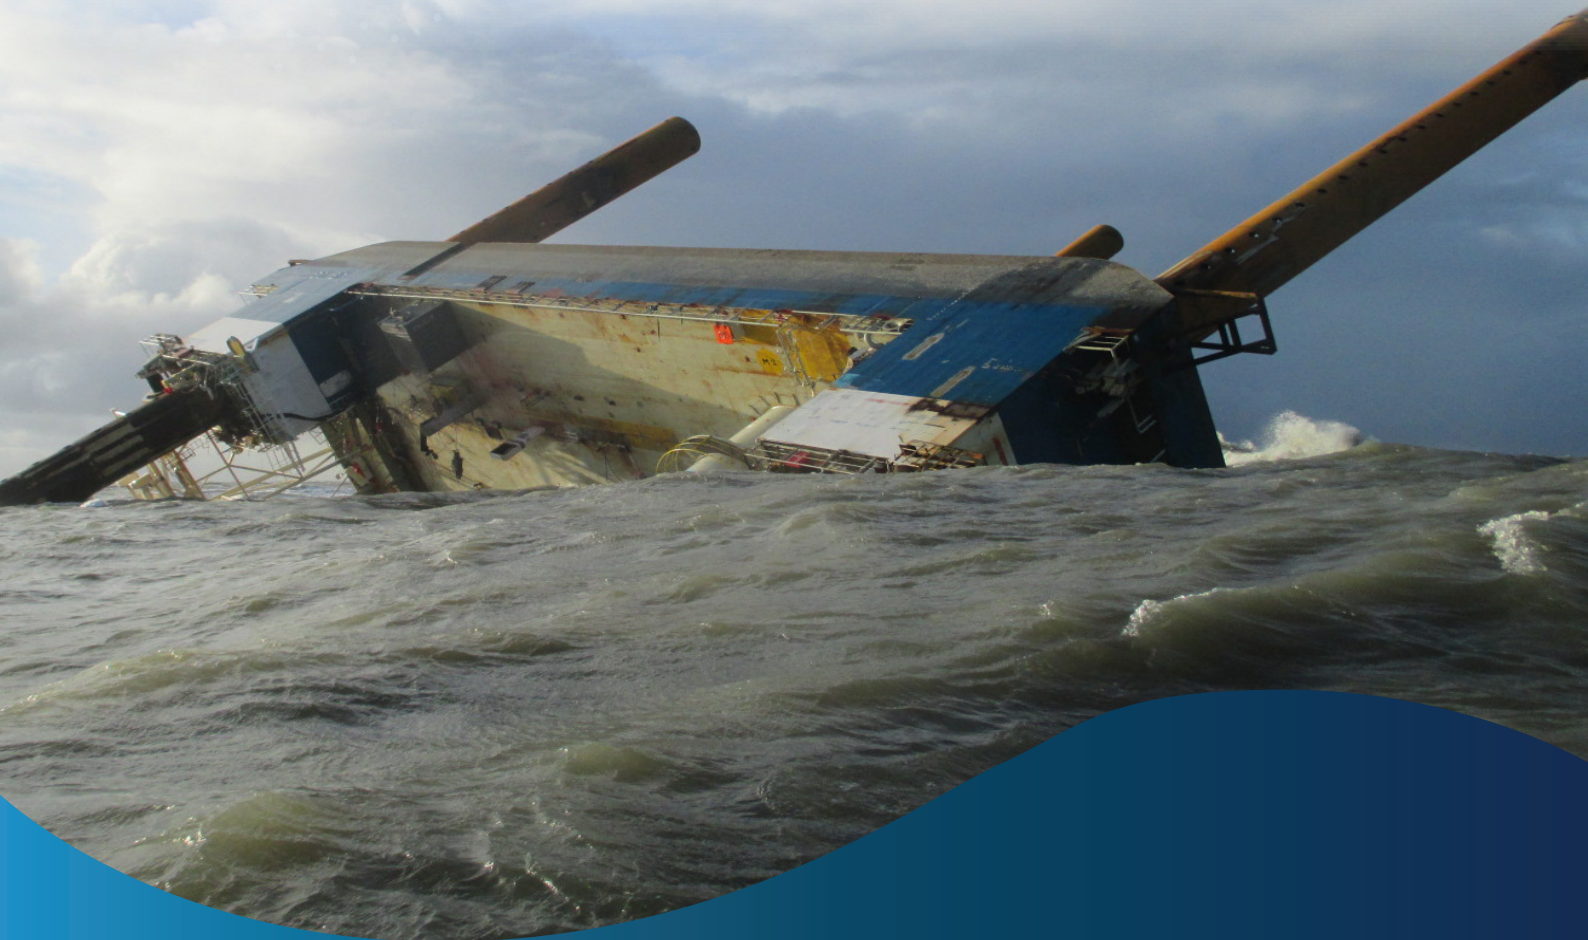
Front page: Capsized SEA WORKER. Source: A2SEA

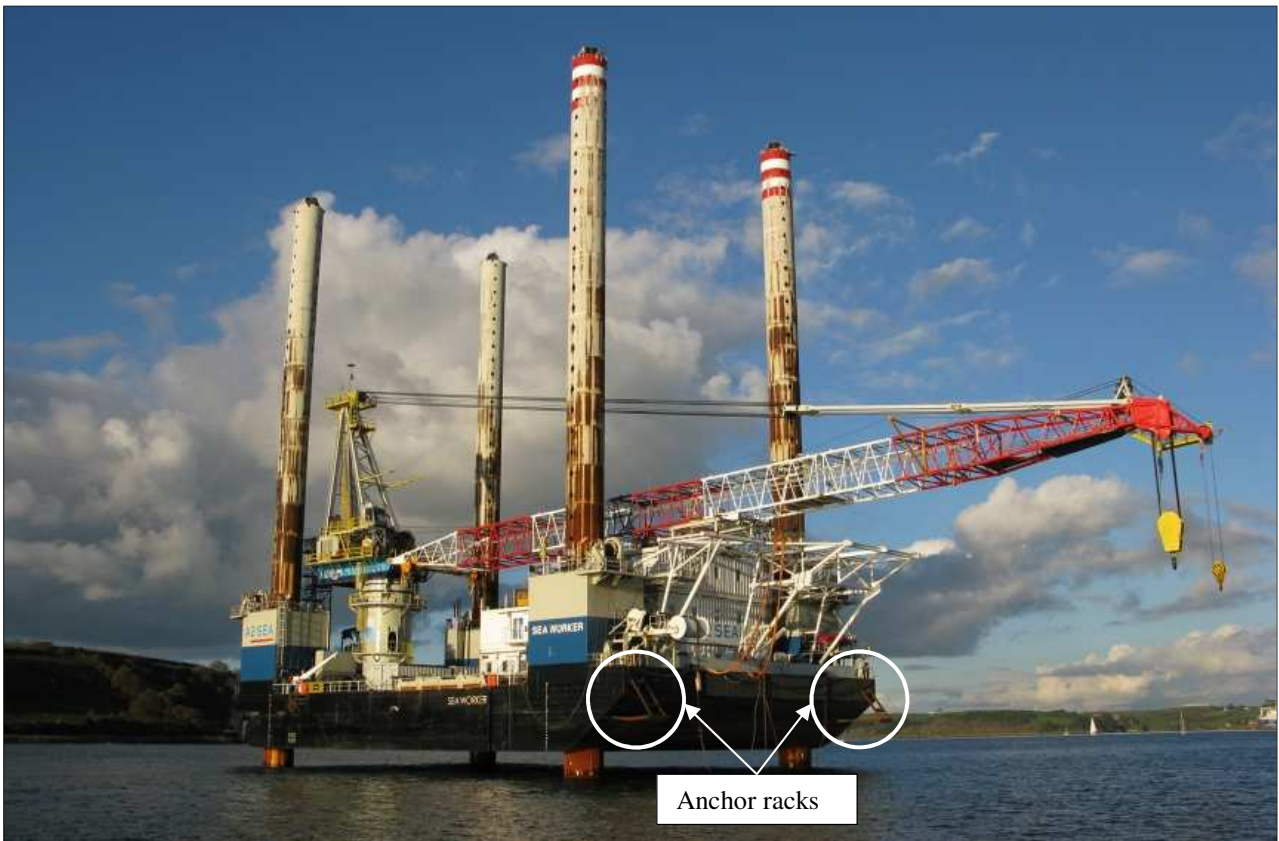
As the raft was lowered down the side of the platform, it got caught by an edge on the platform's hull and started to tilt. The chief officer climbed out of the raft and up on top of it, where he managed to free the raft from the edge while holding the raft's wire with his hand and pushing with his feet on the ship's side. The chief officer climbed inside the raft and lowered the raft on to the water. Once in the water, the chief officer had to climb out of the raft to manually operate the release hook, which succeeded after a couple of attempts. The raft drifted alongside the platform. At each corner of the platform, anchor racks protruded (figure 5), and due to the motions of the sea these were constantly moving up and down several metres. As the raft drifted very close to the platform's side, the chief officer was worried that the raft could get caught underneath one of these racks, but as it passed the rack, the raft steered clear of the platform.

Figure 5: Anchor racks on SEA WORKER
Source: A2SEA

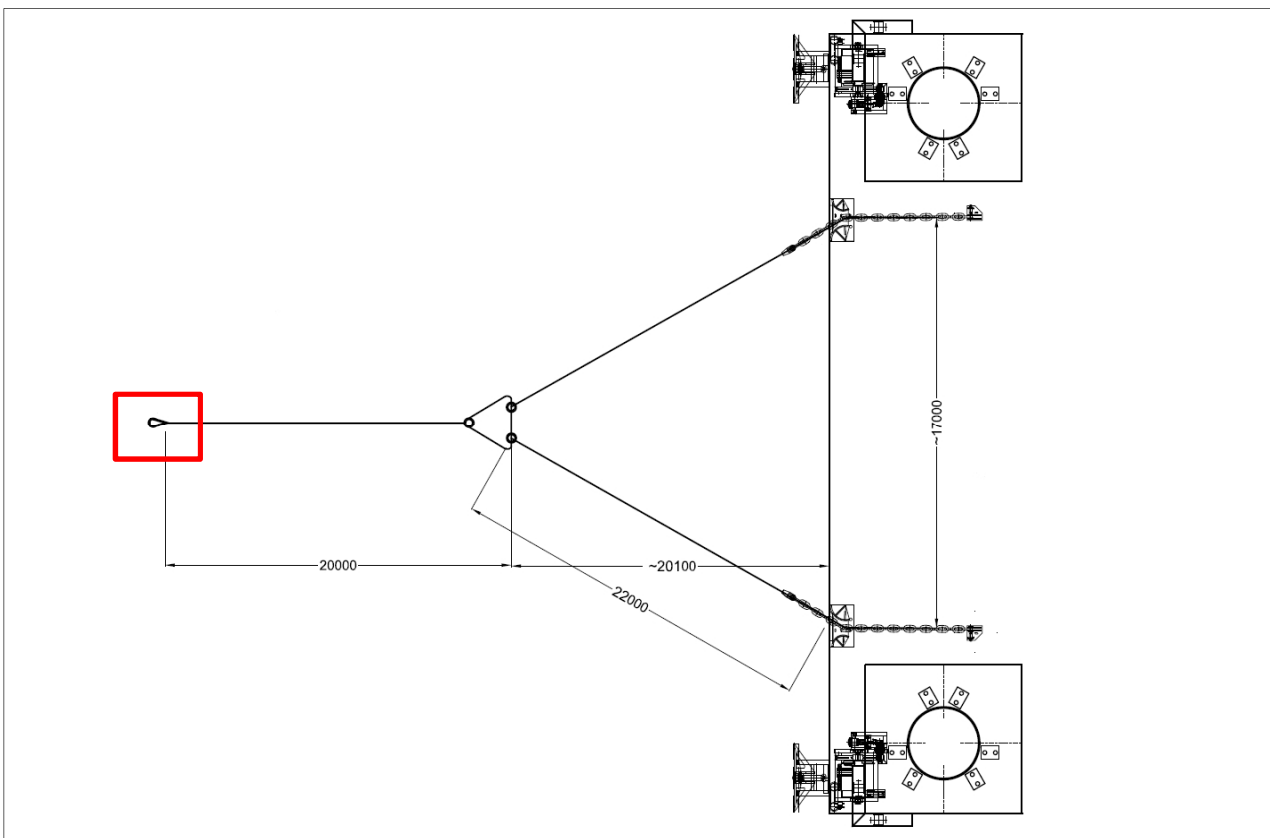
Figure 8: Location of the wire fracture

The tow broke at SEA WORKER's towing pennant, just behind the aluminium clamp of the pennant's thimble eye (figures 8, 9, 10). The fractured wire has been examined by FORCE Technology with the purpose of establishing the condition of the wire and a cause for the fracture.

Based on the FORCE report and the facts provided on the weather conditions at the time the wire broke, the DMAIB has found it likely that the towing pennant broke due to overload. The strain on the wire, caused by heading up against strong winds and current, the impact and movements of towing in high waves with short roll periods, and the tug pulling at a constant engine power, exceeded the wire's minimum breaking point, causing the wire to break at its weakest and least flexible point, the aluminium clamp.

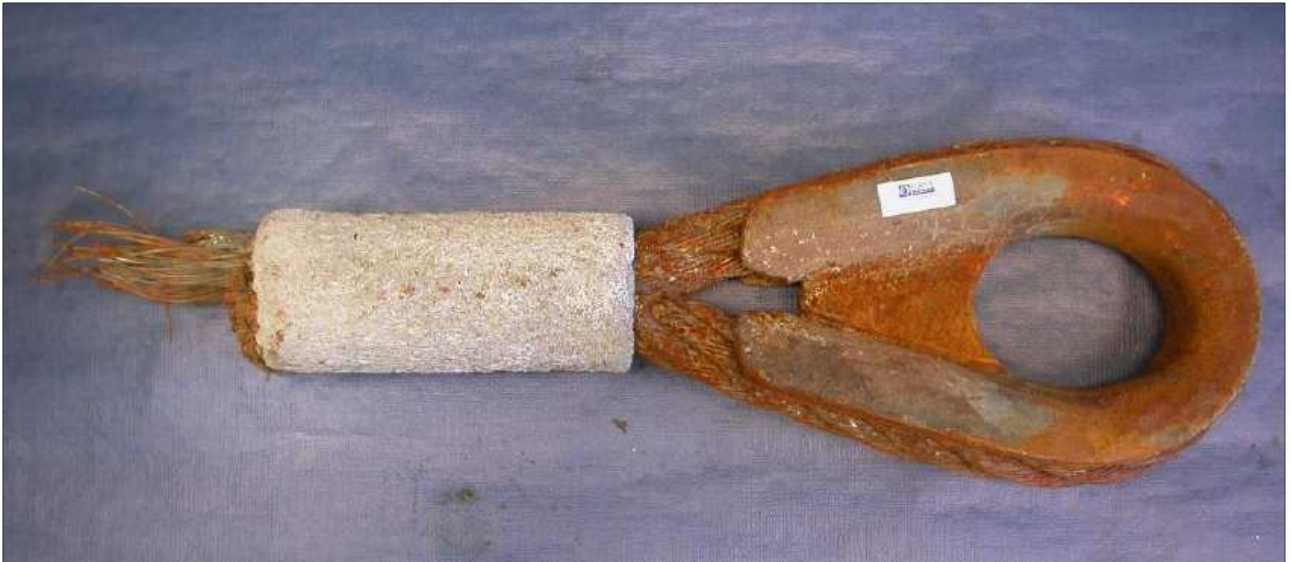
Figure 9: The fractured steel wire
Source: FORCE Technology

The FORCE report concludes that the wire showed no signs of material defects or manufacturing imperfections. The wire appeared with slight surface corrosion as expected due to normal wear and tear, which might cause the tensile strength of the individual wire strands to be slightly below the required value. The Talurite clamp appeared severely corroded. However, the FORCE report does not ascribe these results as significant factors for the fracture. Instead, FORCE suggests that, based on the location of the fracture, the angle of the individual wire strands' fractures and contractions at the fracture surfaces: *"the cause for the fracture is a sudden overload at an unfortunate angle for the wire rope end"* (figure 10).

An examination of the wire carried out by FORCE Technology concluded that the fractured steel wire showed signs of wear and tear as expected for a wire that had been exposed to sea water in normal service, and that it showed no sign of manufactural defects. However, the corrosion found on the wire was not linked directly to the parting of the wire. Instead, the report concluded that the nature of the fracture indicated that the wire broke due to overload.

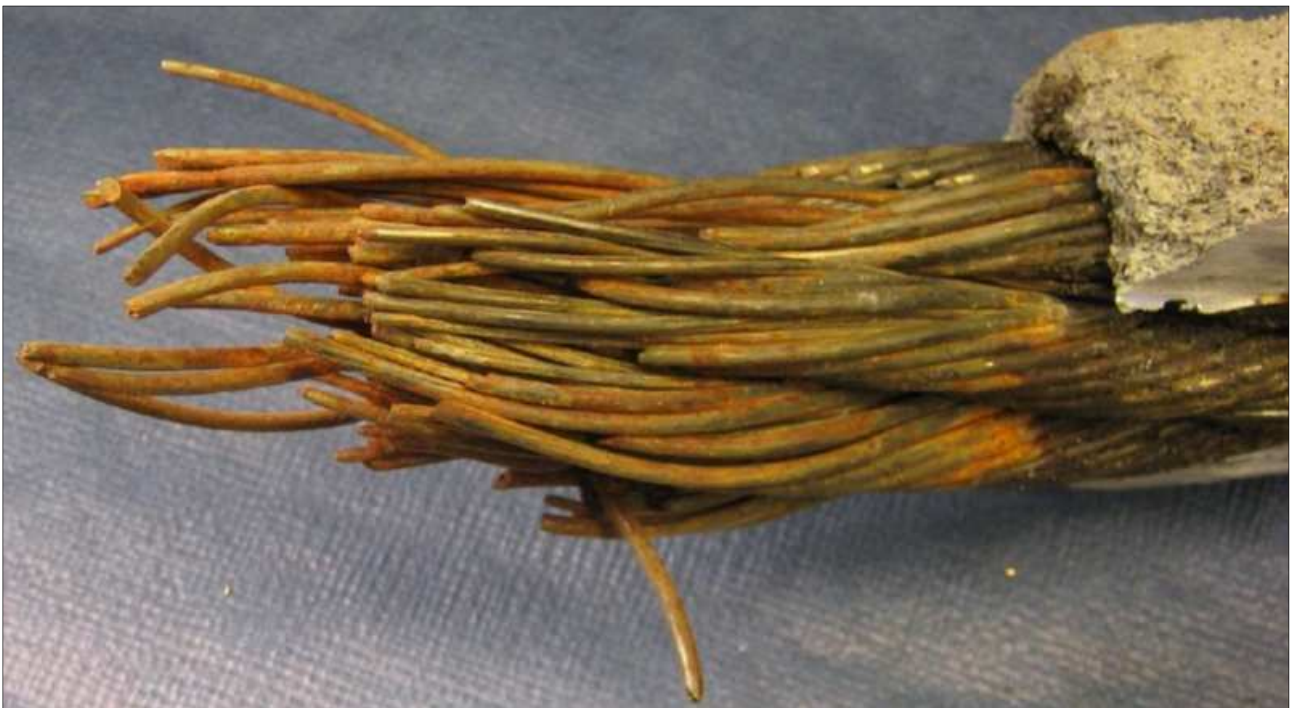
Figure 10: Close-up of the wire fracture
Source: FORCE Technology

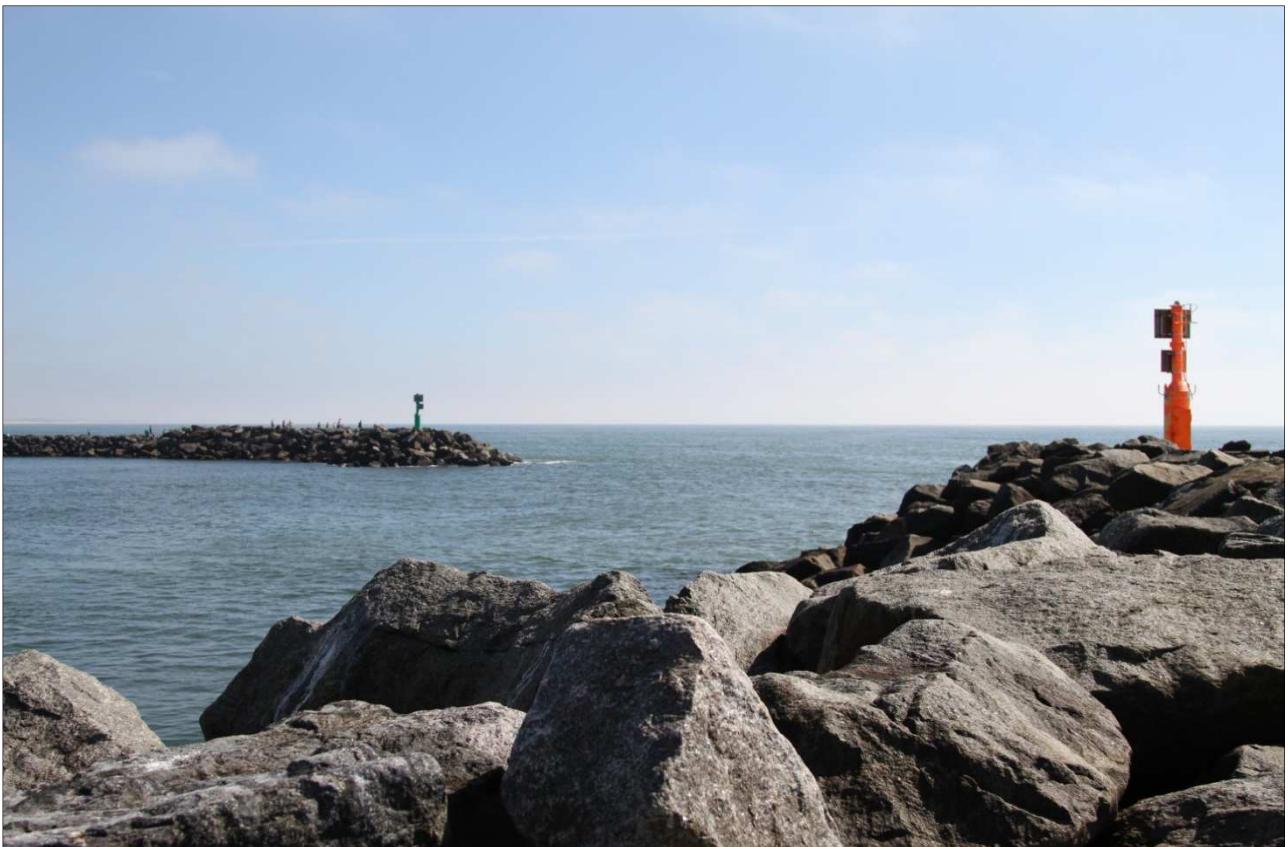
- *Nature of the break water:* The breakwater at the port's entrance consisted of rows of piled large, edged stones (figure 14). The construction broadened from the top down, which meant that the stone breakwater would extend considerably under the water. Both pilots perceived contact with the breakwater as a serious event and even life-threatening, because the stones could tear up the ship's hull.
- *Waves and possibility to board AMBER II or SEA WORKER:* In Hvide Sande, the rescue boat serves as a pilot boat. The rescue boat has an operational limit of 3 m wave height for this service. This means that the port effectively closes for pilotage at this wave height. At the estimated time of arrival, it was forecasted that the limit would be exceeded.

Figure 14: Breakwater, port of Hvide Sande
Source: DMAIB
