Unintentional release of the freefall lifeboat from *Aquarosa*

Indian Ocean | 1 March 2014

ATSB Transport Safety Report
Marine Occurrence Investigation
307-MO-2014-002
Final – 20 May 2015

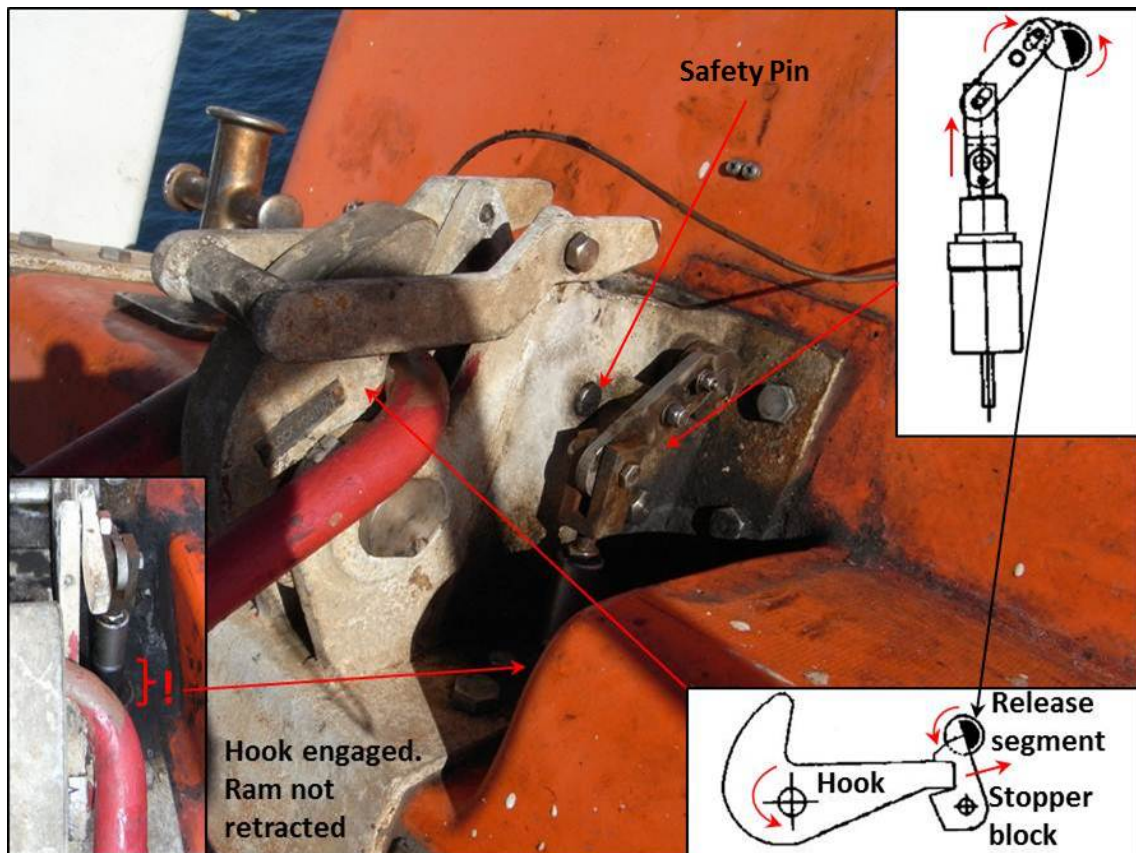
Figure 3: Freefall lifeboat on-load release

Resetting the on-load release and securing the lifeboat in place required the ring link to be positioned over the hook and then rotating it until its tail engaged in the stopper block. An alignment mark, on the side of the hook (Figure 6 and Figure 7), provided a visual confirmation that the hook was in the correct position. The release segment then had to be rotated into position, locking the stopper block in place, by opening the valve on the pump and the activating cylinder ram retracting. Once the on-load release was reset, the hydraulic pump’s valve was closed. This locked the oil in the system and the linkages in position.

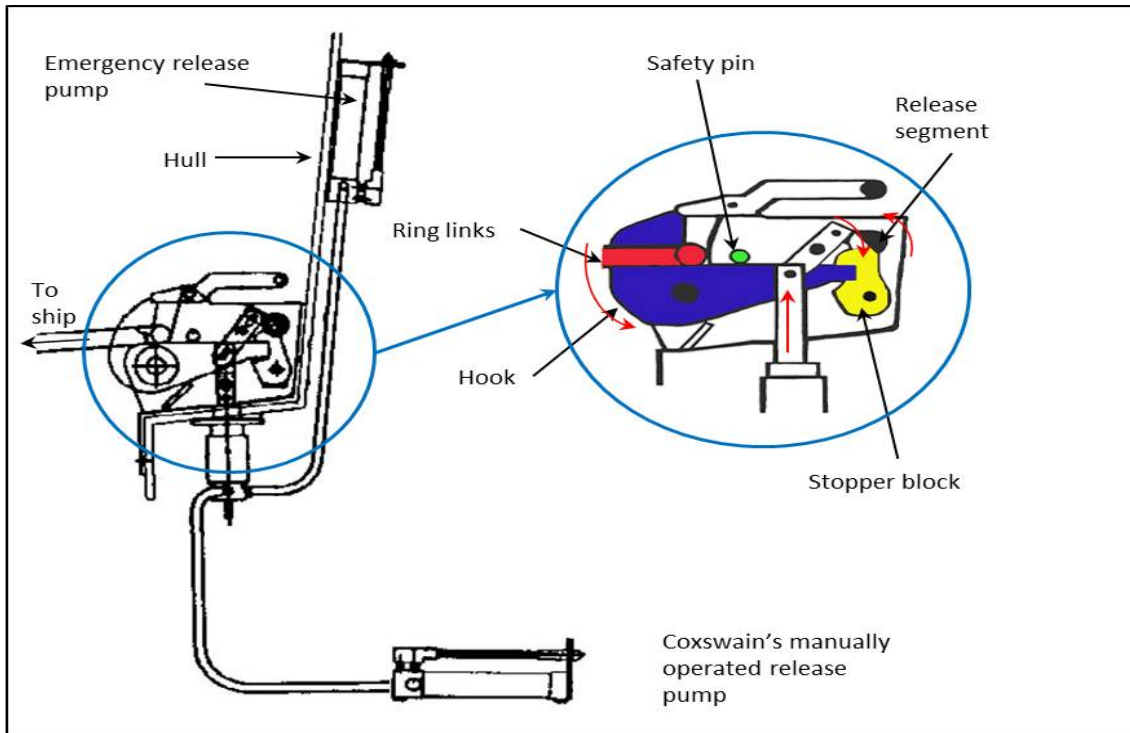
Figure 4: Freefall lifeboat hook release system

The lifeboat on-load release system comprised the on-load release (JJMEC model JX-4) located at the stern of the lifeboat, the hook hydraulic activating cylinder and two hand-operated pumps. One pump was adjacent to the coxswain's position. The second, emergency pump to be used in case the coxswain's pump failed, was located within arm's reach of the aft-most port-side seating position.

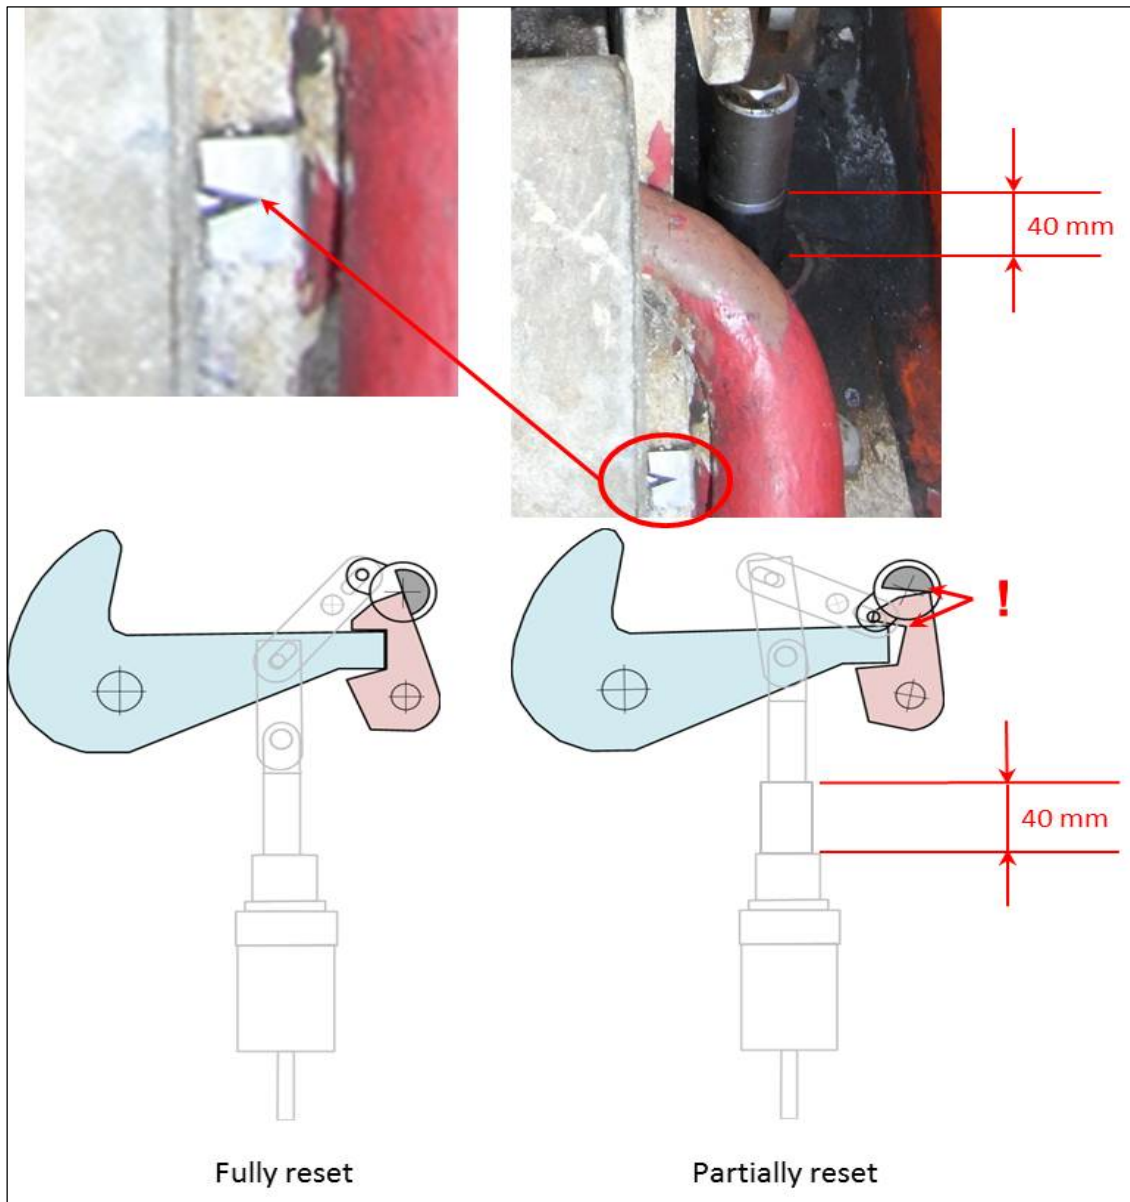
Figure 6: On-load release partial reset.

The on-load release had tripped unexpectedly because it did not properly reset when last operated. When the lifeboat was housed on completion of maintenance in the previous port, the activation cylinder ram had not fully retracted. This condition was not apparent because of a cover (Figure 7) fitted over the release mechanism and the lack of an indicator for the release linkage, which prevented a person being able to see that the ram had not fully retracted.

While the design of the on-load release system allowed the reset position of the hook to be visually confirmed, it did not allow for visual confirmation that the release segment and mechanism had been correctly reset. Consequently, the hook device could appear to be properly reset when it actually was not.

Safety action by the manufacturer included placing alignment marks on the release segment of new on-load releases mechanisms, to indicate when they are correctly reset. A lock-out 'maintenance pin' is also being provided for all new on-load releases to ensure the release cannot trip while maintenance is being performed.
