**The Report of the Investigation
Into the Allision incident involving the
Liberian Bulk Carrier NEW LEGACY (IMO No: 9804942) and the
Malta Registered Bulk Carrier DENSA TIGER (IMO No: 9432476)
Causing the foundering of a Bangladesh local cargo barge CHAR SHAMAIL,
And resulted in missing crew members of the barge
At Chittagong Anchorage, Bangladesh
On September 29, 2018.**

PUBLISHED BY THE LIBERIA MARITIME AUTHORITY

**December 20, 2019
Monrovia, Liberia**

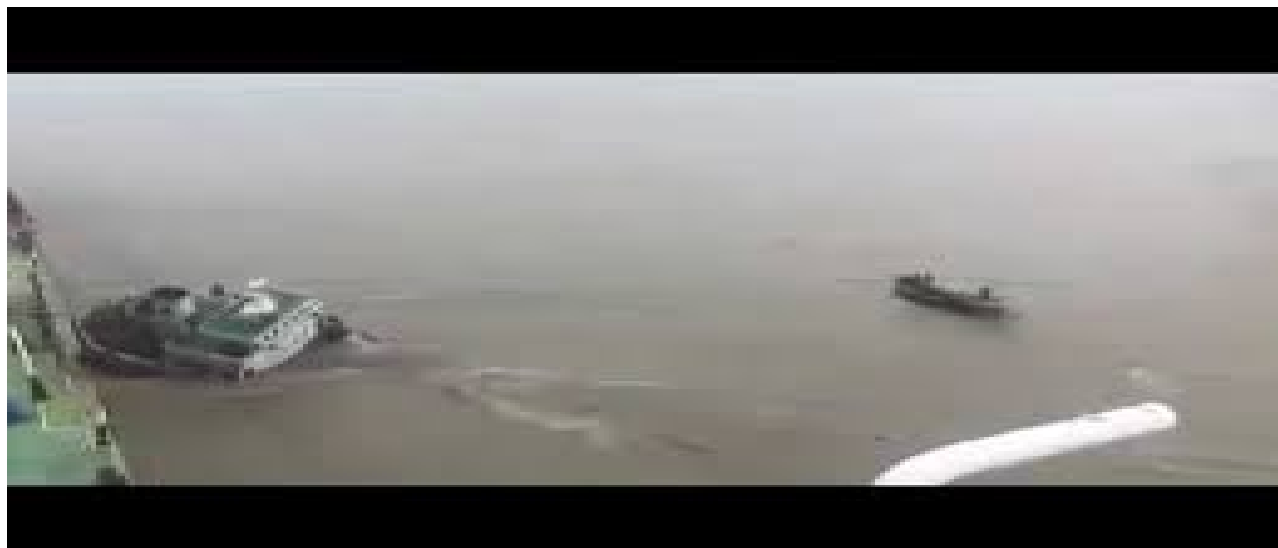
The Bangladesh Registered Inland Dry Cargo Barge CHAR SHAMAIL Seen Foundering on September 29, 2018)

The inland cargo barge CHAR SHAMAIL was at the starboard aft side of NEW LEGACY at the time of the contact, and she was crushed between the two vessels resulting in her severe breach to her hull, and causing in her foundering in less than five (5) minutes.

CHAR SHAMAIL sustained severe damages to her hull, causing her to take in water and founder as a result. The strong currents pushed CHAR SHAMAIL rapidly past DENSA TIGER and at 1117,LT the barge foundered in position 22°15.06' N 091° 45.3' E .

It is recommended that the barges having 'Bay Crossing' permission should be fitted with an inflatable liferaft with hydrostatic release placed at the aft/forward of the barges.

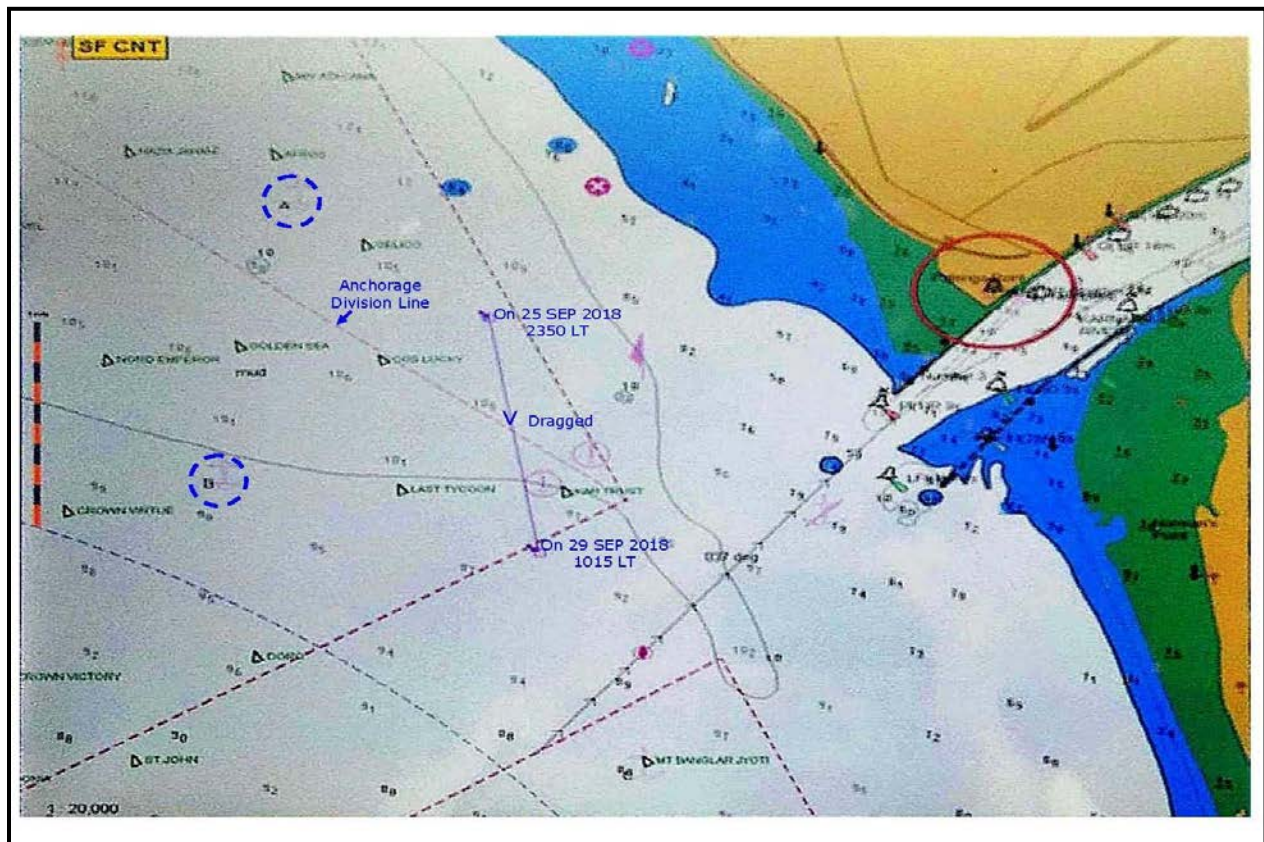
FIGURE 1 - *The Lightering Anchor Position of the NEW LEGACY*

The NEW LEGACY arrived at the 'A' anchorage of the Chittagong port on September 25, 2018 and at 2350 LT anchored at position 22^o 13.5' N and 091^o 46.1 E (*shown in Figure-1*). The vessel arrived with drafts of 9.80 m at forward and 10.45 m at aft, laden with 35,200 MT of "Carbon Steel Scrap in bulk" cargo from Portland, Oregon, USA.

At 1055 LT when the vessel was about to drop anchor, the Port Control Radio station advised not to anchor at 'A' anchorage and proceed to 'B' anchorage and drop anchor, as the vessel's draft was suitable for 'B' anchorage. The Chittagong A' and 'B' anchorages and the line of division are shown in *Figure-1* of this report.

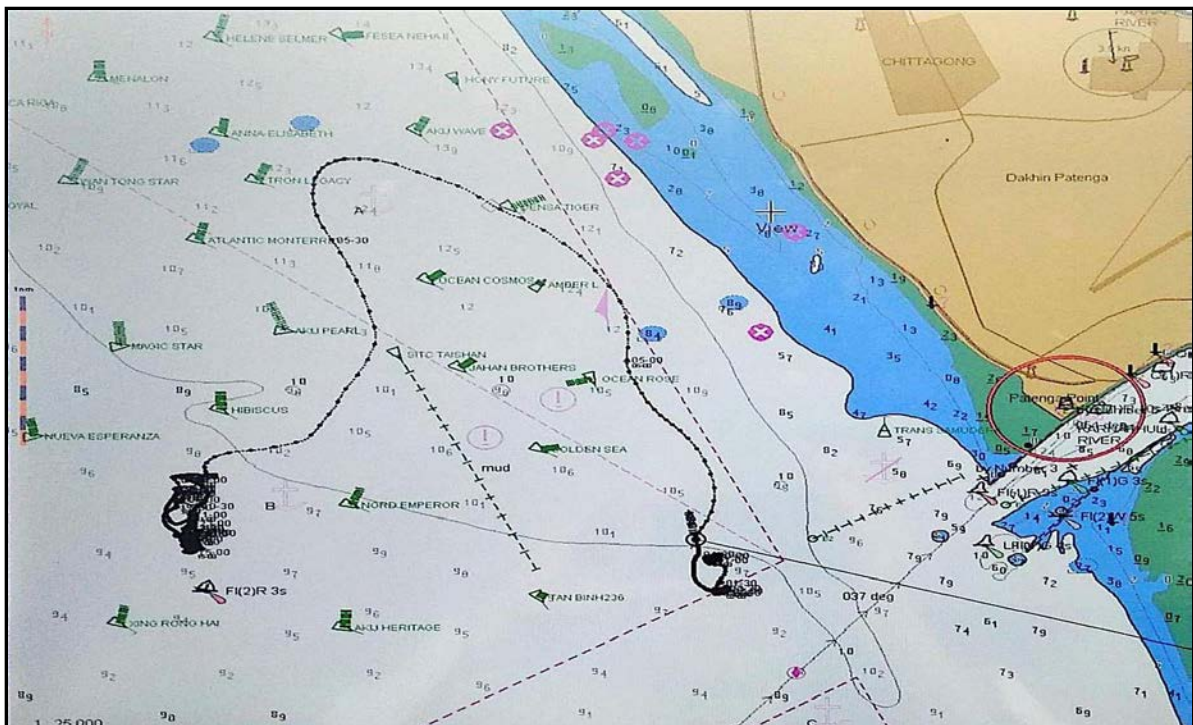
FIGURE 7 Anchorage Shifting Track of the NEW LEGACY

The track of NEW LEGACY from heaving up anchor at 1048 LT on 29 September 2018 until dropping anchor at 'B' anchorage at 1200 LT, is (*shown in the Figure -7*). The location of collision is the position of DENSA TIGER in the diagram shown by an arrow.

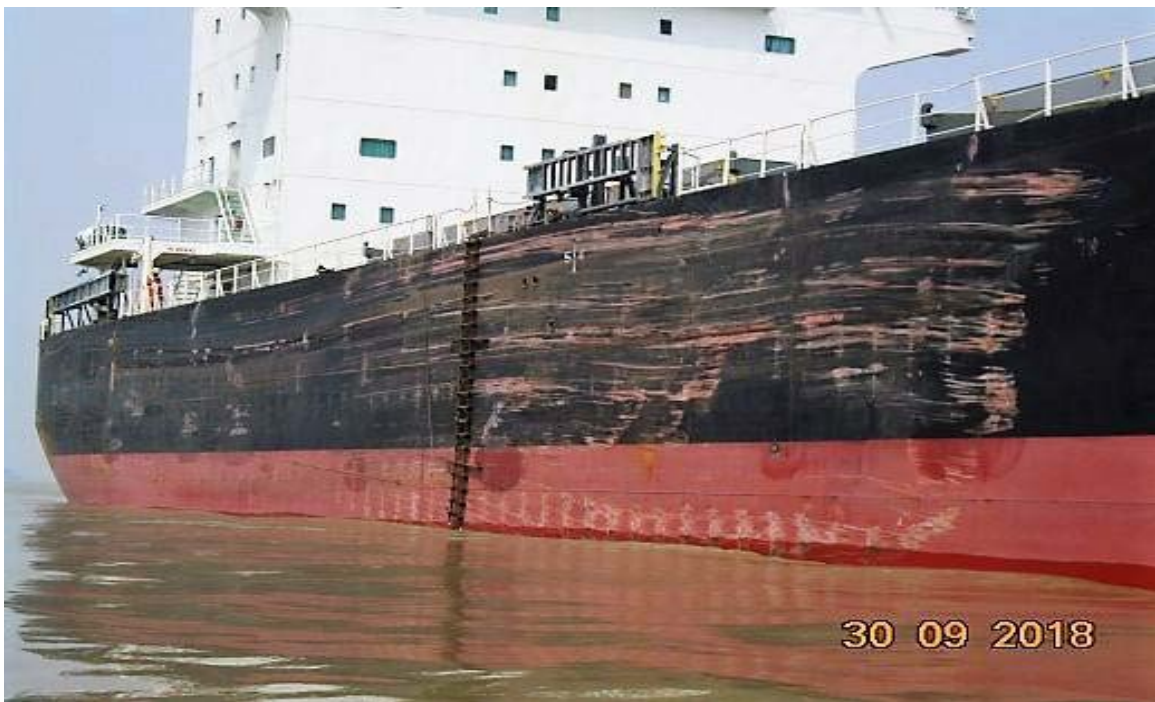
FIGURE 8 – Allision Damage to the NEW LEGACY

As for both the NEW LEGACY and DENSA TIGER, sustained minor damages because of the allision. The NEW LEGACY had long streak of paint scratches on her Starboard side shall plate in way of Cargo hold No 4 & 5. Three tier guard rails deformed at frame No 10 and 20, approximate length about 9.0 meters, and guard pipe of fairlead in way of poop deck on Starboard side were damaged (*as shown in Figure 8*),
