**MARINE ACCIDENT INVESTIGATION REPORT ON COLLISION BETWEEN MV SAMIR
AND MV GAZI AT CHITTAGONG PORT ON 11 NOVEMBER 2016**

Subject	FLAG STATE INVESTIGATION REPORT ON COLLISION/ALLISION BETWEEN M.V.SAMIR AND M.V.GAZI AT KARNAPHULY RIVER, CHITTAGONG ON 11 NOVEMBER 2016.		
Our Ref.:		Date	25 FEBRUARY 2017

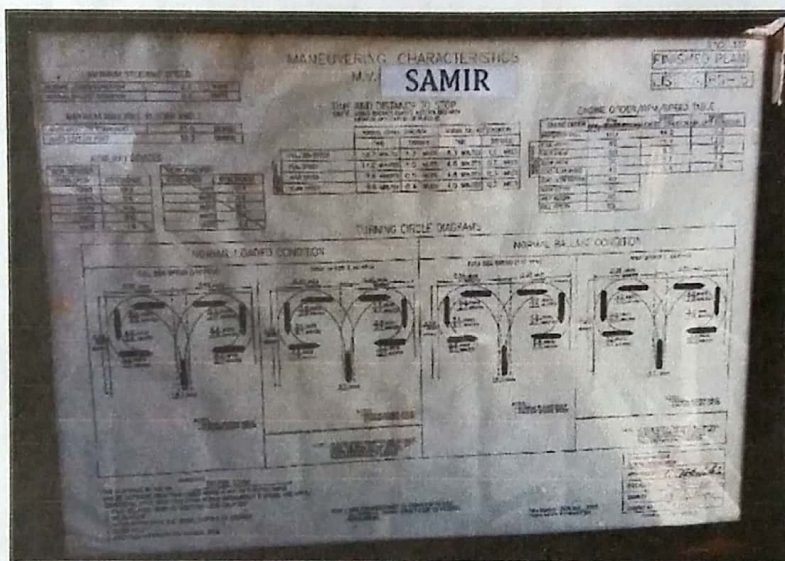
- 11.3 The vessel did not maintain safe speed in the prevailing condition and restricted visibility.

- 11.4 During restricted visibility the pilot was also maneuvering the vessel with the help of ECDIS where the chart setting and course laid up was not correct. It was also observed that the Chittagong Port pilot was not properly trained to navigate a vessel with the help of ECDIS.

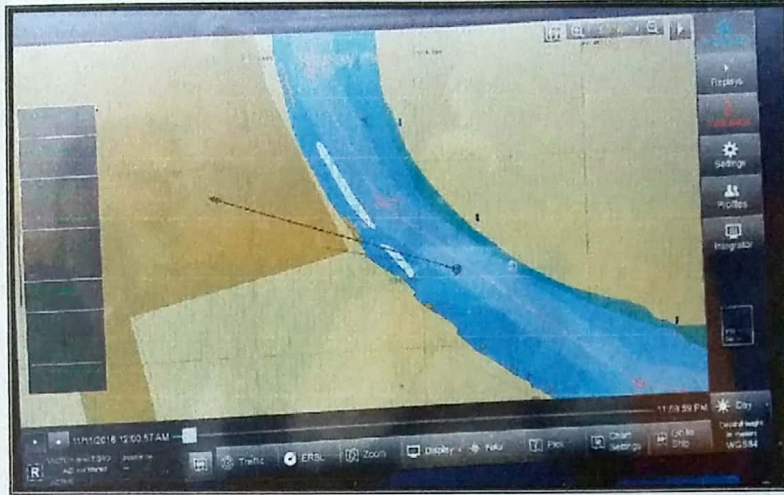
11.6 Prudent use of RADAR was not done (From the statement and practice of the ship's crew it was observed that in spite of the restricted visibility the prudent use of RADAR was not done to avoid the accident). The location of radar equipment may have discouraged the officers to make best use of it.

- 13.3 According to the SPECIFICATIONS FOR CHART CONTENT AND DISPLAY ASPECTS OF ECDIS the IHO publication S-52 para2.2.7 it is mentioned that, "the navigator should be able to see the display clearly, and to reach the controls, from his normal conning position, - it is an advantage to locate radar and ECDIS side by side". In the above case analysis it was observed that both RADARs were placed beside one ECDIS, which will reduce the productivity of RADAR by restricting many user. Also it should be mentioned that the RADAR watch can not be substituted by the use of ECDIS. ***As such there is scope of more study on ergonomics and implementation of new regulation to find out the best possible location for both ECDIS and RADAR so that both equipments may be used judiciously to avoid grounding and collision by the Master, Pilot or Watch keeping officers.***

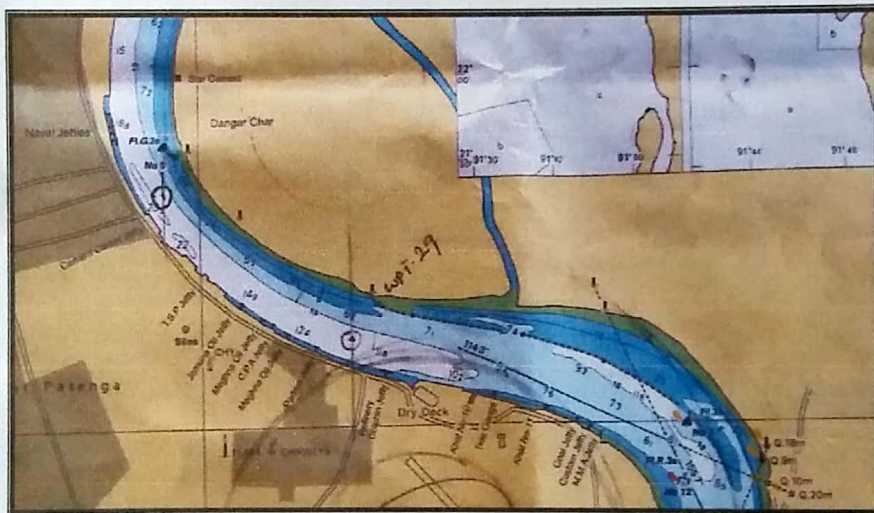
- 11.8 It was also observed that there is no lateral buoy mark in between Buoy No 7 and No 9, where the distance is about 1.8 nautical mile and the river also bends to the starboard direction.

13.5 The lateral buoy mark may be increased for all critical areas including not more than a distance of 0.5 nautical mile apart within the Karnaphuly river for the sake of safe navigation in restricted visibility and night navigation.
