**Report on the Investigation of
The Fatal Accident On Board
M/V HAZAL**

**Port of Ünye
13th June 2013**

Report No: 06/2015

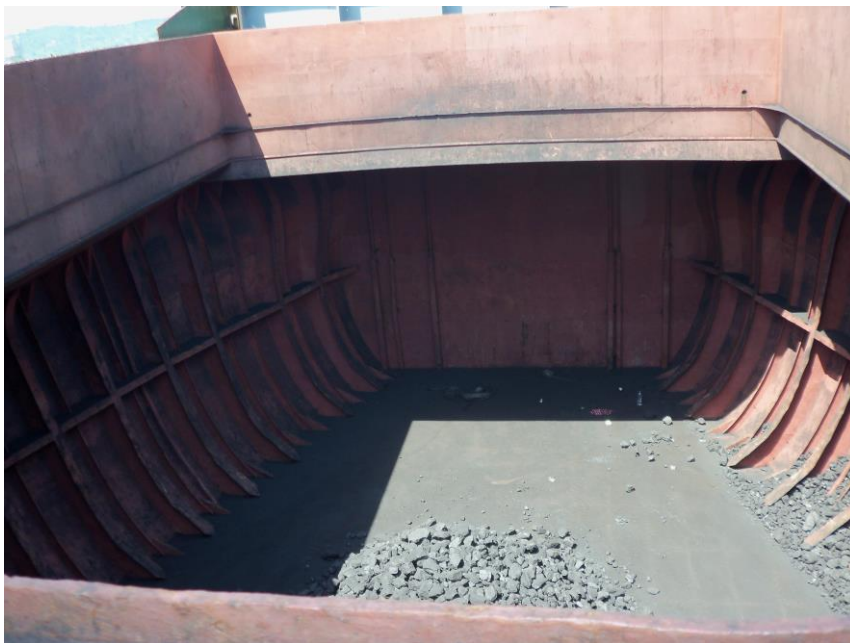
Figure 2: Location of the accident: No.1 hold

Vessel has three holds and the discharging operation started from No.1 cargo hold and before the cargo in No.1 hold was completely finished, it was stopped and continued in No.2 and No.3 holds. Then they resumed discharging from No.1 hold. Accident occurred in No.1 cargo hold and at the time of the accident the least quantity of Cargo was in No.1 hold, compared to No.2 and No.3 holds.

The deceased worker stood up from where they were resting and proceeded to the frames at the the fore part of the hold to move the coal between those frames. While he was trying to pass behind the bobcat, the bobcat hit him and he fell on the floor. His friends/coworkers ran to help him; he was conscious at that time. He was taken out of the hold on a stretcher and taken to hospital by an ambulance. As a result of the injury he was suffering, the worker lost his life.

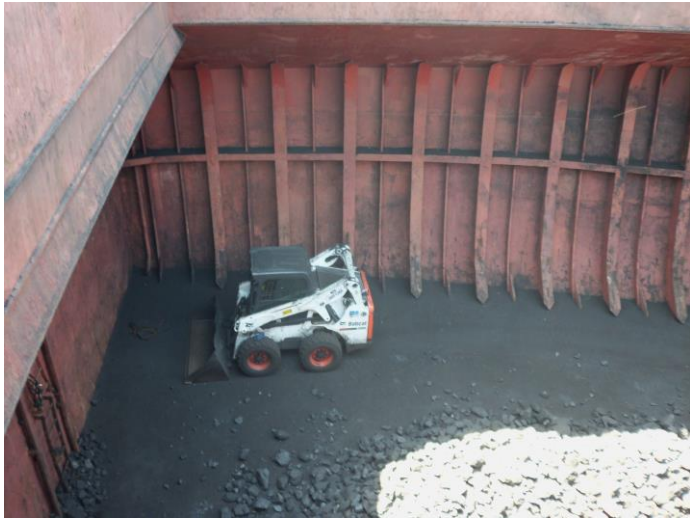
Figure 3: Bobcat inside the hold

Inside the ship, bobcat's job is to carry or sweep the coal to within reach of the shore crane. The edge of the scoop of the bobcat is straight and made of steel. It can carry up to 1220 kg of cargo.

Company has two bobcats; old one is Model 250 and new one is Model 650. The bobcat which was used on the day of the accident was the new one. It was bought two years ago. Its manoeuvre is fast and its scoop can be raised and lowered.

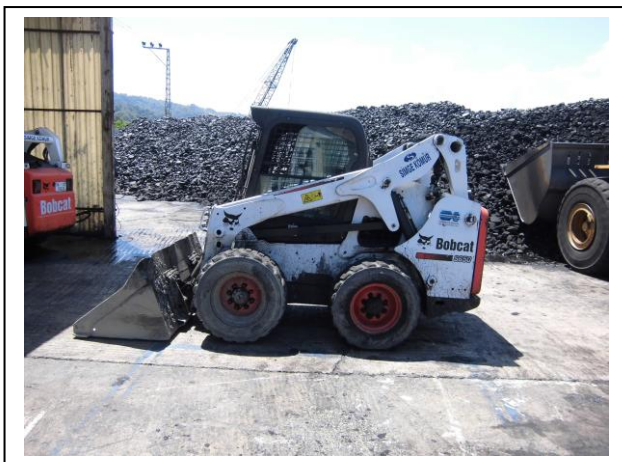
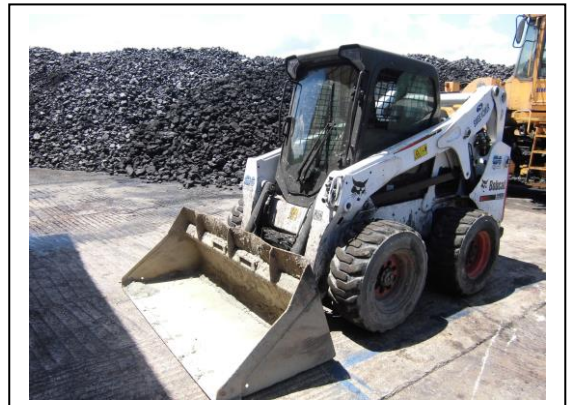
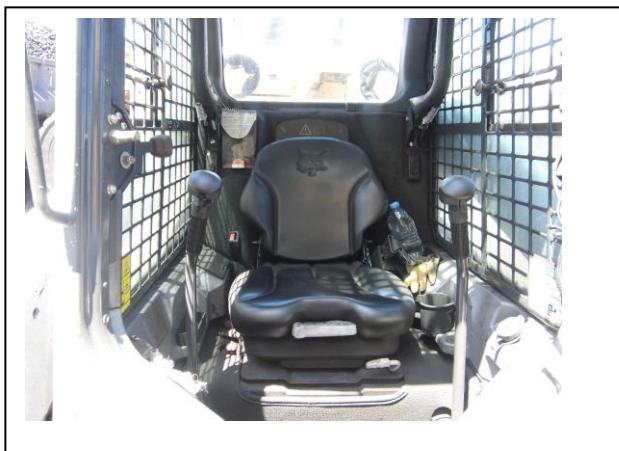
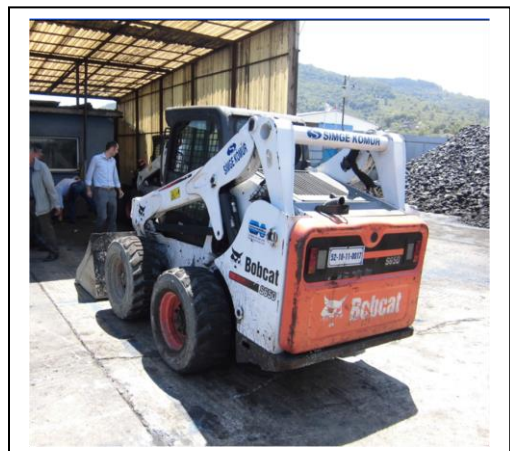
Figure 4: Bobcat from different sides and from inside the cabin

Bobcat has its own projector lights and they are strong enough for the illumination of the site. The driver cabin is totally closed, but there are windows on either side which can be opened by the driver. However, the window has protection bars outside and the driver cannot hold his head out of the cabin.

Bobcat did not have a side mirror to observe the back, when it would go backwards. The back window of the bobcat was usually stained with dust and was being covered with dust quickly again even if it would be cleaned. There is a wiper in the front

window, which is also equipped with a water spray; but the back window does not have such a mechanism.

3.1 Bobcat did not have a signal, visual or audial, to warn the workers while it was moving backwards.

4.1.5 Equip the bobcats with a signal for backward movements.
