Report on the Investigation of
The Collision Between
M/F ANKARA and M/V REINA 1

Adriatic Sea/Off Port Durrës
20th October 2011

Report No: 05/2012

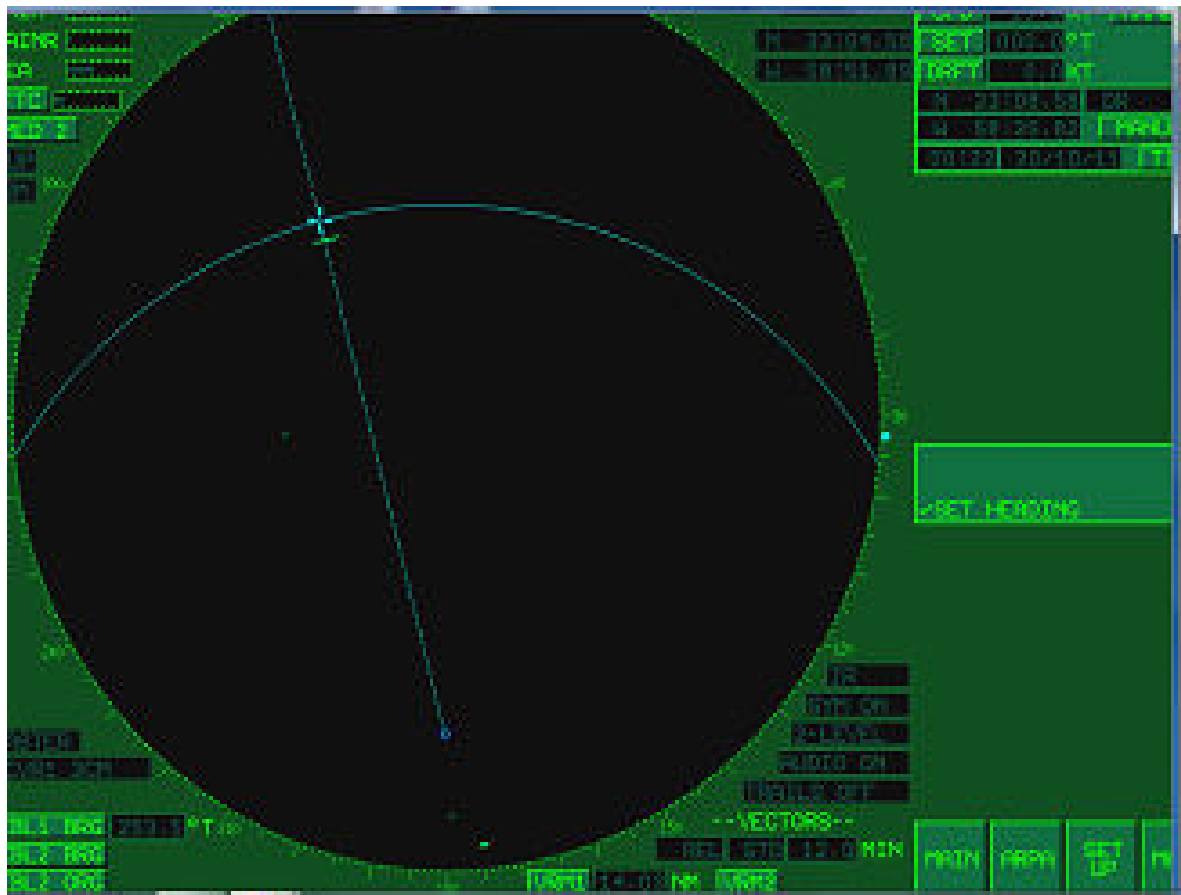
Figure 5: The screen shot when REINA 1 first appeared on the radar

When the master first started to monitor REINA 1, the vessel was at a distance of 8,57 nm and its bearing was 241°. The first communication between the two vessels took place at 00:40, when the vessels were approximately 2,5 nm from each other. The OOW of REINA 1 called ANKARA via VHF. In the meantime, the master of ANKARA was still monitoring the position of REINA 1. This communication and subsequent calls on VHF between the two vessels were in Turkish.

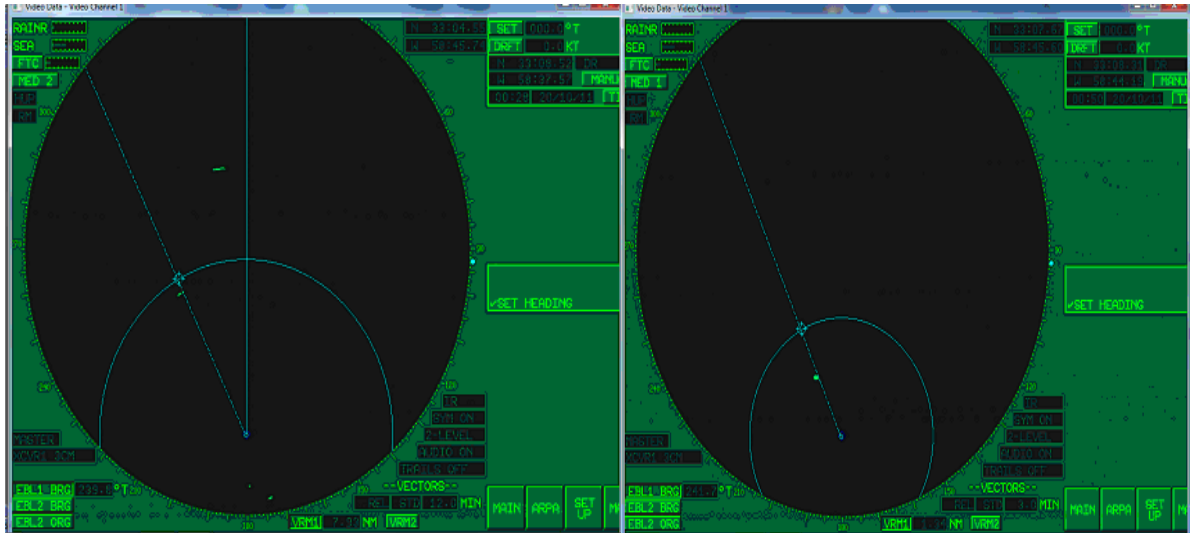
Figure 8: REINA 1's bearing not changing at 8 nm and 7 cable distances

Although there were no changes in the bearings from the moment REINA 1's echo was detected by ANKARA until REINA 1 contacted ANKARA via VHF, both vessels maintained their respective courses and speeds.

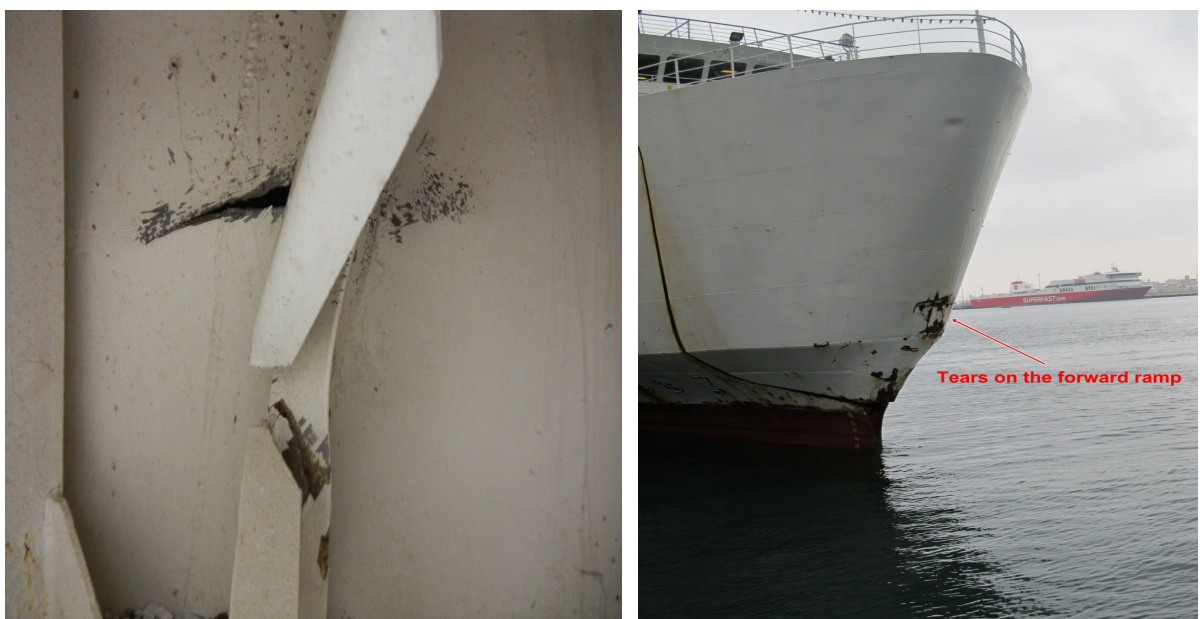
Figure 9: Damage to the bow of ANKARA (1)

The master of ANKARA deduced that there was no serious damage to his ship that could affect its buoyancy/stability. There were two cracks on the forward ramp, approximately 2,5 metres above the water line. The vessel sustained other hull damages in way of the forward ramp, bulbous bow and to a number of structural elements inside the fore peak tank (including frames, stiffeners, stringers, etc.)

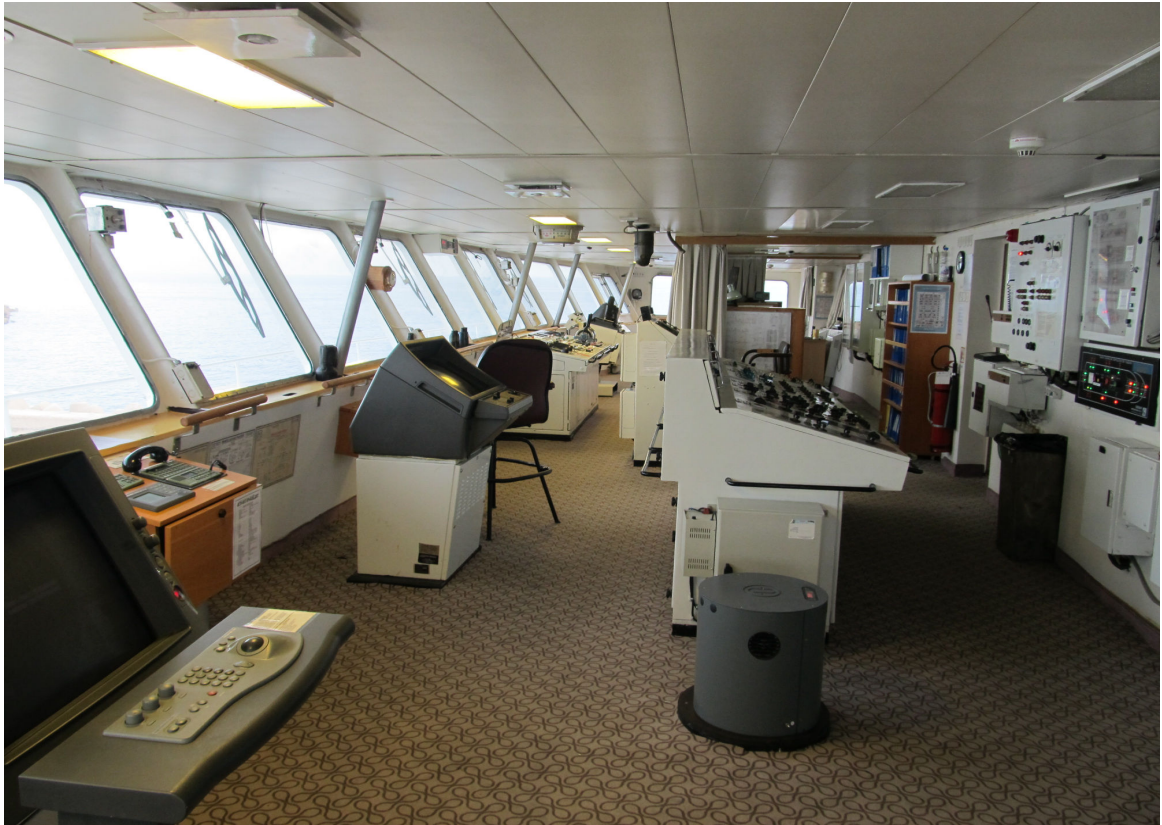
Figure 11: Bridge deck of ANKARA

In addition to this, one of the basic methods to determine whether or not a ship's course is creating risk of collision, (changes in its bearing or the extent which its course is changing) is by the use of gyro repeater/pelorus. Proper use of such equipment can give an excellent indication on whether or not a ship is creating a risk of collision. However, ANKARA has a closed bridge deck, with no bridge wing. Moreover, there was no gyro repeater on the bridge console.

It is evident that in the moments prior to the collision, the master of ANKARA was not monitoring the progress of REINA 1 with the use of the gyro repeater, but only by using the EBL and VRM functions of the ARPA radar. As the gyro repeater is located on the fly bridge, it is probable that the master did not find it practicable to leave his watch on the bridge to monitor the bearing of REINA 1 using the gyro repeater. Rather, he was satisfied to monitor REINA 1 with the use of the radar, which nonetheless was not set in the better display option.
