INTERIM SAFETY INVESTIGATION REPORT

202012/007

December 2021

MV *Atlantic North* **Propulsion malfunction of another vessel** **leading to two allisions** **in the port of Bejaia, Algeria** **05 December 2020**

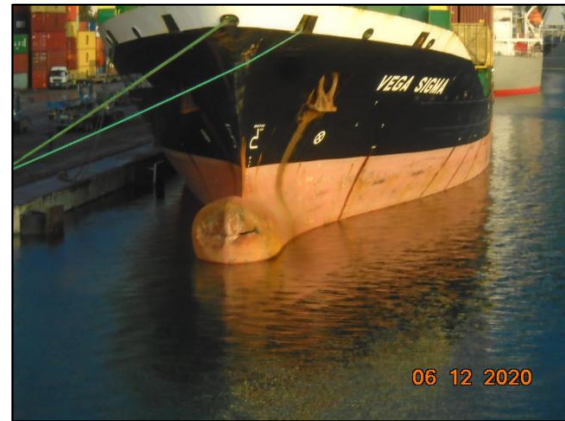
Vega Sigma sustained a metre-long crack on the port side of her bulbous bow, and indentations on the starboard side (Figure1).

Figure 1: Damages to *Vega Sigma*'s bulbous bow

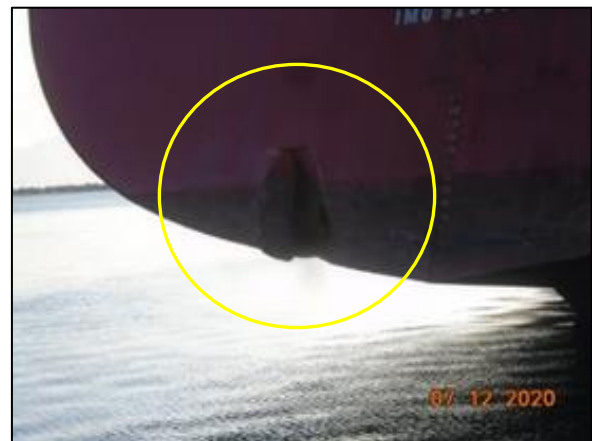
Vega Sigma struck *Atlantic North* in way of her aft peak tank. As a result, *Atlantic North*'s aft peak tank was breached (Figure 2).

Figure 2: Hole in aft peak tank

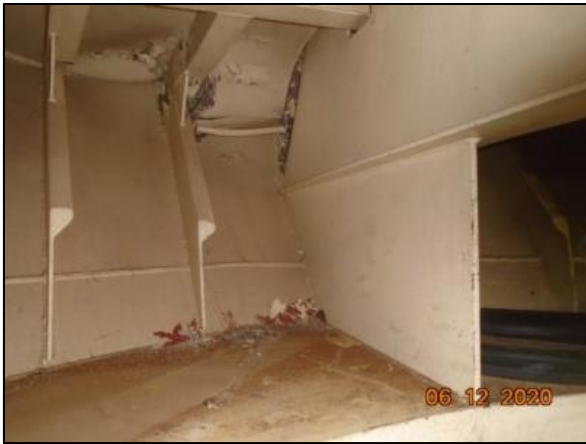
Having moved along her berth and making contact with *Owl*, *Atlantic North* sustained damages to her forecastle and her bow area (Figures 3 and 4).

Figure 3: Deformed internal structure in the forecabin store

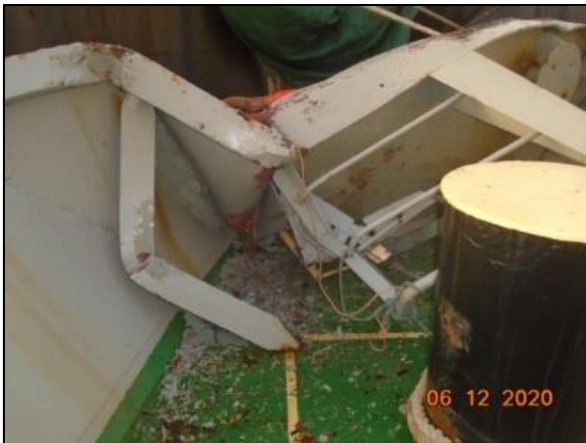
Figure 4: The damaged bulwark on the bow of Atlantic North

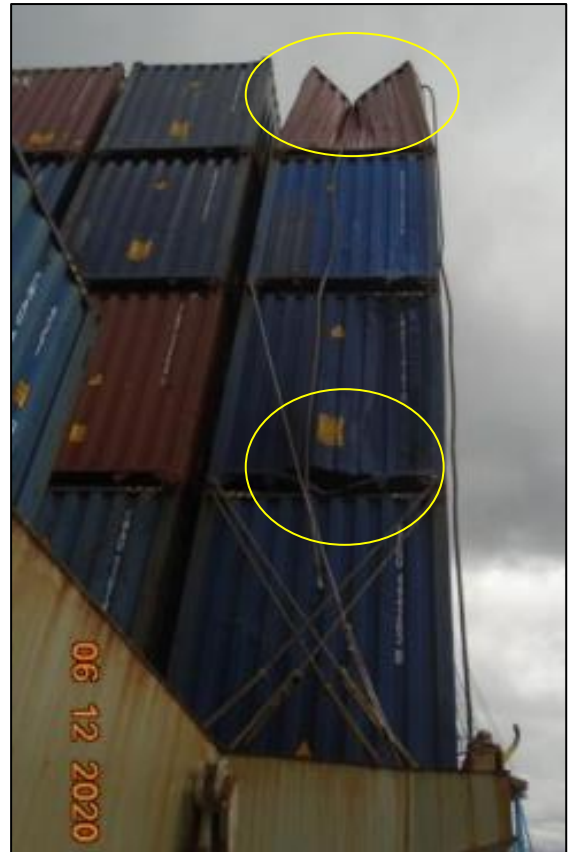
Once *Atlantic North* moved forward along the pier, the mobile shore crane loading containers on bay 10, was struck with the containers stacked on board. Several cargo hold boundary railings were bent. In addition, the containers that struck the shore mobile crane had sustained multiple structural damages (Figure 5). Several of these containers contained cargo.

Figure 5: Several damages sustained by the containers on board Atlantic North

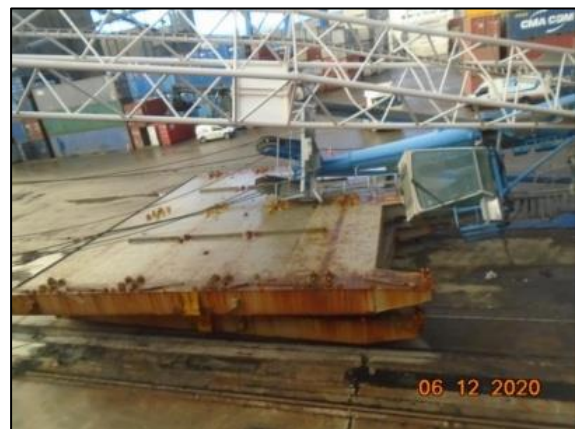
The shore crane toppled over onto the vessel's pontoon type hatch covers of bay 10, which at the time were lying on the berth. Several cracks and dents to the hatch covers were reported by the crew (Figure 6).

Figure 6: The hatch covers of bay 10 struck by the mobile shore crane

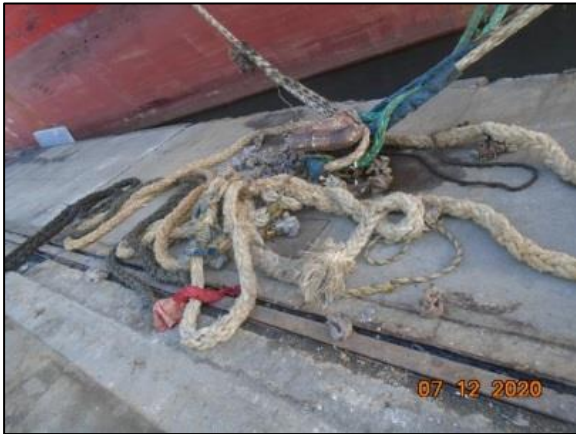
Atlantic North's mooring ropes failed during the impact (Figure 7).

Figure 7: Several remains of *Atlantic North's* mooring lines on the berth

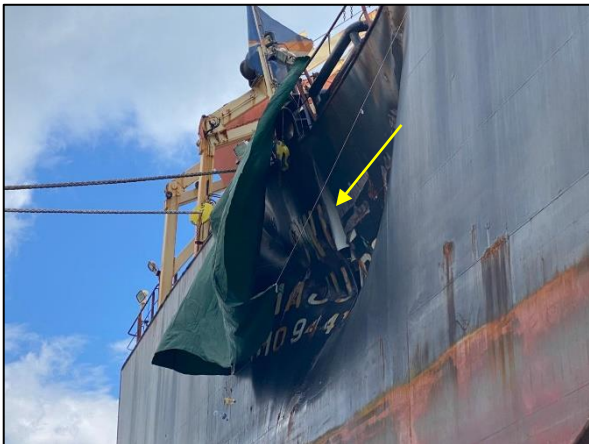
Owl was struck by the bow of *Atlantic North* in way of her steering gear room. This resulted in a hull breach and a deformed poop deck, including dislodged mooring leads (Figures 8 and 9).

Figure 8: The breached stern plating of *Owl*

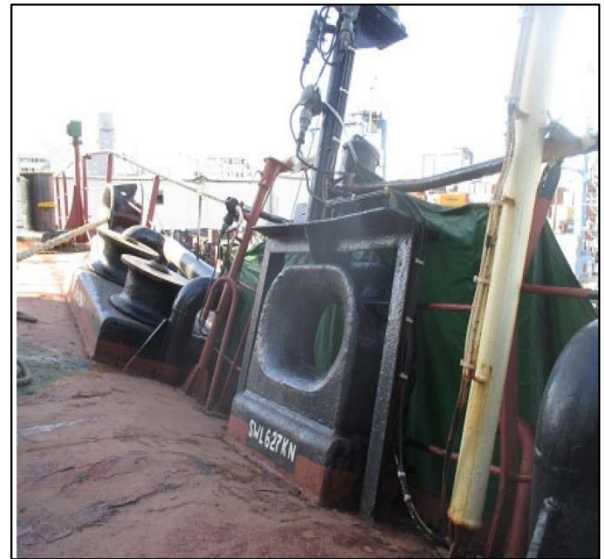
Figure 9: Deformations on poop deck

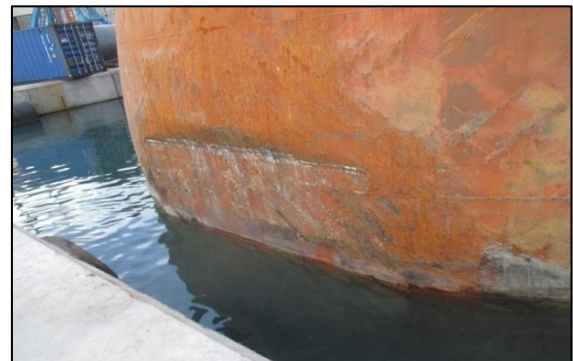
Additionally, *Owl* sustained a dent on her bulbous bow, when she allided with the pier ahead of her (Figure 10).

Figure 10: Dent on *Owl's* bulbous bow
