Summary

At 1026 (UTC +1) on 9 August 2011, *CSL Thames*, a Maltese registered self-discharging bulk carrier, grounded briefly in the Sound of Mull while on passage from Glensanda to Wilhelmshaven. The vessel sustained bottom damage to her hull, including a 3-metre fracture to one of her water ballast deep tanks, which flooded. There were no reported injuries or pollution.

Grounding of *CSL THAMES* in the Sound of Mull 9 August 2011

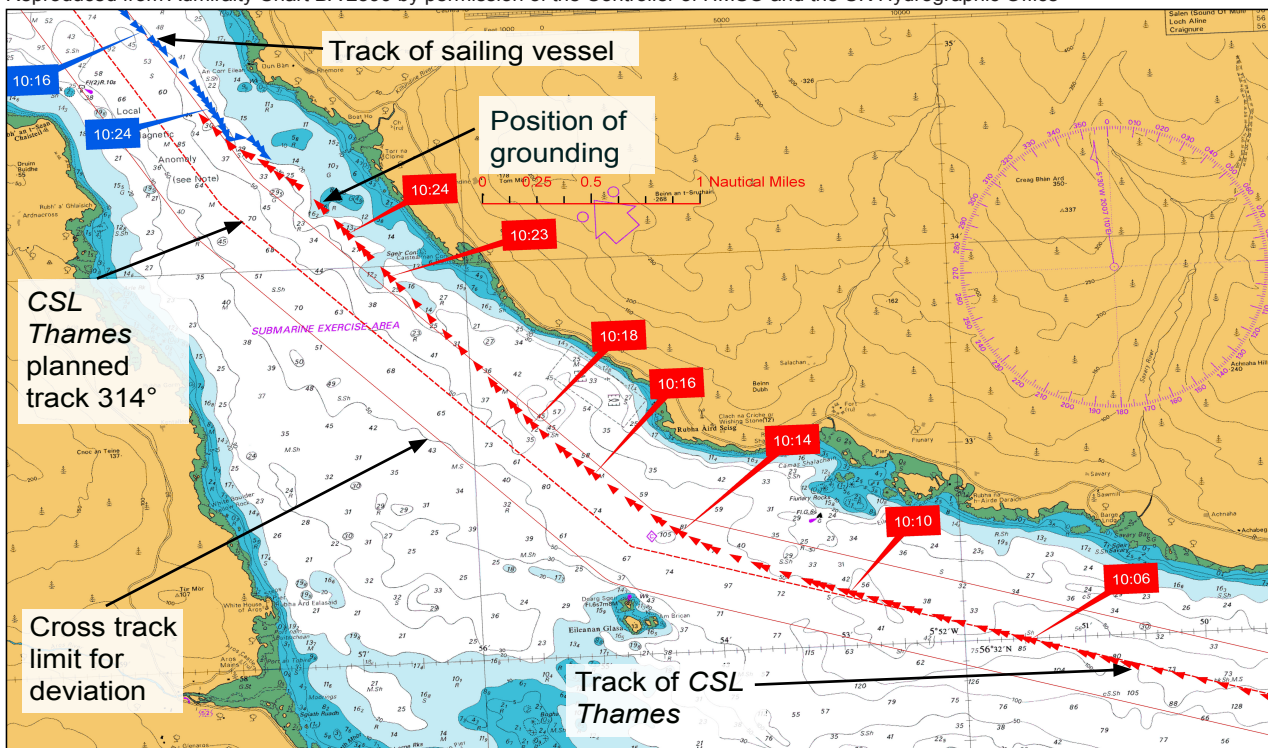
Figure 1: AIS tracks of *CSL Thames* and sailing vessel

At 1006 (**Figure 1**), with *CSL Thames* on a heading of 290°(T) at a speed of 12 knots, the master instructed the helmsman to engage the autopilot and then handed the con to the third officer, who stood facing the starboard radar display, with the

At 1010, the third officer interpreted from the ECDIS display that *CSL Thames* was about 1 mile from the next planned waypoint; he also estimated that a sailing vessel he could see on the starboard bow would be ahead of *CSL Thames* when she was steady on her new course. Intending to leave the sailing vessel to port, he decided to turn early and, by adjusting the autopilot, initiated a slow alteration of course to starboard towards the next planned course of 314° (T). At 1014 (**Figure 3**), as *CSL Thames's* heading was passing 308°(T), the third officer acquired on the radar an automatic identification system (AIS) target of the sailing vessel at a range of 3.6 miles and on a bearing of 318.5°(T). At 1016, with *CSL Thames* approaching her planned course of 314° (T), he decided to continue the alteration to starboard to place the sailing vessel onto the port bow. At 1018, *CSL Thames* was on a heading of 321° (T) when the third officer observed another small vessel right ahead at about 1 mile range. With the intention of leaving the small vessel to port, he continued altering course to 324° (T). The ECDIS anti-grounding warning zone alarm then activated on the display, but no audible alarm sounded.

The third officer's decision to prematurely initiate a turn to starboard before *CSL Thames*'s next waypoint was based on an assumption that the sailing vessel would follow an approximately reciprocal course to *CSL Thames*'s next planned course. He perceived that the planned alteration of course would result in the two vessels being placed at risk of collision, and therefore he opted to alter course early to keep to the starboard side of the Sound. Soon afterwards, he acquired the sailing vessel's AIS target on the radar display bearing 318.5° (T). This required him to alter *CSL Thames*'s course further to starboard than originally intended to bring the sailing vessel onto *CSL Thames*'s port bow. The third officer then saw another small vessel ahead, which he presumed to be crossing from starboard to port. In again opting to leave this vessel to port, the third officer altered course further to starboard and onto a track that would cause *CSL Thames* to run aground within 10 minutes.

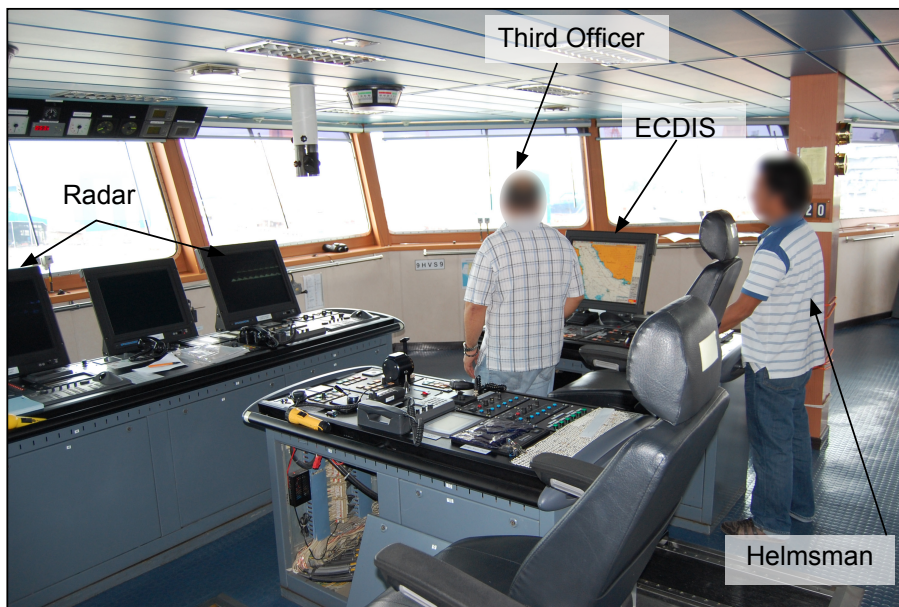
Figure 2: View of ECDIS and position of bridge team

ECDIS display to his right (**Figure 2**). The master increased the volume on a portable compact disc player that had been playing music on the bridge since the pilot disembarked, and moved to the communication centre on the port side of the bridge to send routine departure messages.

While the third officer relied on the ECDIS as the primary means of navigation, he did not appreciate the extent to which he needed to monitor *CSL Thames*'s position and projected track in relation to the planned track and surrounding hazards. The ECDIS display was orientated so that the OOW had to face to starboard to look at the screen (**Figure 2**). Although this might have been ergonomically satisfactory for routine navigational watchkeeping, the third officer's overriding priority during the period leading up to the accident was collision avoidance, which required him to look ahead. Had the ECDIS display been located in front of him, he would have been more likely to routinely consult it when monitoring the navigational situation.

3. Had the ECDIS display been located in front of him, the third officer would have been more likely to routinely consult it when monitoring the navigational situation.

- Repositioned the main ECDIS unit adjacent to the starboard radar to enable the officer of the watch to view the display while facing forward.
- Reconnected the ECDIS unit to the bridge alarm monitoring unit to provide a functioning audible alarm.
- Arranged for *CSL Thames's* bridge officers, and the management company's DPA and nautical superintendent to attend an 'equipment specific' training course on the ECDIS type fitted on board.
- Arranged for the fleet's bridge officers to attend a bridge resource management course.
- Arranged for the nautical superintendent to provide onboard ECDIS training to the fleet's other vessels fitted with ECDIS or electronic charts.

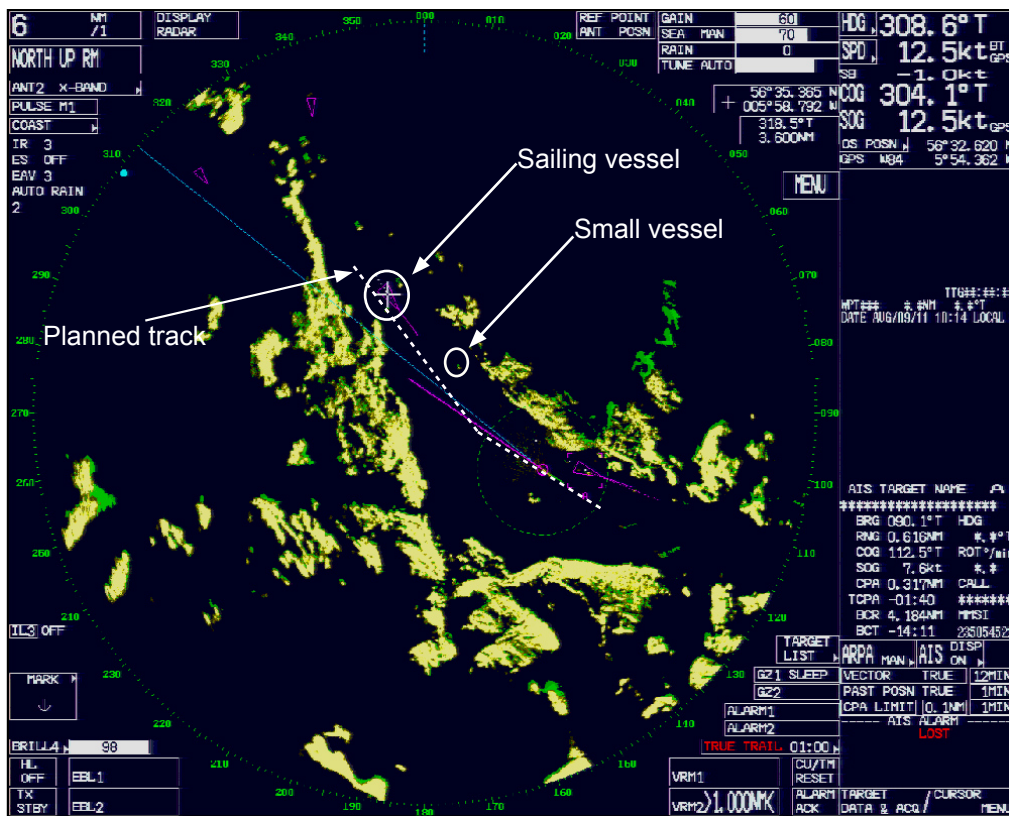
Figure 3: Radar display at 1014 - overlaid with planned track

The third officer was required by Rule 7 of the COLREGS⁴ to determine if a risk of collision existed before taking action. Analysis of *CSL Thames*'s radar recording indicates that, had the third officer followed the planned track in accordance with the passage plan, the other two vessels would have passed clear on her starboard side (**Figure 3**).

2. Analysis of *CSL Thames's* radar recording indicates that, had the third officer followed the planned track in accordance with the passage plan, the other two vessels would have passed clear on her starboard side.

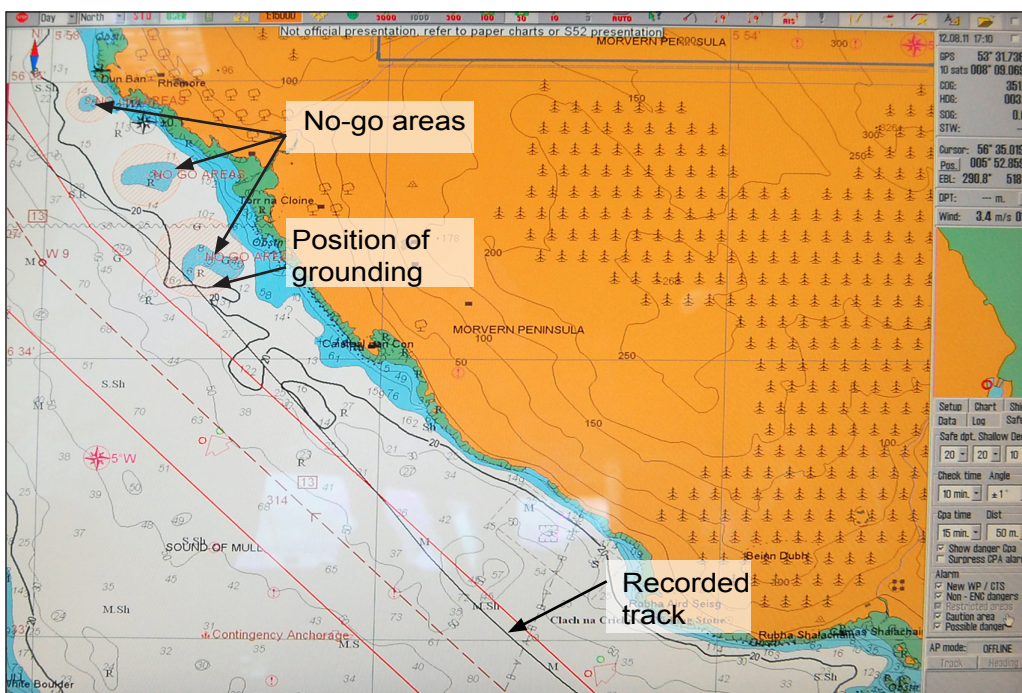
Figure 4: ECDIS display showing recorded track

At 1025, *CSL Thames* grounded in position 56° 34.3'N, 005°57.2'W at a speed of about 12 knots (**Figure 4**). The contact with the seabed lasted 16 seconds and caused the vessel to vibrate loudly. This prompted the master to return to the conning position and to look at the ECDIS display. Recognising that his vessel had run aground, he instructed the helmsman to switch to manual steering and ordered the wheel to hard-a-port. The sailing vessel also altered course to port and both vessels narrowly avoided colliding with each other.

A safety contour setting of 10 metres was inappropriate for *CSL Thames's* draught of 10.63 metres. Taking into account the height of tide of 1.4 metres and an estimated squat of 0.9 metre, the vessel would have grounded at a charted depth of 10.13 metres, before crossing the safety contour. Although the ECDIS anti-grounding warning zone visual alarm activated, the audible alarm, which should have alerted the third officer to the fact that *CSL Thames* was heading into danger, did not function. This was because the ECDIS unit was not connected to a loudspeaker or buzzer capable of sounding an audible alarm, contrary to the IMO's performance standards⁵.

4. The third officer did not detect activation of the anti-grounding warning zone visual alarm because he was not monitoring the ECDIS display.
5. The ECDIS anti-grounding warning zone audible alarm, which should have alerted the third officer to the fact that *CSL Thames* was heading into danger, did not function.
