**MARINE ACCIDENT  
INVESTIGATION REPORT**

# MARINE ACCIDENT INVESTIGATION REPORT

Accident Type	Injury of crew members
Date and Time	At around 1700 hours (local time, UTC+9 hours) on November 15, 2011.
Location	In the northwestern waters of Tsunoshima, Shimonoseki City, Yamaguchi Prefecture, Japan. At around 312° true bearing, 10.2 nautical miles from Tsunoshima Light House (Approximately 34°28.1' N., 130°41.3' E.)
Process and Progress of the Investigation	(1) Set up of the Accident Investigation The Japan Transport Safety Board appointed an investigator-in-charge from Moji Office and one other investigator to investigate this accident on November 16, 2011. (2) Comments from parties relevant to the cause of accident Comments on the draft report were invited from parties relevant to the cause of the accident. (3) Comments from the flag State Comments on the draft report were invited from the flag State of a cargo ship, CABRERA.
Factual Information Vessel type and name, Gross Tonnage, Vessel number, Owner, etc. L x B x D, Hull material, Engine, Output, Date of launch, etc.	A Cargo ship CABRERA (registered in Republic of Malta), 24,210 tons, 9537977 (IMO No.), CABRERA SHIPPING A/S (

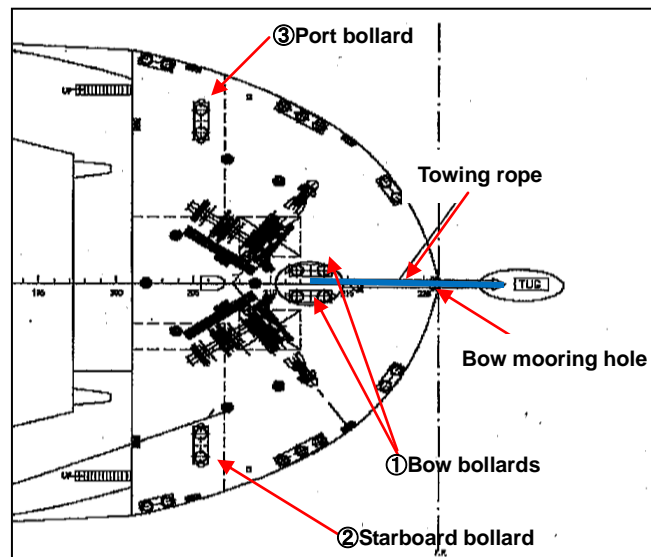
“Excerpt from Emergency Towing Equipment Manual”

The numbers and designations of bollards mounted at the forecastle deck of Vessel A are as shown in the chart below “Bollard Equipment and Designations”, and their locations are as indicated in the figure below, “Excerpt from Emergency Towing Equipment Manual.”

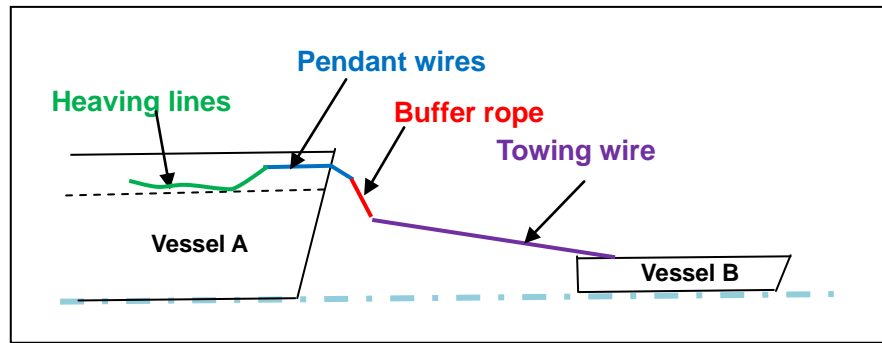
“Schematic of Towing Rope”

Vessel A → pickup rope → heaving lines → pendant wires → buffer rope → towing rope → Vessel B

The towing rope of Vessel B consisted of a buffer rope connected with a shackle to a towing wire wound at the Vessel B drum, which is then shackled to the two pendant wires.

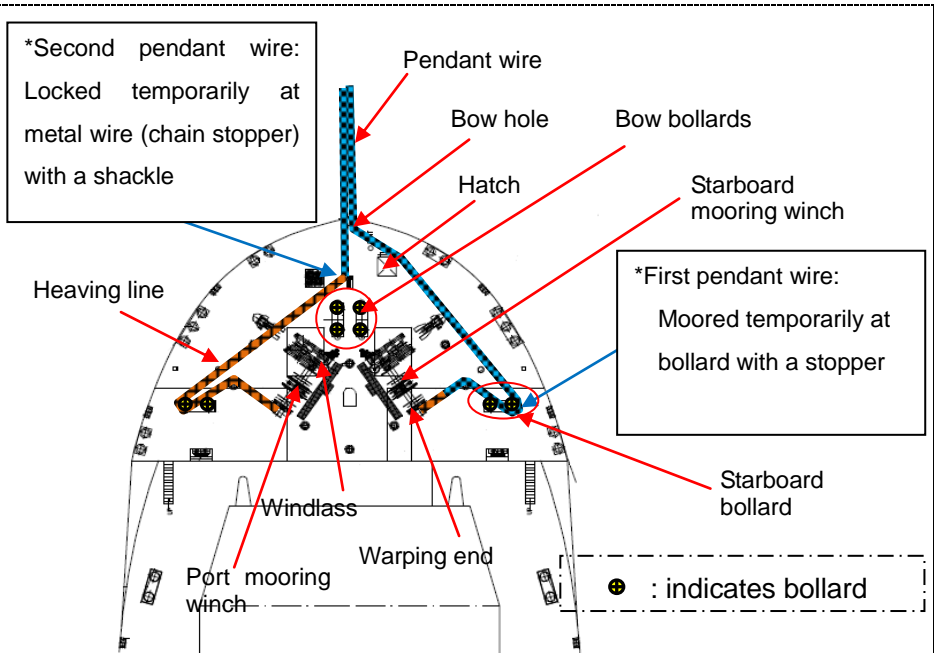
“Towing Rope Arrangement”

When the pendant wire’s eye being wound up with warping end of the starboard mooring winch came to a position to be moored at the bollard, but the eye’s diameter was smaller than that of the bollard, so the Vessel A decided to pass the pendant wire around the bollard and to attach a shackle to the wire’s eye.

The heaving line and the pendant wire being wound with the warping end of the starboard mooring winch were in contact with the corner of the hatch located towards starboard bow of the forecastle deck.

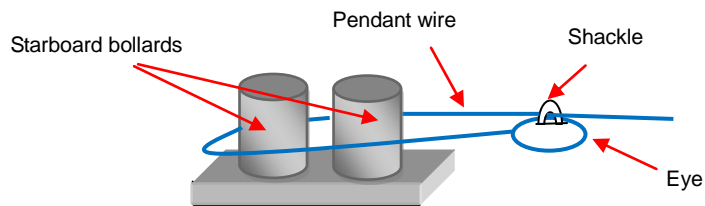
“Assumed Status of Pendant Wire Locking”

The ordinary seaman  $A_1$  was standing right side of the starboard bollard with a backup stopper to replace the cut-off stopper, and the ordinary seaman  $A_2$  was standing about 1 m away from the bow, while they were taking the stopper to the starboard bollard in order to moor the pendant wire temporarily at the said starboard, when, at about 17 00 hours, the heaving line was broken, and the pendant wire hit the lower leg of the ordinary seaman  $A_1$  and  $A_2$ , knocking both of them down screaming.

<p>not be clarified as no one witnessed the situation wherein the said line was broken.</p> <ul style="list-style-type: none"> <li>• It is possible that when Vessel B was oscillating up and down due to the waves, breaking load over the capacity was imposed on the heaving line.</li> <li>• It is possible that the breaking load capacity of the heaving line had been weakened since it had been passed for about 14 years since the vessel's launch.</li> <li>• It is possible that the heaving line was passed through the bow hole, instead of the starboard fairlead as planned by the Vessel B, and therefore when it was wound up with the warping end of the starboard mooring winch, it came in contact with the hatch corner in front of the starboard forecastle deck, which thus impaired the line strength.</li> </ul>
<p>Probable Cause</p>	<p>It is probable that this accident took place while the Vessel A was working on the mooring of the towing rope with Vessel B in the northwestern waters of Tsunoshima, they tried to moor temporarily the pendant wire, which were picked up by heaving line rolled by warping end of the starboard mooring winch, with the starboard bollard and attached the stopper to the said bollard, when the heaving line was broken and thus the pendant wire hit and injured the lower legs of Ordinary Seaman A<sub>1</sub> and Ordinary Seaman A<sub>2</sub> working there.</p>

<p>Actions Required</p>	<p>The following are possible measures to prevent the recurrence of similar accidents:</p> <ul style="list-style-type: none"> <li>• When engaging in mooring operation of towing ropes, crews of a towing boat and a towed vessel shall have full discussion on mooring method and safe towing method by giving consideration to the arrangement of mooring equipment of the towed vessel as well as using a mooring schematic, etc.</li> <li>• It is advisable to inspect the towing rope properly and replace it with a new rope as needed.</li> <li>• When taking a stopper, care shall be taken not to impose load on a rope of low breaking strength and to secure safety of crew members. The crew members shall engage in the work in a safe location in case the towing rope is broken.</li> <li>• The operation leader shall always keep in mind the behavior of the crew members so that they do not enter the danger area.</li> <li>• The operators of equipment machines shall not leave their assigned position except for compelling reasons such as approaching danger, and in the event of leaving the machines in operation, such</li> </ul>
