MV *SPRING BOK* and MV *GAS ARCTIC* Collision 6nm south of Dungeness, UK 24 March 2012

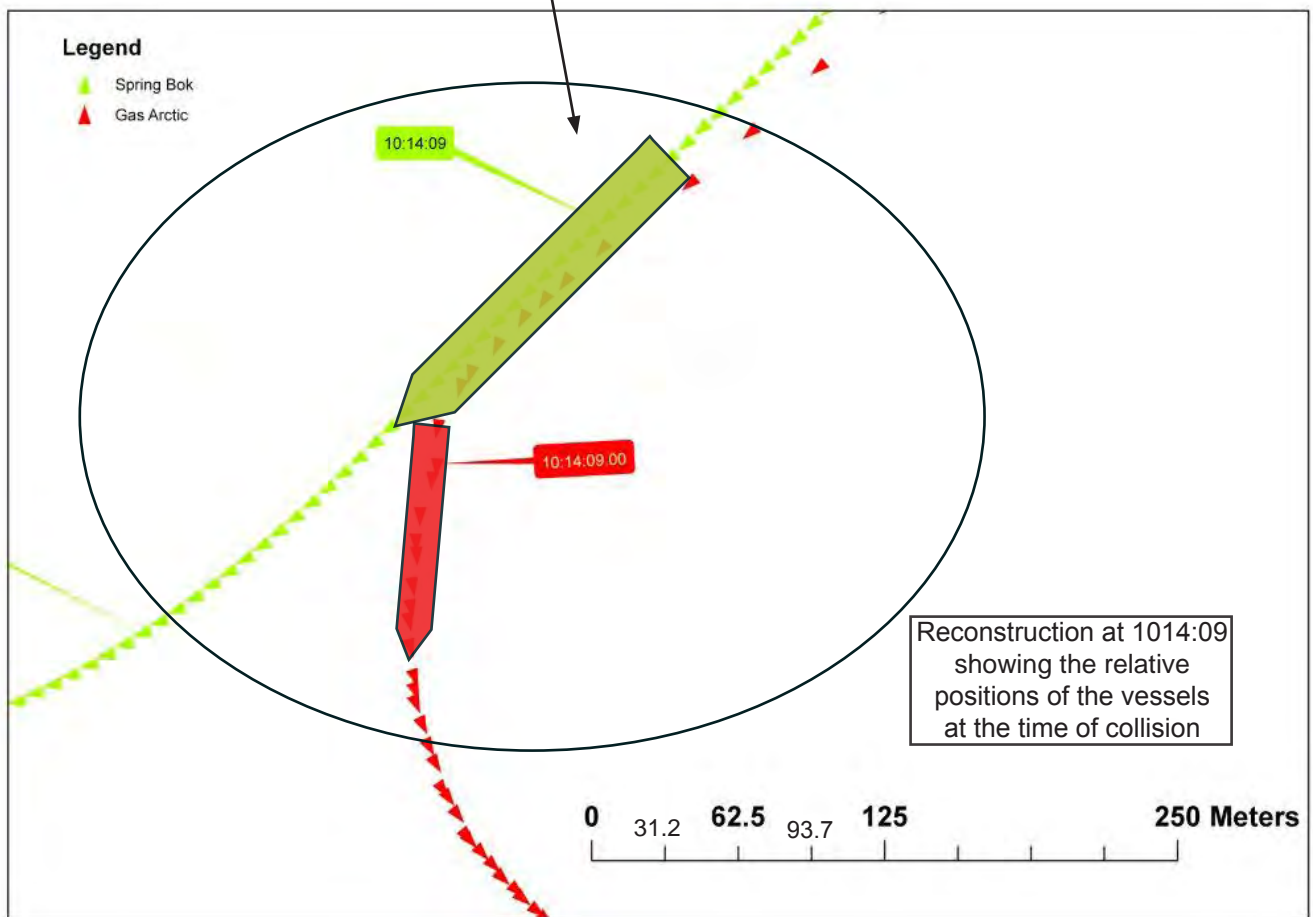
Figure 7: Reconstruction

The reconstruction of the ground tracks of *Spring Bok* and *Gas Arctic*, based on GPS information (**Figure 7**), confirms that *Spring Bok* was overtaking *Gas Arctic* and made no alteration of course before the collision.
