**REPUBLIC OF CROATIA  
MINISTRY OF THE SEA, TRANSPORT AND  
INFRASTRUCTURE**

## **MARINE ACCIDENT REPORT**

### **COLLISION OF THE MOTOR VESSEL "JOERG N" AND THE FISHING VESSEL "GOLUB"**

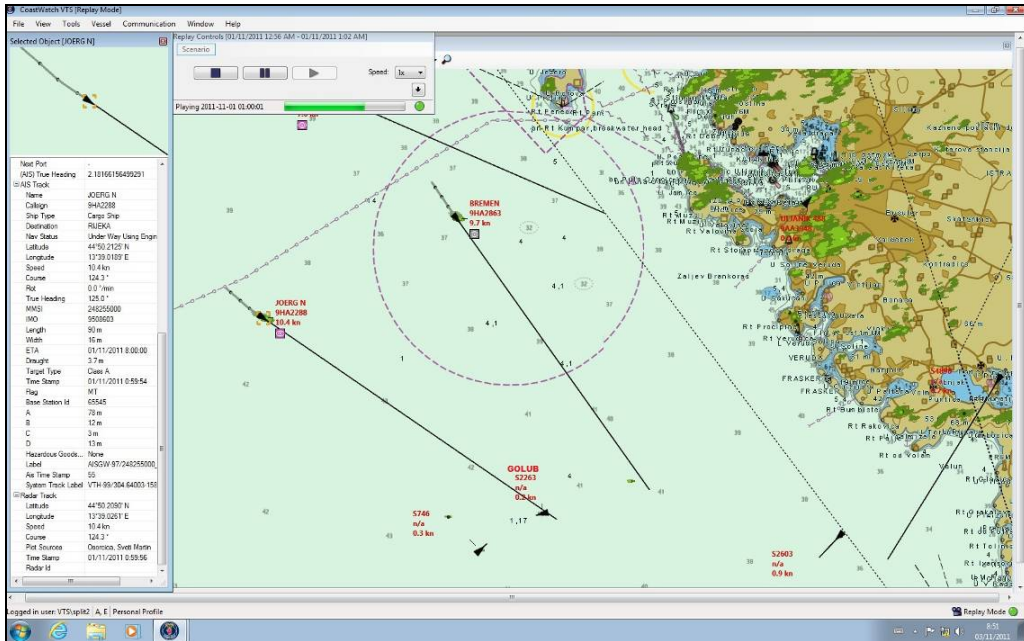
Figure 9. Change of course of the "Joerg N" motor vessel to approximately 125° - the "Golub" fishing vessel is situated dead ahead of "Joerg N" (1 Nov at 01:00)

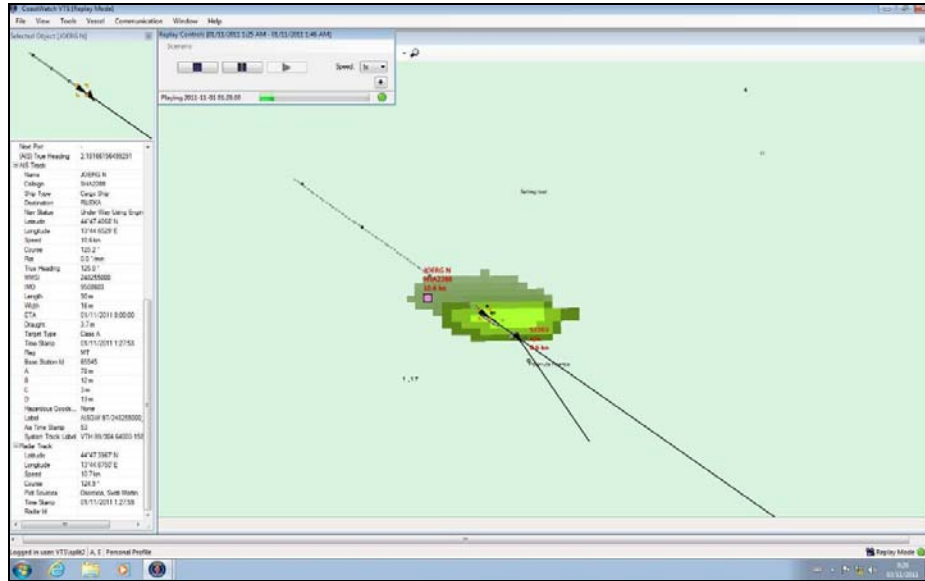
Figure 13. The moment immediately before the collision (1 Nov at 01:28)

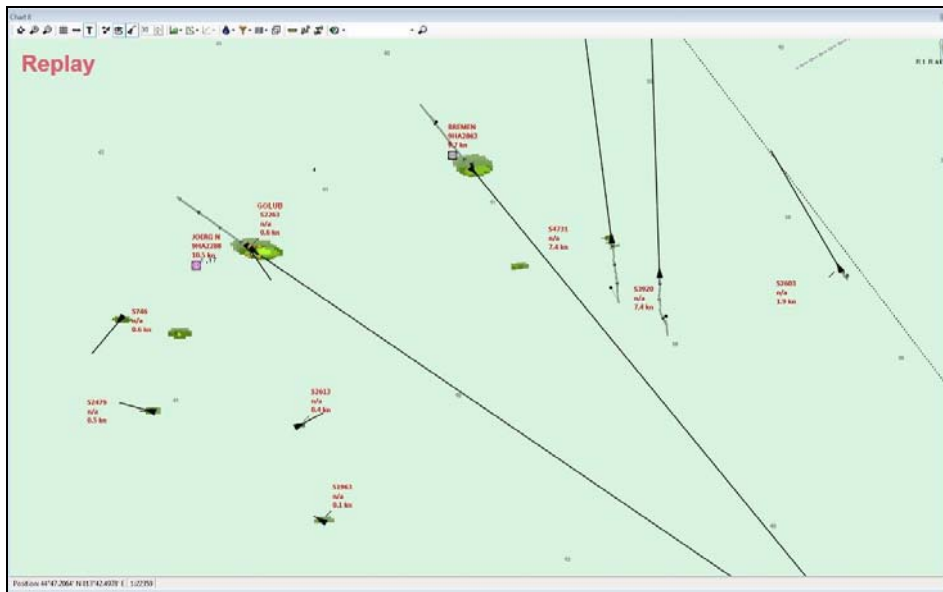
Figure 14. The moment of collision (1 Nov at 01:28)

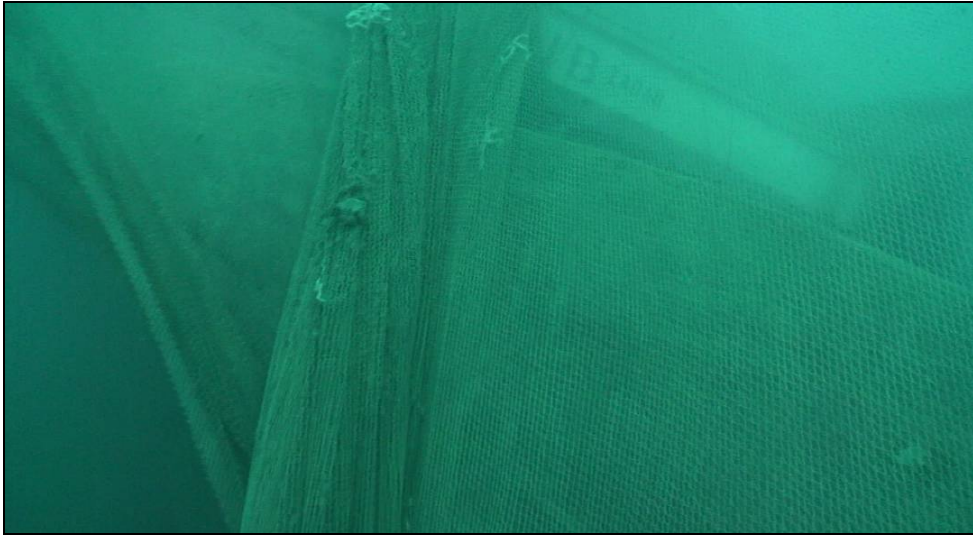
Figure 19. "Golub" fishing vessel at the point of sinking (ship's stern)

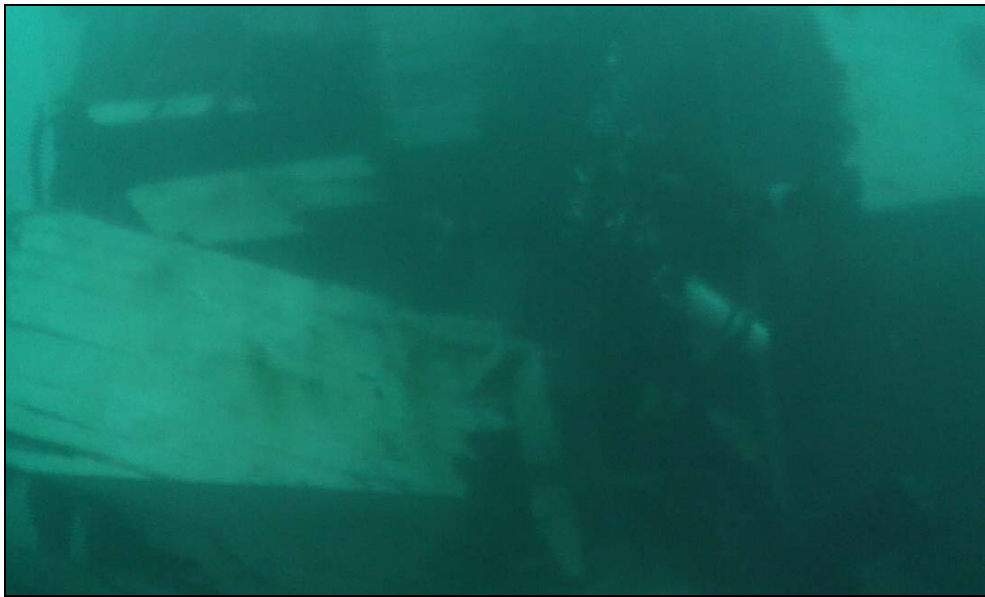
Figure 20. Damage of the "Golub" vessel on the left hull (towards the bow)

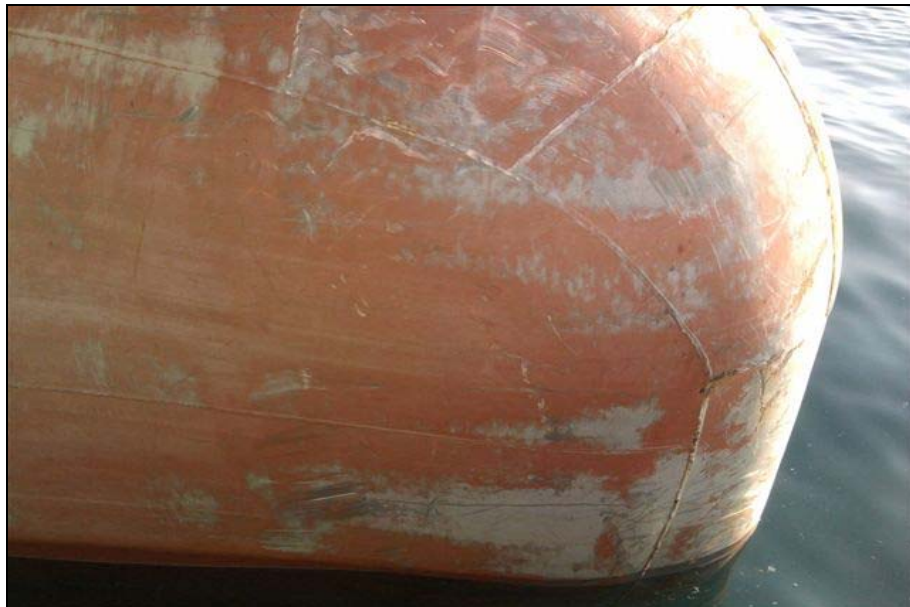
Figure 22. Damage of the "Joerg N" vessel on the bow
