## INTERIM SAFETY INVESTIGATION REPORT

REPORT NO.: 202006/006

### *MV Margarete Schulte* Fatal injury to stevedore in the port of Manzanillo, Panama 10 June 2020

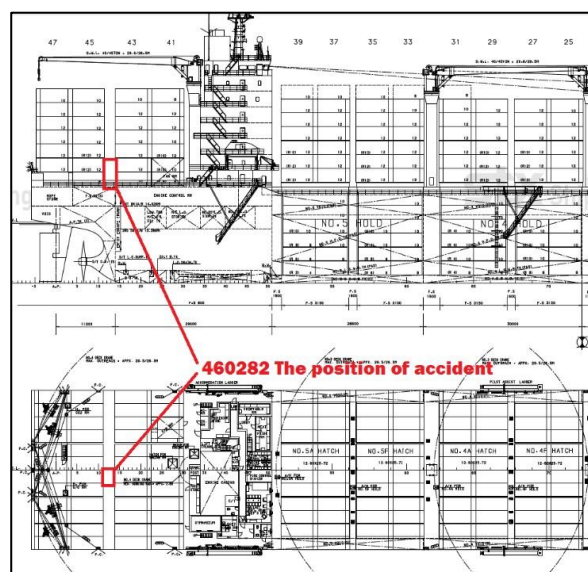
The third officer rushed out to the deck to investigate. A shore security guard, stationed at the vessel's gangway near the accommodation block, informed him of an accident involving a stevedore, forward of bay 46 (Figure 2). The third officer immediately notified the second officer, followed by the chief officer and the master, who were in their respective cabins.

**Figure 2: Location of the accident**

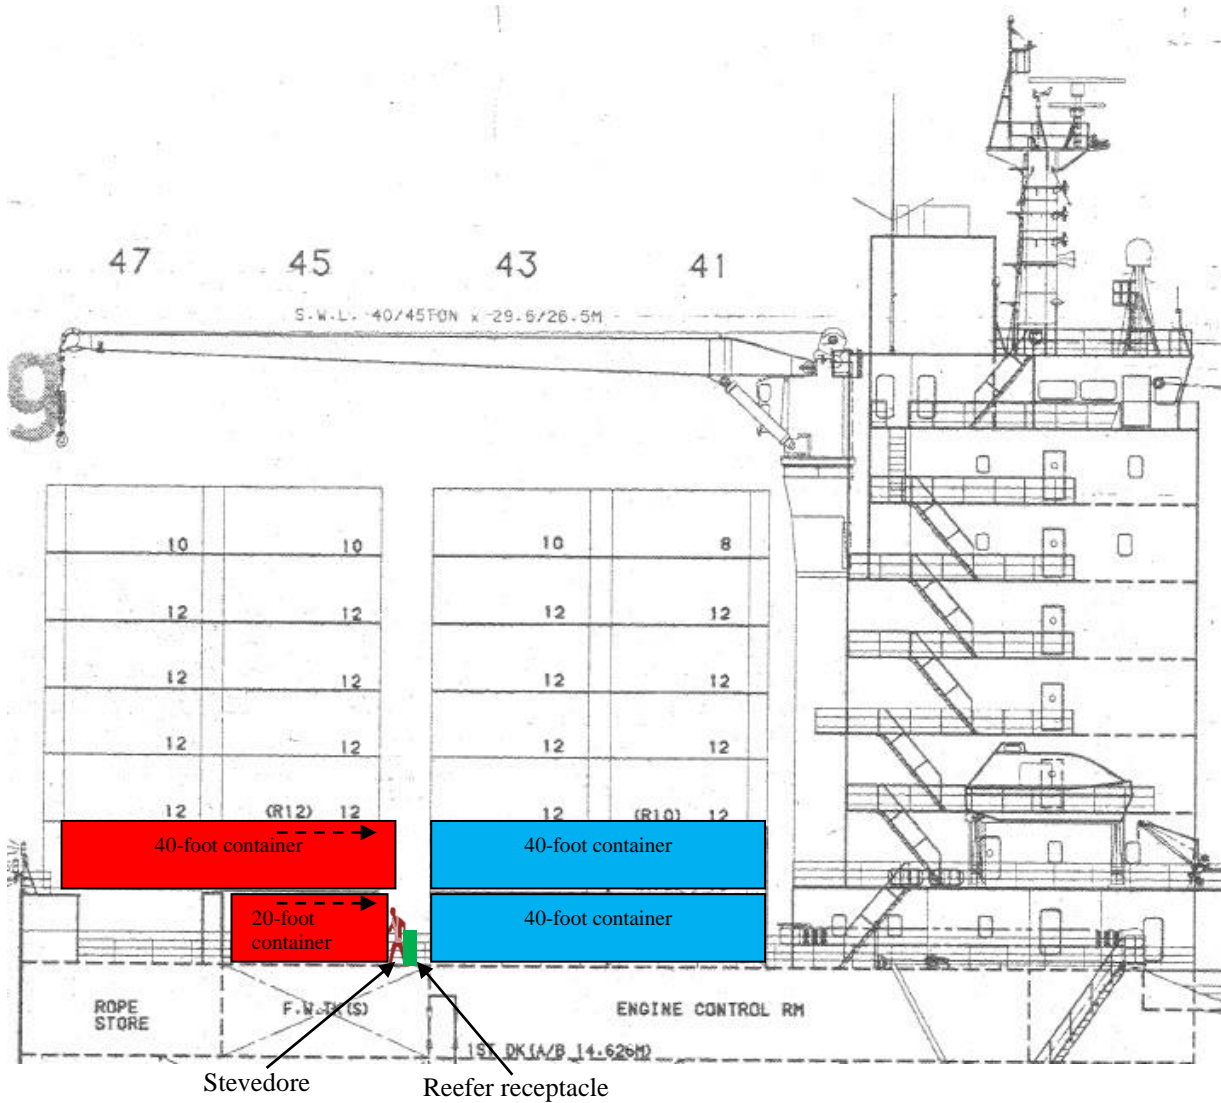
On reaching the accident site, the second officer and duty AB noticed that a 20-foot container, loaded in bay 45, row 02, tier 82 (450282), and a 40-foot container loaded above it (460282) had slid forward from their stowage positions. Consequently, a stevedore who was working forward of bay 45 was entrapped between the 20-foot container and the guardrails of a reefer receptacle (Figures 3 and 4).

**Figure 3: Accident dynamics (the red containers shifted forward from their stowage positions)**

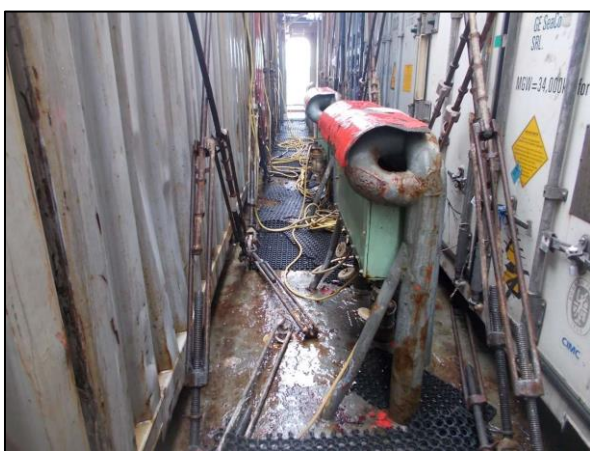
**Figure 4: The reefer receptacle with guardrails**

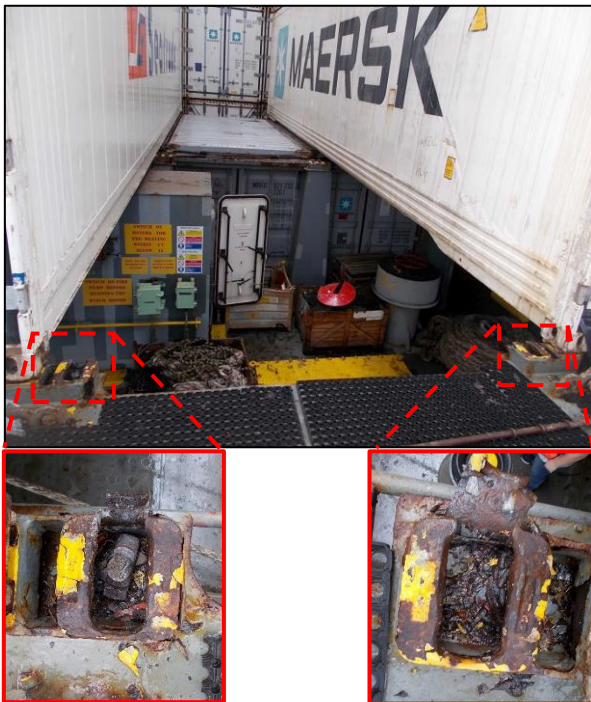
At around 0518, the local authorities disembarked from the vessel and proceeded to the morgue. Thereafter, the master and chief officer inspected the accident site and found that two deck container sockets in the aft part of bay 46, row 02, tier 84 (460284) were damaged (Figure 5).

Figure 5: Damaged deck container sockets
