STATE MARINE ACCIDENT INVESTIGATION COMMISSION

FINAL REPORT 47/15

M/V NEFRYT

Poisoning of the ship crew after the fumigation of cargo in the port of Abidjan
on 25 and 26 September 2015

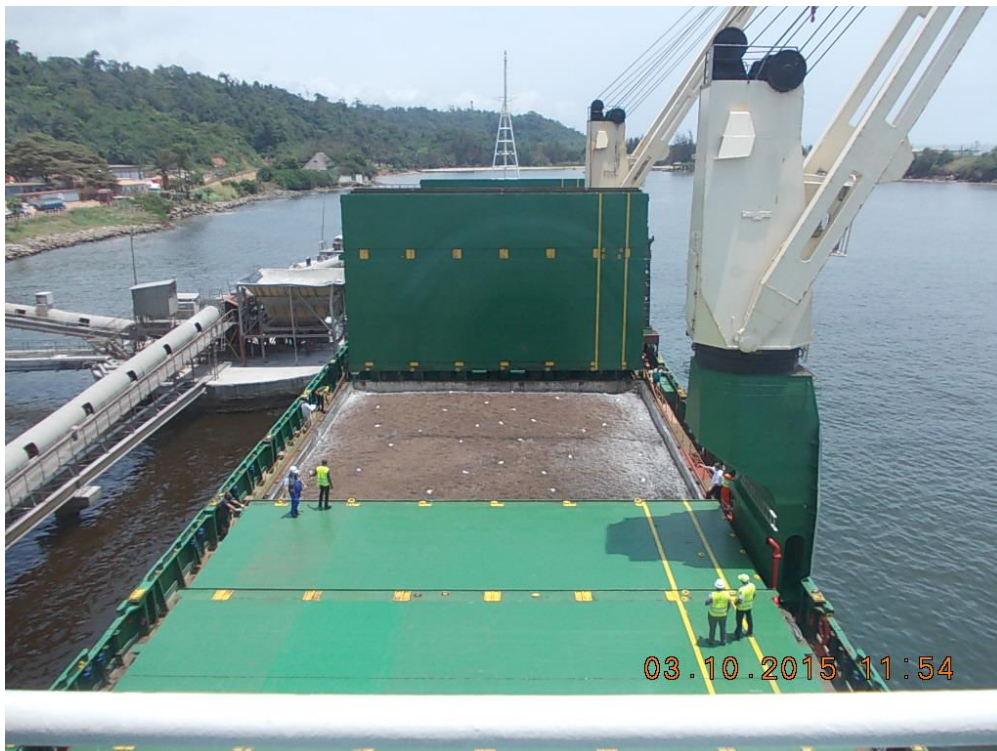
Photograph 2. Bags (white) with fumigant laid out in the cargo hold

A total of 120 bags with approximately 18,500 pellets of the fumigating agent were laid out. During the distribution of the preparation, the crew smelled an unidentified sharp odour. When the bags with fumigant were laid out, sections 3 and 4 of the cargo hold hatches were closed as ordered by the chief officer. The chief officer advised the crew to avoid inhaling the smelling substance when closing the hatches.

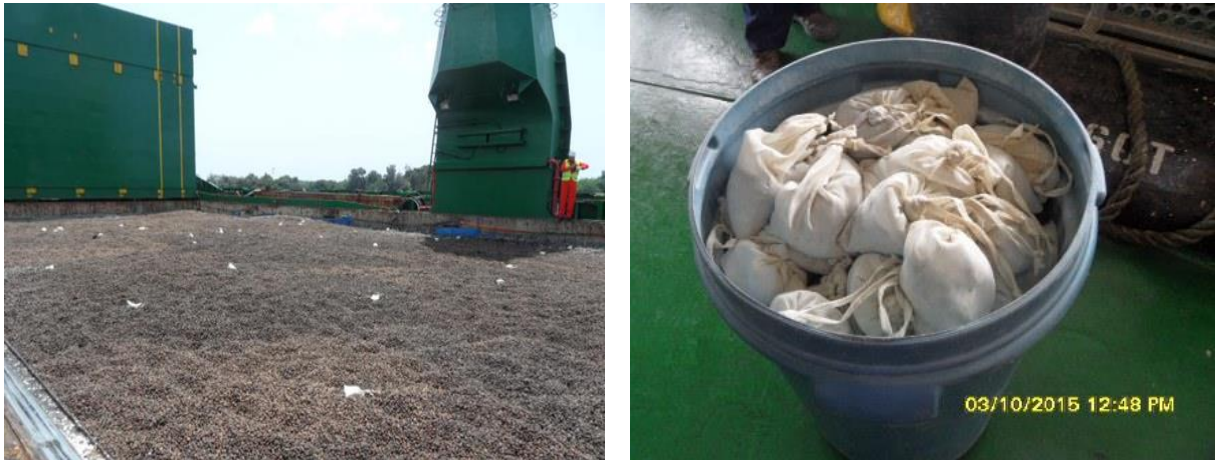
Photograph 4. Phosmium bags distributed on top of cargo and placed in a container after the accident, at San Pedro.

The Commission established that on board of Nefryt the quantity of fumigation preparation was calculated adequately to the volume of fumigated cargo in proportion of 3 g/m^3 . The expected effective time of the active substance was calculated at 72 hours.

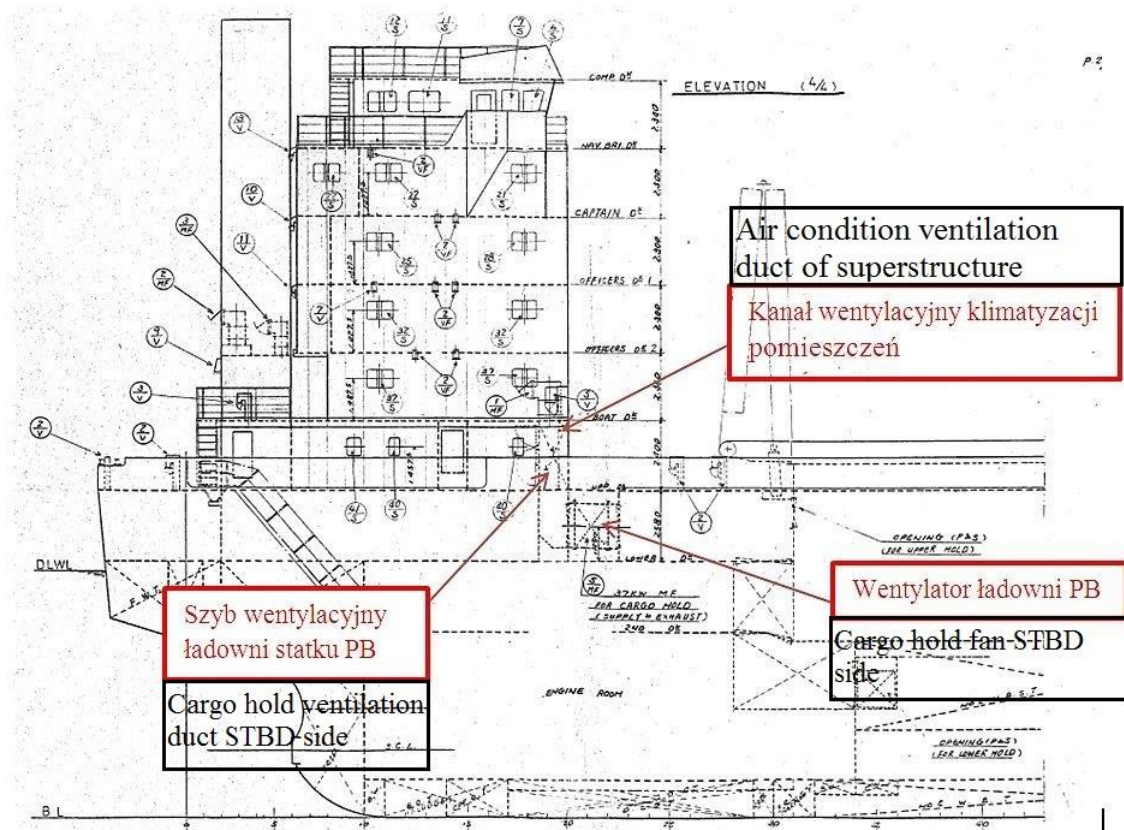
Figure 3. Location of ventilation casing of cargo hold and air conditioning trunk in crew living quarters on ship starboard side.

The mechanical factor that contributed to the incident were leaks in the ventilation trunk of the air conditioning system running inside the starboard side ventilation casing of cargo hold that supplies air to the air conditioning control room and further on to living quarters in ship superstructure (Figure 3).

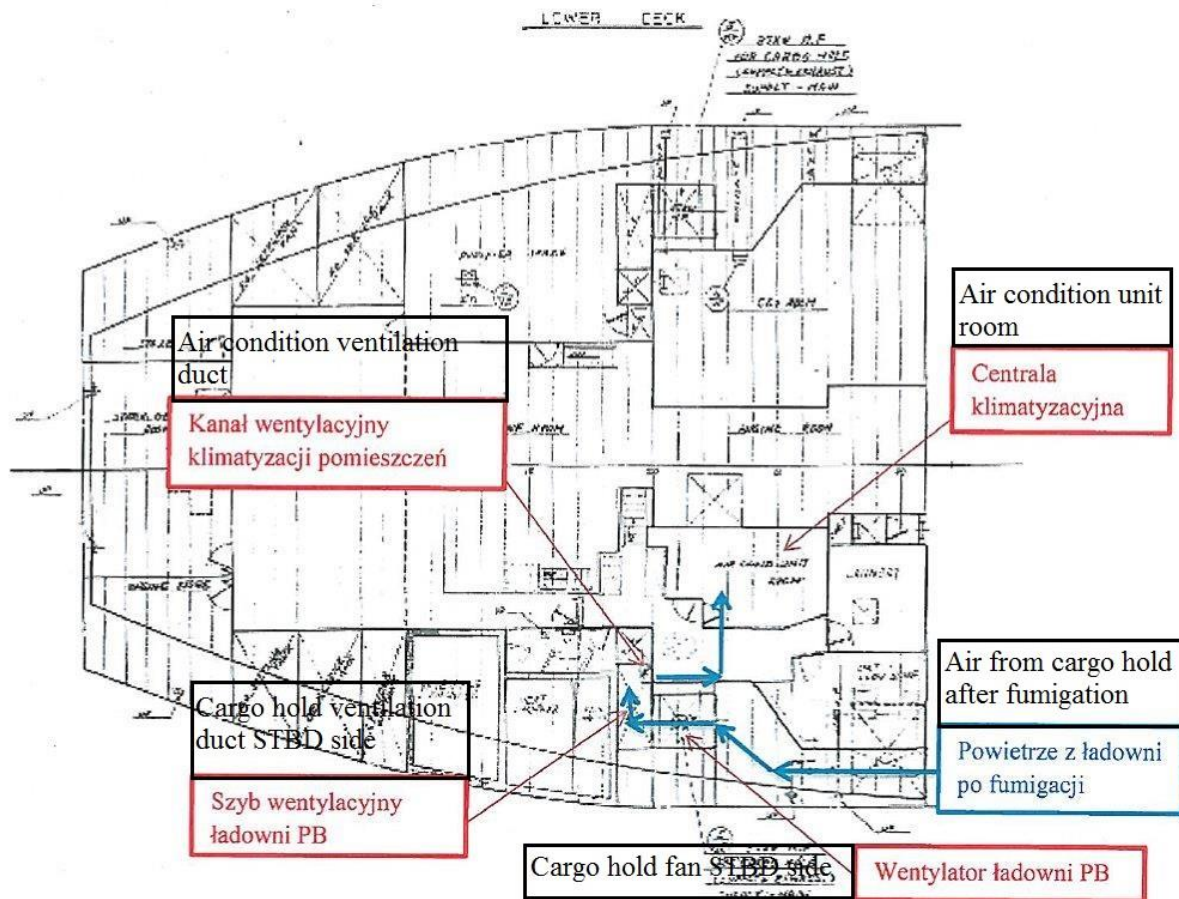
Figure 4. Location of the ventilation casing and trunk on lower deck of Nefryt superstructure.

To enhance the air cooling effect, the air conditioning system in living quarters on Nefryt worked in recirculation mode: air inlet was on the corridor on the superstructure lower deck. Leaks in the upper part of the air conditioning ventilation trunk inside the cargo hold ventilation casing allowed poisonous gas from the fumigated cargo hold to get to the air conditioning control room by the ventilation trunk (Figure 4).

The air conditioning unit sucked in poisonous phosphine gas from leaking ventilation casing and air from the inside of the superstructure which, after cooling and drying, was sent as a mixture of poisonous gas and air to crew living quarters. Thus, each recirculation cycle of cooled air from the superstructure increased the concentration of poisonous gas blown into the living quarters.

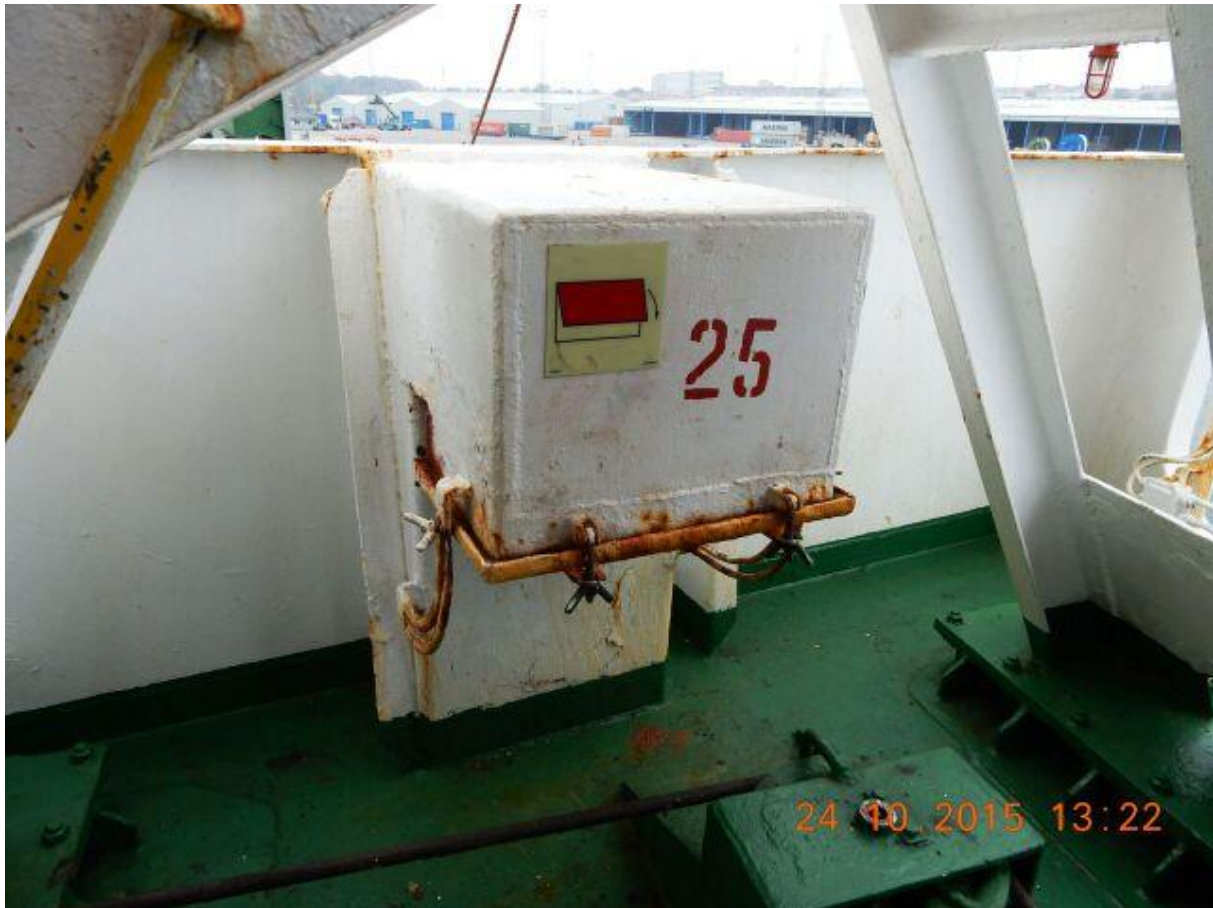
Photograph 5. Air conditioning inlet in ship superstructure on boat deck on starboard side.

Air conditioning inlet in ship superstructure on boat deck on starboard side (Photograph 5) has most probably not been closed after the ship left the port, but even if it was, it would not eliminate the threat of sucking in poisonous gas from the cargo hold generated during cargo fumigation.

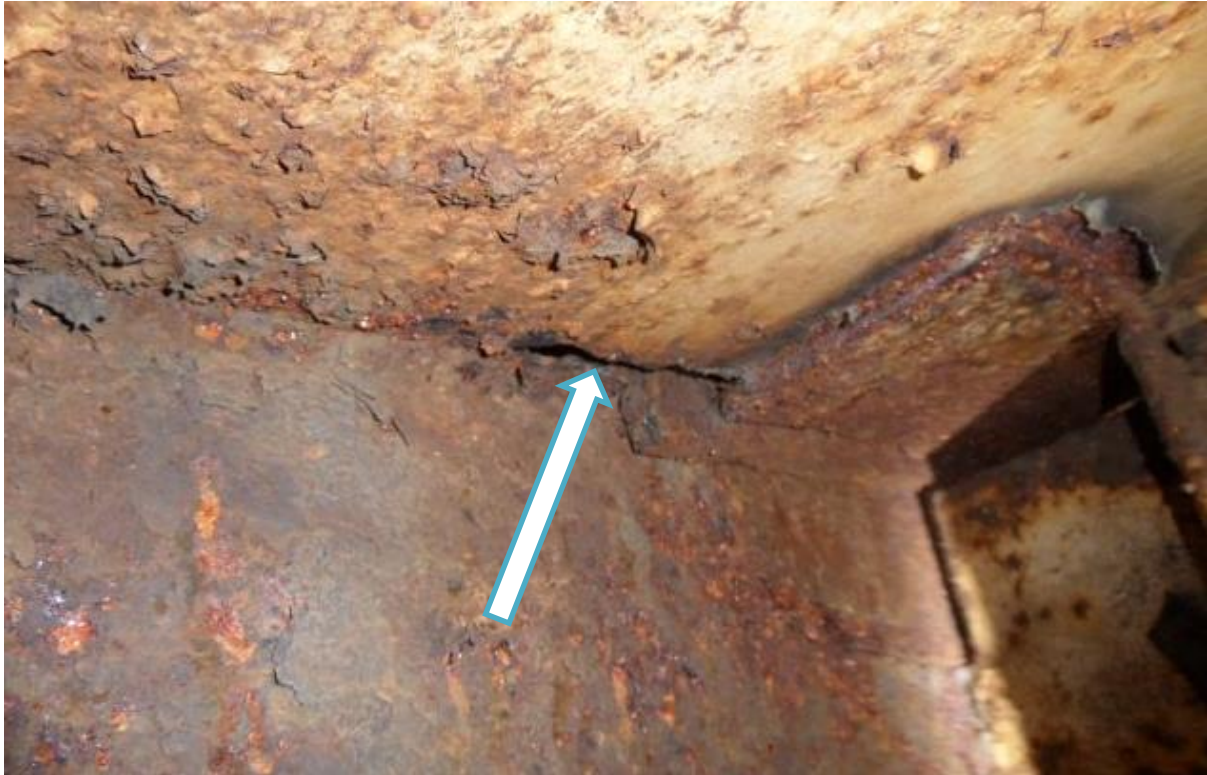
The ventilation trunk of superstructure air conditioning system running inside the stern cargo hold ventilation casing²² on starboard side was considerably corroded. There were pronounced cracks in the upper part of the trunk next to gussets along welded metal sheet joints of cargo hold ventilation trunk and the air conditioning trunk, there were visible cracks in the place of the previous repair at the meeting place of both ducts. One of these cracks is shown in photograph 6 taken at San Pedro port on 3 October 2015. Signs of the previous repair are visible in the lower wall of the air conditioning trunk.

Photograph 6. Cracks in the upper part of the air conditioning ventilation trunk on welded joints of metal sheets in the ventilation casing of ship starboard side cargo hold.

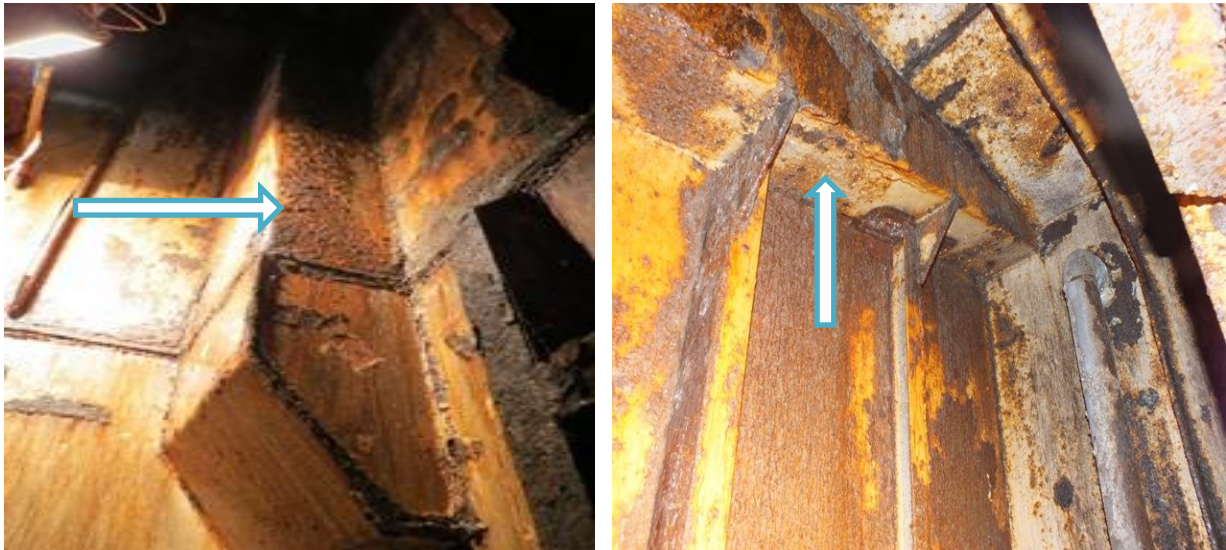
Only careful visual inspection and repair after the accident, i.e. crew poisoning with gas from the cargo hold in October 2015, have shown the actual technical condition of both ventilation trunks, extensive corrosion on trunk metal sheets and cracks at the welded joints.

The condition of some trunks before and after the repair is presented in photographs 7 (taken on 21 October 2015) and 8 (taken on 28 October 2015).

Photograph 7. Air conditioning ventilation trunk before the repair.

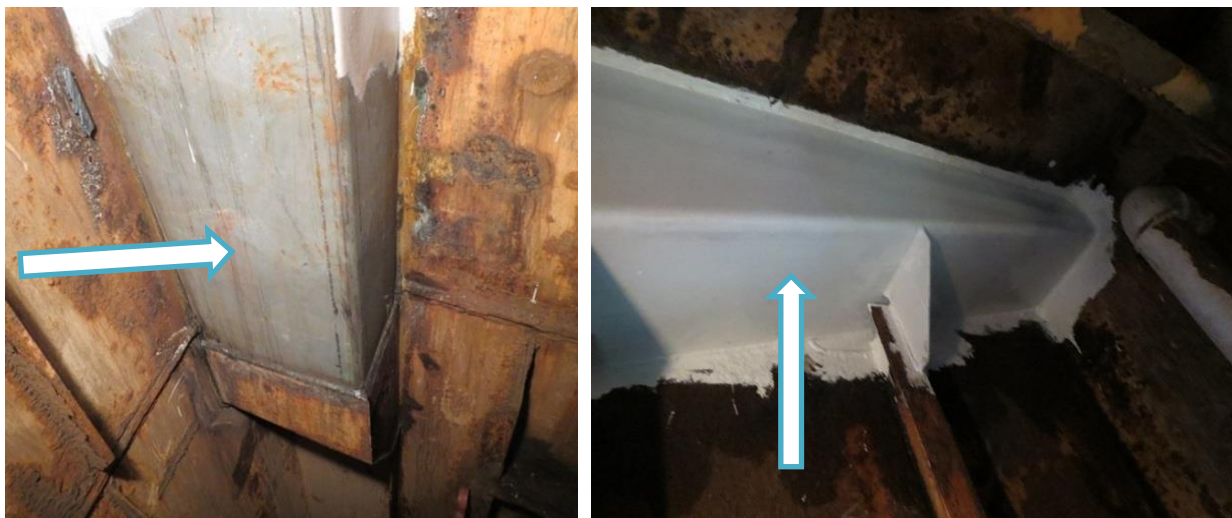
Photograph 8. Air conditioning ventilation trunk after the repair.

The Commission established that during the between voyage repair, when the ship was in Gdańsk in November 2014, the damaged front superstructure plate was repaired (during maintenance, two holes leading to cargo hold ventilation trunk were tapped out) on the starboard side at about 2 m over the main deck by cutting and welding in the plate two patches of steel plate with dimensions of 300 x 300 x 8 mm and 300 x 400 x 8 mm. The repair of the front superstructure wall which is at the same time the front wall of the ventilation casing of the cargo hold and the ventilation trunk of air conditioning, was done from the outside (from the deck side). After the repair no in-depth inspection of the condition of both ventilation trunks from the inside was carried out and the cracks were not detected (weld cavity) between the ventilation casing of the cargo hold and the ventilation trunk of air conditioning.

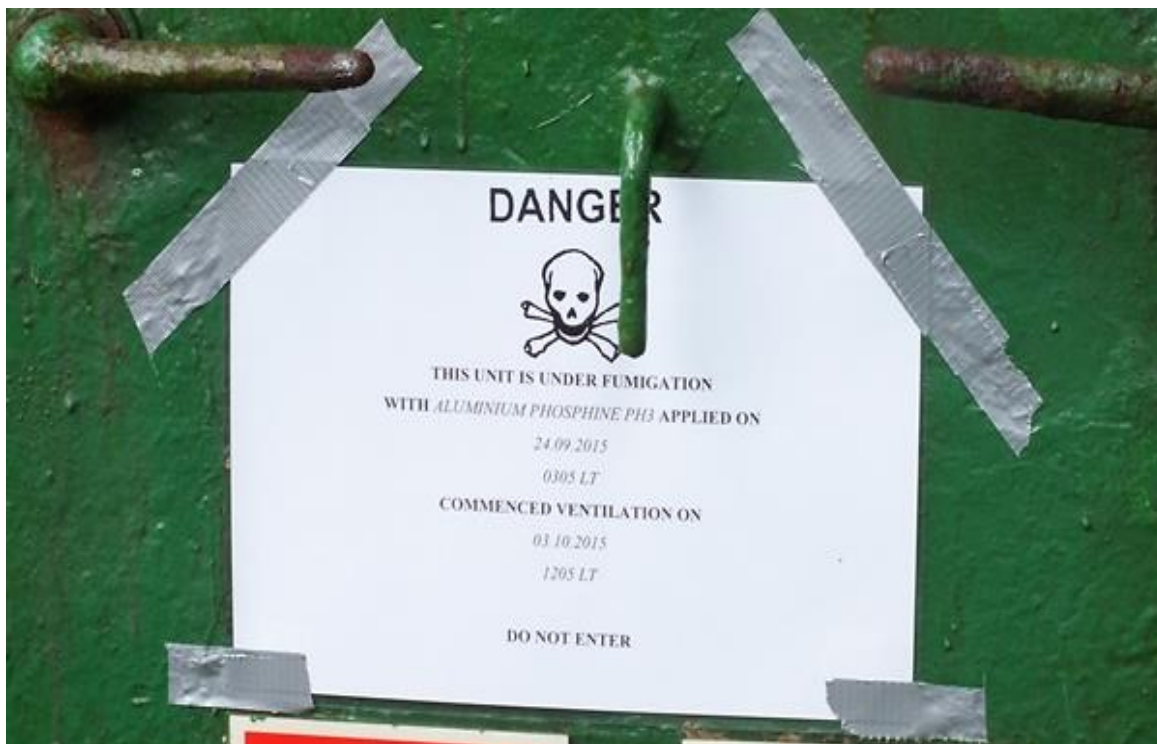
Photograph 9. Entry to the Nefryt cargo hold marked during ventilation with a sign warning of fumigation using PH₃.
