Panama Maritime Authority
Directorate General of Merchant Marine
Maritime Affairs Investigation Department

M/V “BLUE STAR I”
IMO No. 9375159
R-002-2020-DIAM
CASUALTY DATE: 05th October 2019

REPORT ON THE INVESTIGATION OF COLLISION BETWEEN

At Danube River near Tulcea, Romania

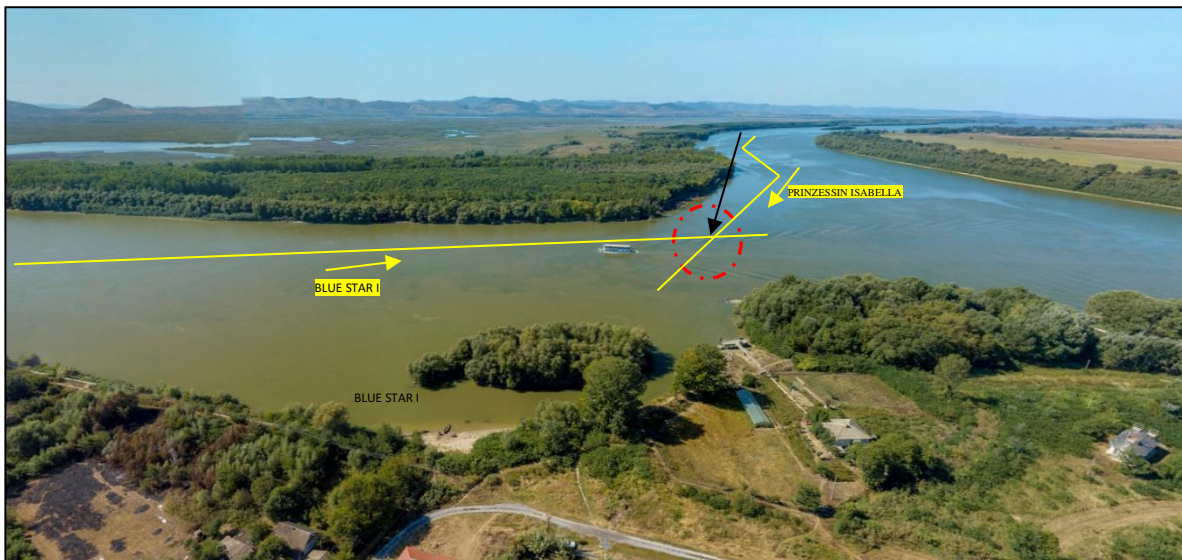
Figure 1.3 – Position of Collision

- 1.3 During the passage around 05,15 hrs UTC both ships approached closer to each other towards the river elbow at point M.43
- 1.4 Vegetation impeded visual contact one to each other.
- 1.5 With no instructions received from neither VTS nor pilot and without any communications between ships, both vessels found themselves on the elbow in a cross situation causing the fore end of the BLUE STAR I colliding with the starboard side of the PRINZESSIN ISABELLA.

- 1.6 As a consequence of the collision, a number of cabins on the starboard side of the PRINZESSIN ISABELLA were heavily damaged and a number of passengers were injured.

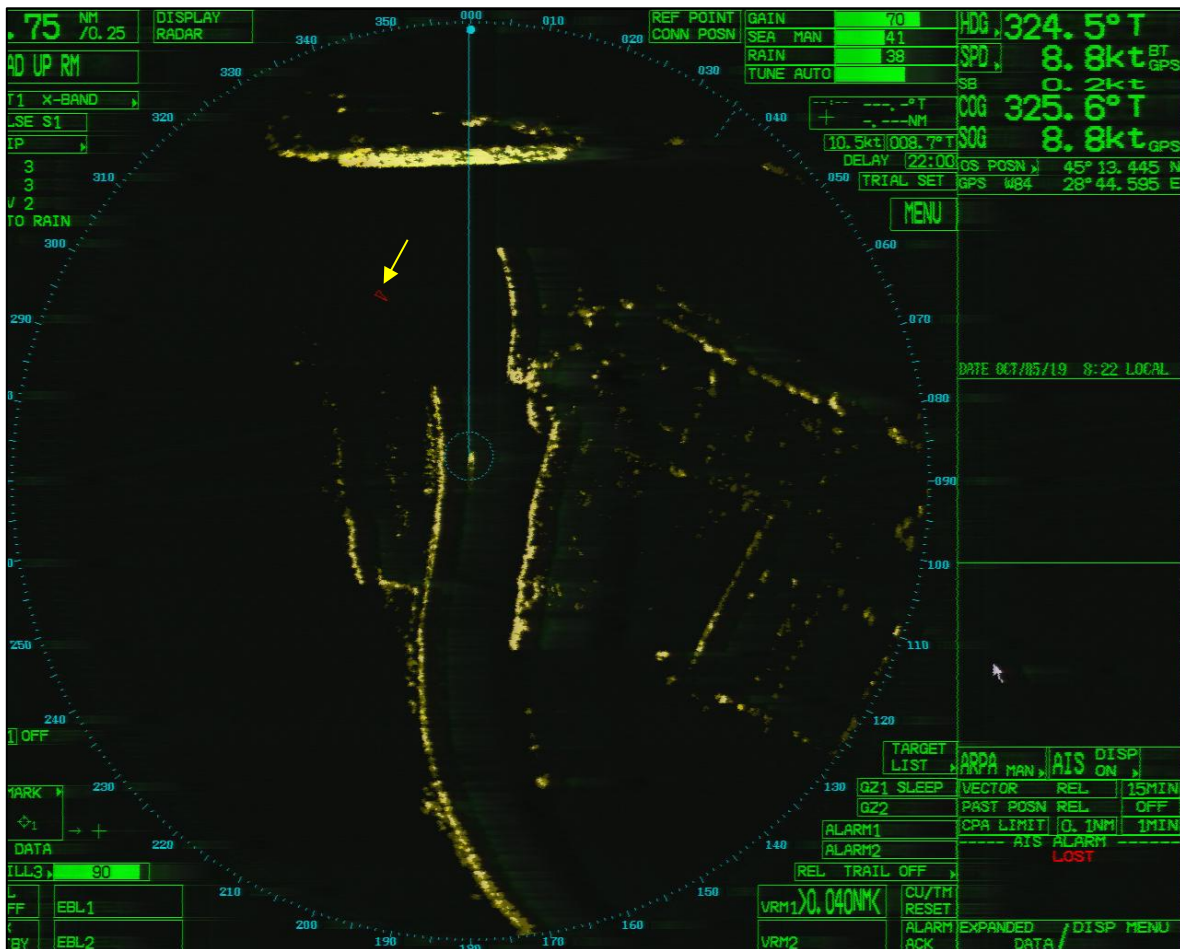
Figure 3.1 – View of radar seconds prior getting visual contact with PRINZESSIN ISABELLA

- 3.19 At 05,10 hrs the PRINZESSIN ISABELLA appeared on the AIS /radar but apparently unnoticed by the Master and the pilot.
- 3.20 As gathered on data from the VDR no VHF contact attempts on the BLUE STAR I were received
- 3.21 During the transit Master was talking to someone else on the bridge on preparations of the ship for authorities and preparation of garbage to be disposed ashore.
- 3.22 Vegetation on the elbow of the river was impeding visual contact from the bridge of the BLUE STAR I and although both ships were approaching fast one to the other no echo was received on the radar.

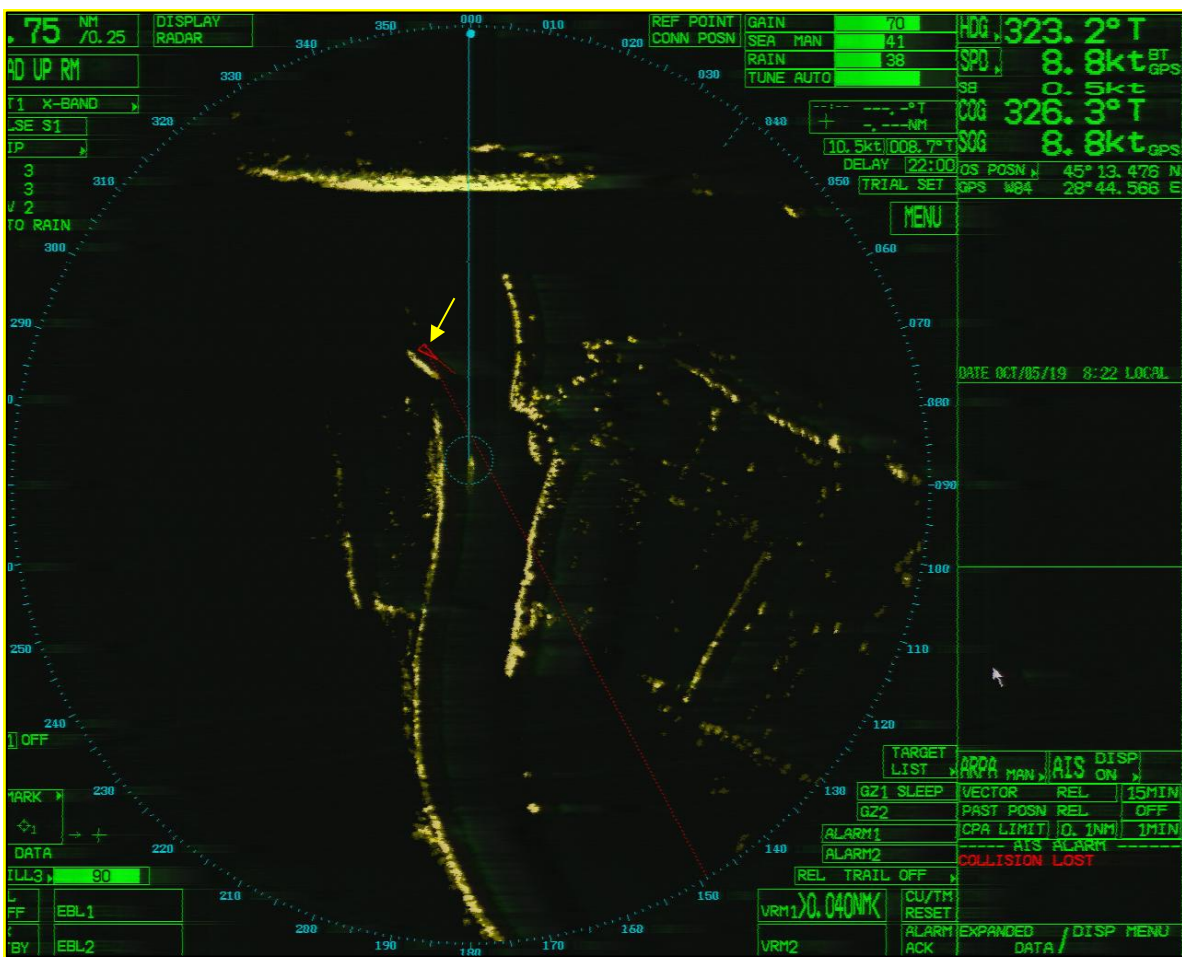
Figure 3.2 – Moment at which the echo is shown on the radar.

- 3.23 The PRINCESSIN ISABELLA approaching at 11.3 knots continued to be unnoticed on the radar while the BLUE STAR I was sailing at 8.8 knots on the right hand side of the river.
- 3.24 Within seconds at 05hr 22min 35s both ships sighted each other.

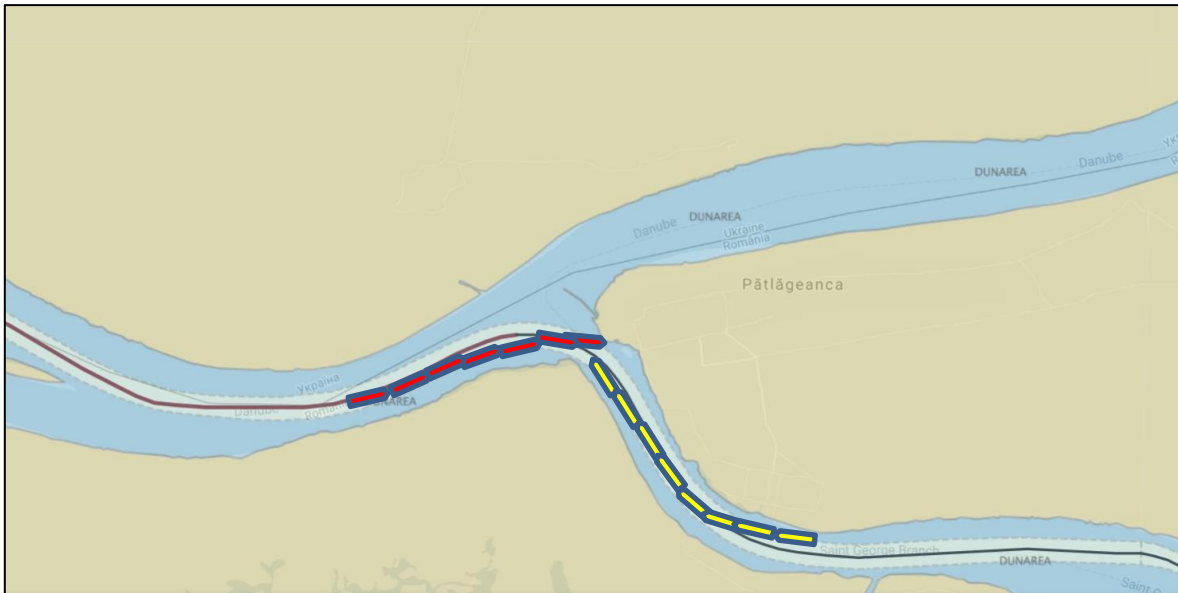
Figure 3.3 – Sailing positions of BLUE STAR I and PRINZESSIN ISABELLA

- 3.25 In view that there was no space on her starboard side between the BLUE STAR I and the shore river line, the PRINZESSIN ISABELLA turned to port side to try to avoid the BLUE STAR I but at that time, at 05hr 23min 05s the fore end of the BLUE STAR I collided with the starboard side of the PRINZESSIN ISABELLA

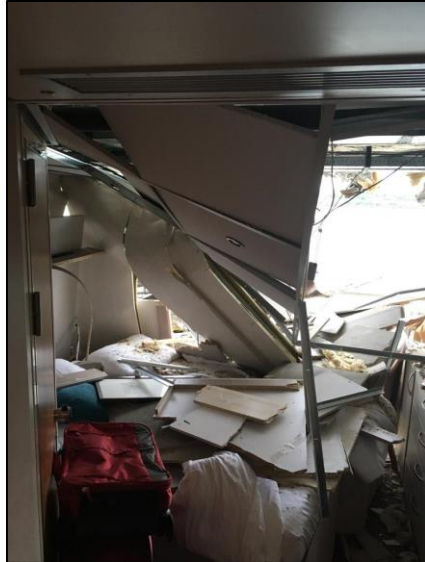
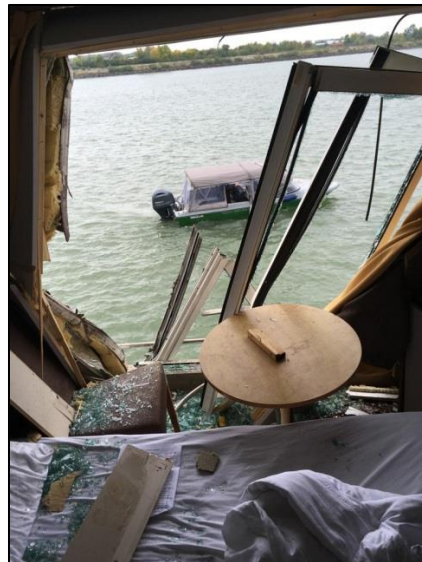
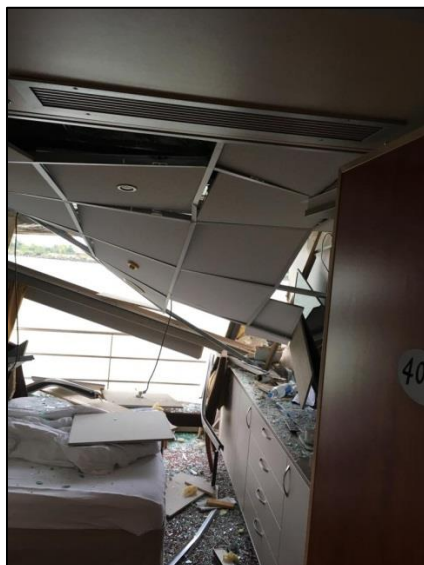
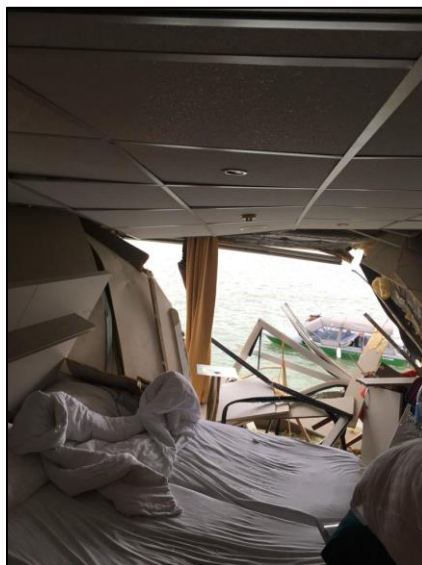
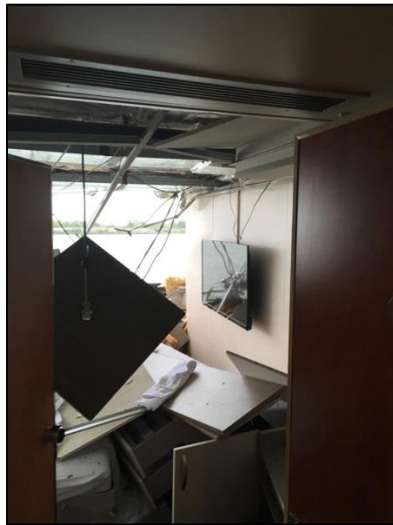
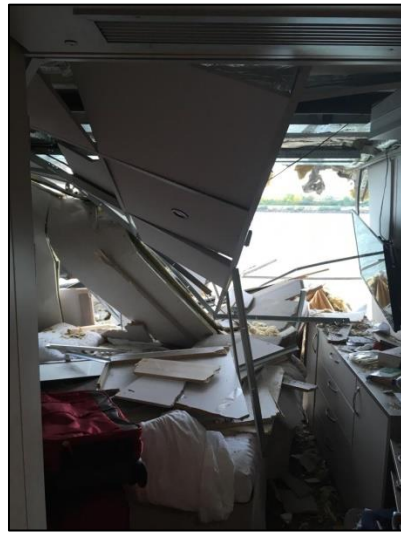
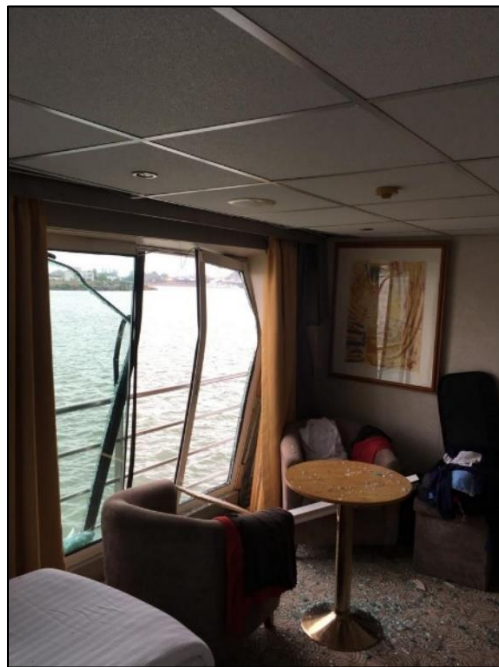
5.1 The PRINZESSIN ISABELLA suffered damages to approximately eleven (11) cabins

Figure 5.1 – Damages to Cabins

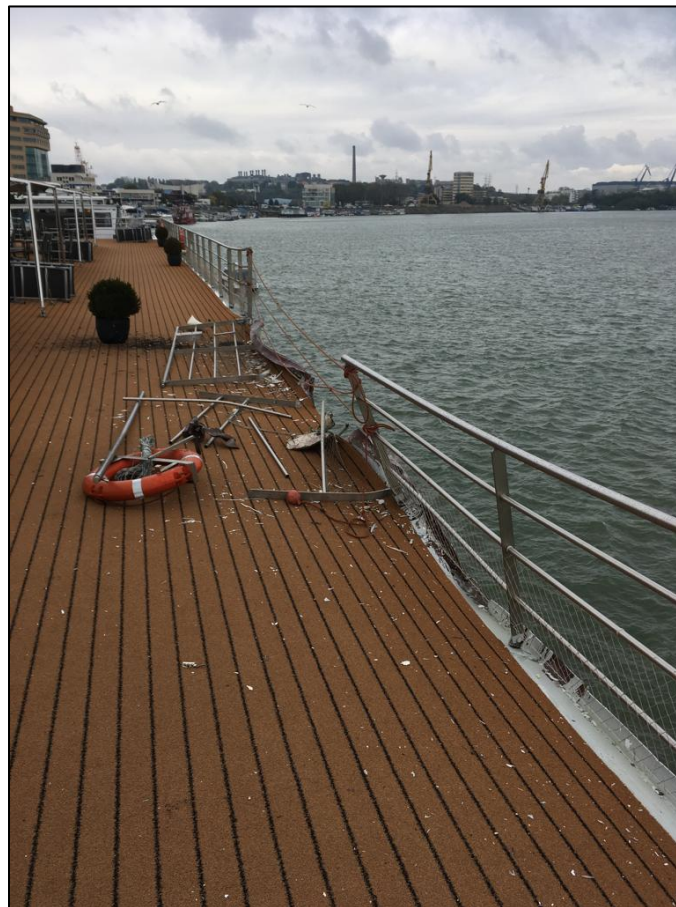
Figure 5.8 – Damages to upper deck

- 5.2 The upper deck of the PRINZESSIN ISABELLA was also damaged by the fore end of the BLUE STAR I

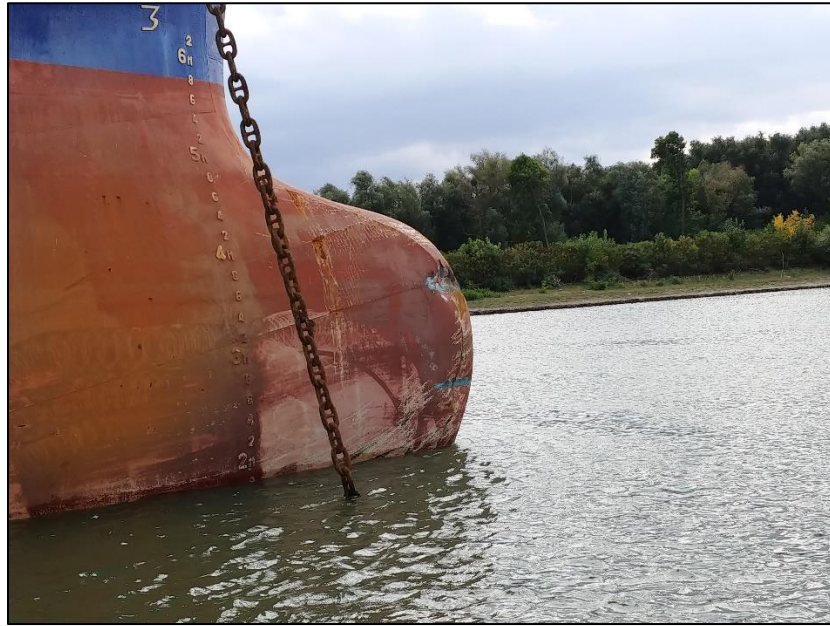
Figure 5.9 – Damages to bulbous bow

- 5.4 The BLUE STAR I suffered damages to the bulbous bow with a hole leading to the fore peak tank and some minor damages to the hull coatings on the fore end.

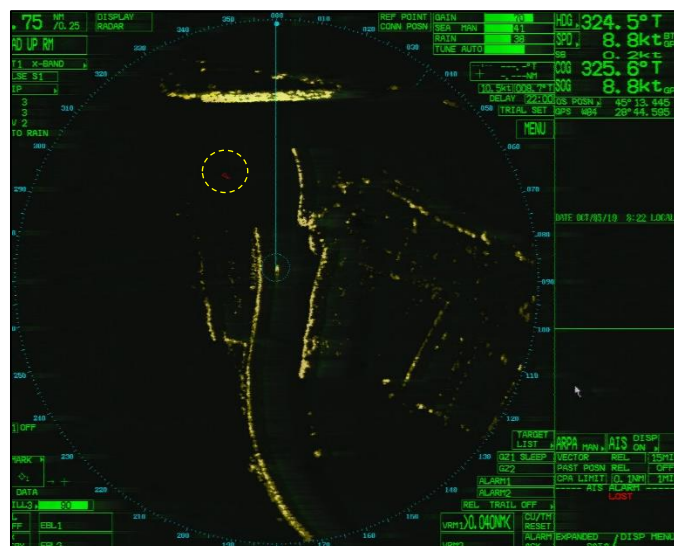
Figure 6.1 – PRINZESSIN ISABELLA showing on radar AIS

- 6.1 The bridge team at the time of the accident on the BLUE STAR I was formed by the Master, one AB helmsman and the pilot.
- 6.2 On the VDR records the pilot is the only one heard giving orders directly to the helmsman.
- 6.3 The bridge team at the time of the accident on the PRINZESSIN ISABELLA was formed of the Master and the 3rd Officer.
- 6.4 At the time of the collision the BLUE STAR I was sailing upstream at 8.8 knots while the PRINZESSIN ISABELLA was sailing downstream at 11.2 knots towards the elbow of the river with limited visual sight due to vegetation.
- 6.5 The BLUE STAR I is installed with an AIS interfaced with the radar and minutes before the eye contact and radar echoes seen on screen, the PRINZESSIN ISABELLA was displayed on AIS on the radar although not targeted.

- 6.6 Despite having the PRINZESSIN ISABELLA displayed on the radar, the AIS data box was empty hence not target selected.
- 6.7 VDR records gathered for the investigation give no evidence of PRINZESSIN ISABELLA and BLUE STAR I communicating to each other agreeing to pass port to port towards the elbow of the river.
