# National Transportation Safety Board

## Marine Accident Brief

### Breakaway of Bulk Carrier *Privocean* and Subsequent Collision with Tanker *Bravo* and Tugboat *Texas*

<b>Accident no.</b>	DCA15LM019
<b>Vessel names</b>	<i>Privocean</i> , <i>Bravo</i> , and <i>Texas</i>
<b>Accident type</b>	Breakaway and collision
<b>Location</b>	Mile* marker 161, Lower Mississippi River, Convent, Louisiana; 30°02.5' N, 90°50.4' W
<b>Date</b>	April 6, 2015
<b>Time</b>	1553 central daylight time (coordinated universal time – 5 hours)
<b>Injuries</b>	Four minor injuries
<b>Damage</b>	Estimated \$11 million
<b>Environmental damage</b>	About 10 barrels of oil
<b>Weather</b>	Clear visibility; southeast winds at 6–7 knots; air temperature 73°F
<b>Waterway information</b>	Lower Mississippi River; high water conditions; current about 5 mph

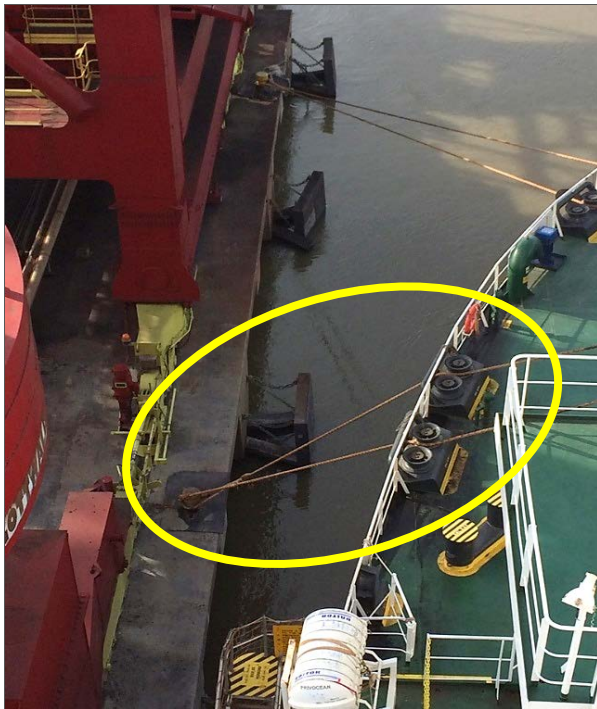
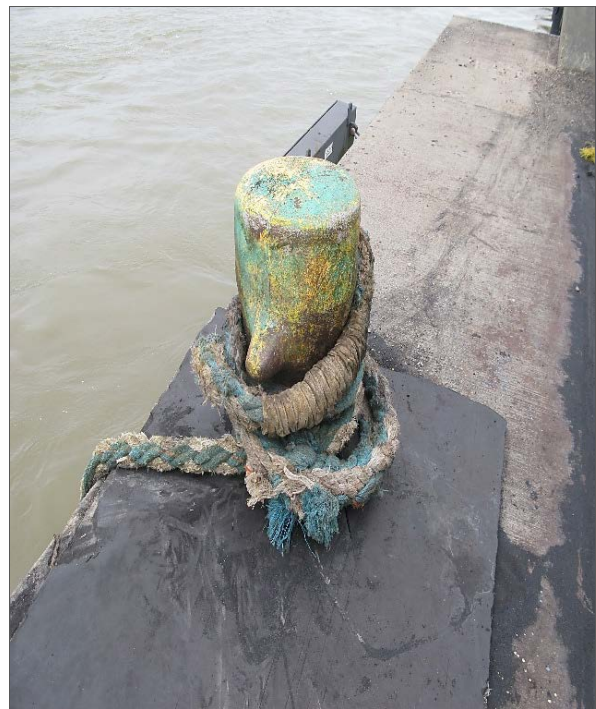
Before the accident, the master expressed concern to the vessel charterer and agent about the location of the bollards on the pier and the force of the river current. In a statement after the accident, the master also noted that the size of the securing wings of the bollards was insufficient; the upper aft breast line was barely staying over the bollard with a nearly vertical lead.

**Left photo, taken by the *Privocean* master, of the aft breast lines at the Convent Marine Terminal before the accident. Right photo shows a bollard with mooring line attached after the accident.**

Because of the size of the ship, draft, and the location on the dock, forward breast lines were not put over to the line handlers. Line handlers confirmed that, because of the angle of the lines coming through, the only chock available on the ship, and the size of the horns on the bollard, forward breast lines would only have slipped off repeatedly. Although aft breast lines were used, they were secured only to one point and initially at a steep angle, allowing them to slip off the bollard. After the aft breast lines were run through a different chock, the situation was rectified.

- Two anchors out of their pockets, ready for deployment, with the forecastle manned.
- Bow lines connected to the 90-ton and 225-ton upriver mooring dolphins.
- Breast lines on both bow and stern.
- Doubling up breast lines on the bow.
- Loading plans for vessels over 740 feet to ensure that shifting is in the downriver direction only. Vessels under 740 feet will be loaded without shifting.
- Pilot required during shifting.

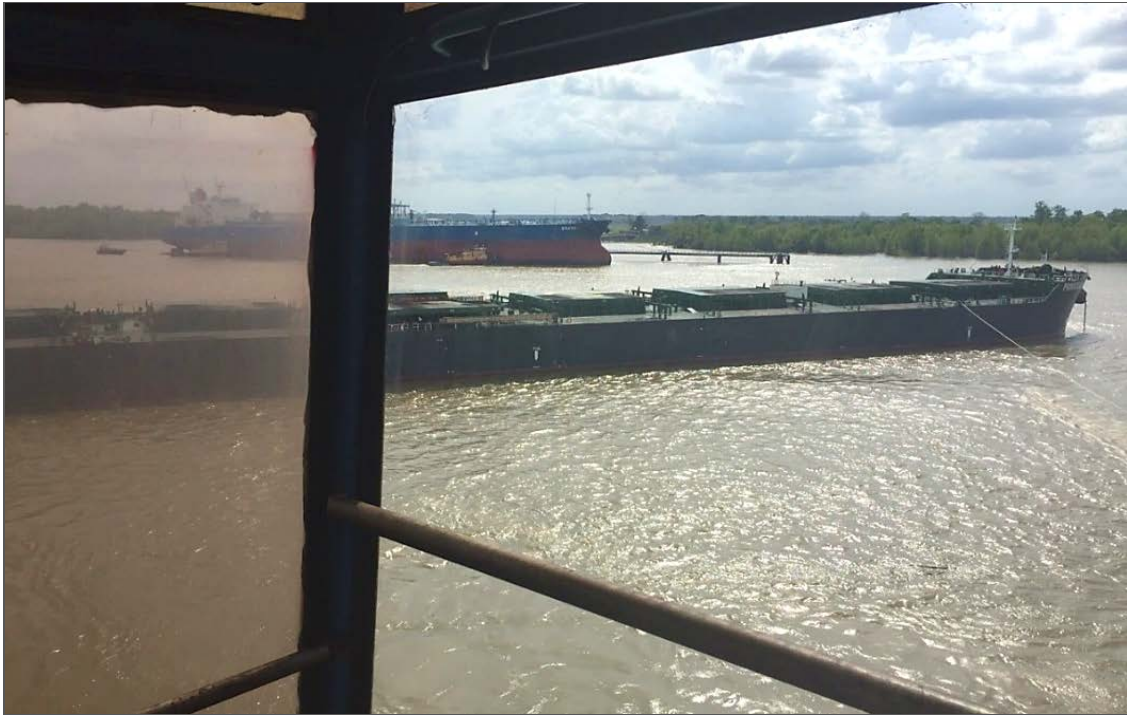
Despite the efforts of the two tugs, the bow of the *Privocean* continued to move in and out from the pier, and the first forward mooring hawser parted about 1551. The master said that the remaining lines parted or paid out under "tremendous strain" during the next 3 minutes, and the *Privocean* began to drift in the current and started crossing the river. The chief mate told investigators that the master ordered him to drop the starboard anchor, which he did, but it dragged at two shots. The anchor was heaved back in.

Photo taken by a crane operator at the Convent Marine Terminal, showing the *Privocean* drifting across the river. A spring line is visible and still connected to the starboard bow of the vessel. In the background, tanker *Bravo* can be seen moored at the Ergon-St. James Terminal.

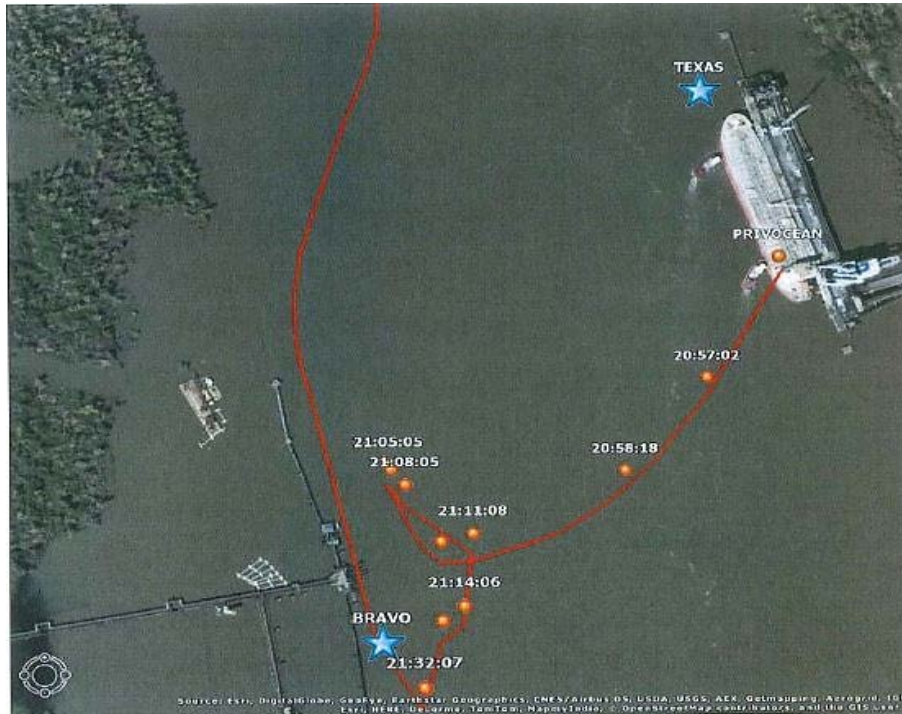
The *Privocean*'s trackline after breaking away from the pier at the Convent Marine Terminal. (Image by the US Coast Guard, based on automatic identification system data)

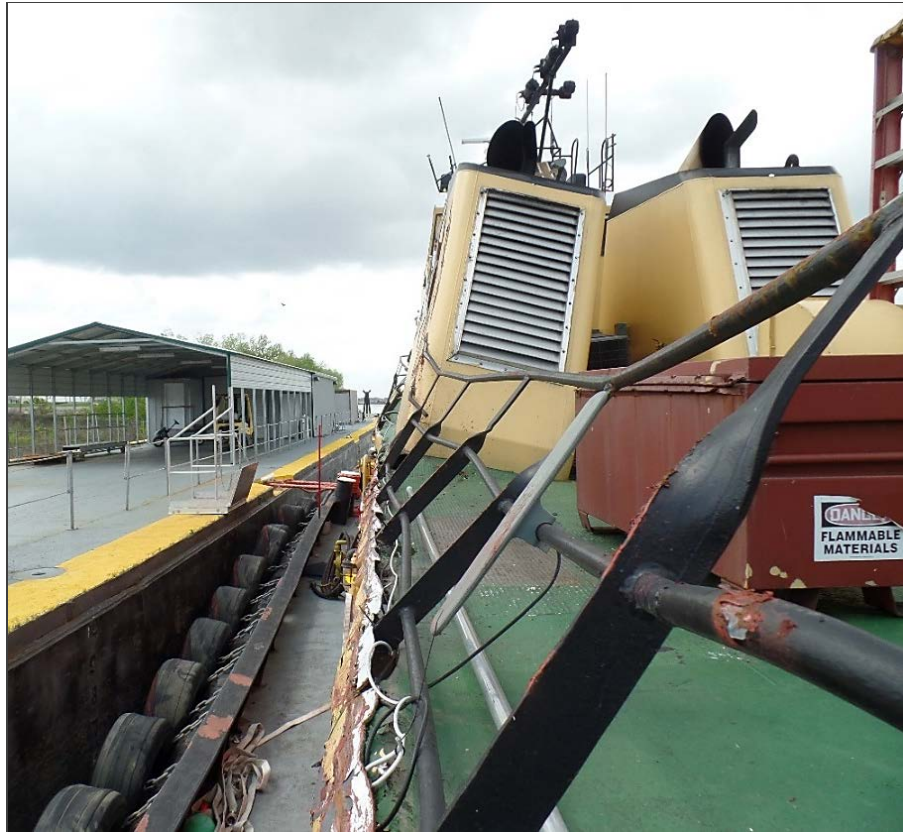
Port side of the *Texas*, showing bent handrails and damaged stack. (Photo by the Coast Guard)

The *Texas* sustained significant damage to the hull, weatherdecks, and superstructure. Both propellers were bent, internal areas were extensively water-damaged, and a 6.5-inch high-strength tow line parted. Damage was estimated at \$1.5 million. All four crewmembers reported injuries. The captain sustained cuts and bruises to his knees, hands, and arms; the wheelman twisted his leg; the deckhand injured his arm; and the engineer injured his leg.
