SMAIC
STATE MARINE ACCIDENT
INVESTIGATION COMMISSION

FINAL REPORT

X-Press Mulhacen

The pilot's fall into the water on the approach to the Northern Port in Gdansk on June 5, 2020.

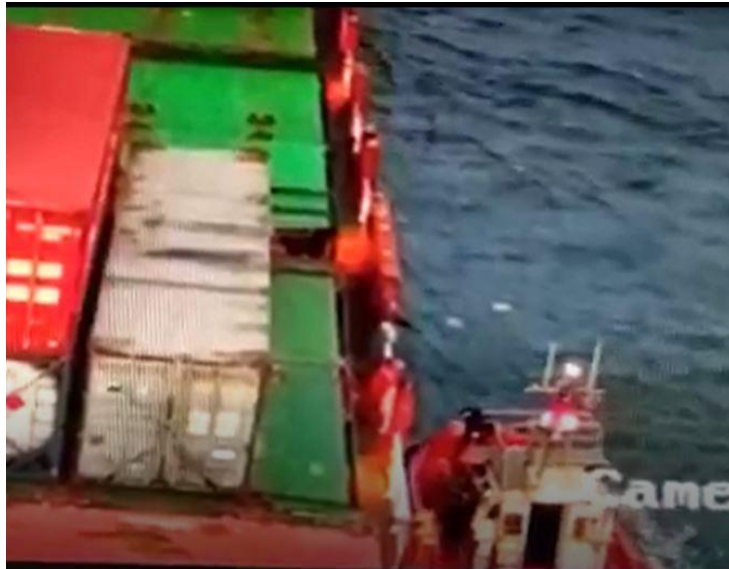
While on the pilot boat, the pilot asked, by radio, the captain of X-Press Mulhacen vessel to slow down to a speed of 6 knots. After about a minute, the pilot boat was nearby entering vessel. After sailing around its stern, at about 3:48 am, the boat was alongside to the vessel's starboard side. The speed of the X-Press Mulhacen was about 6.5 knots, and course 236°, the pilot ladder was rigged on the starboard side of the vessel (Pic. 3).

Pic. 3 Pilot 21 boat alongside X-Press Mulhacen vessel.

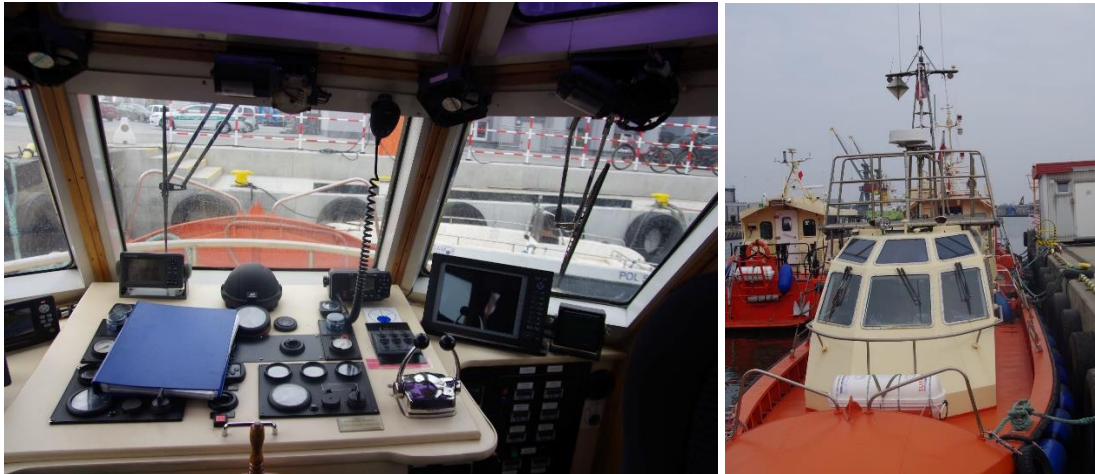
The construction of the Pilot 21 pilot boat makes it impossible to observe the pilot's behaviour while climbing the pilot ladder. Small windows in the sloping roof of the superstructure above the head of the pilot boat do not allow to have a full view of the situation. In addition, the construction of the platform and the ladders attached to it requires the pilot boat to be at a very precise position concerning the pilot ladder of the vessels to be embarked. Lack of stability or the pilot boat navigating the waves makes it difficult for the pilot to climb the pilot ladder.

Pic. 6 The cockpit of Pilot -21 pilot boat.

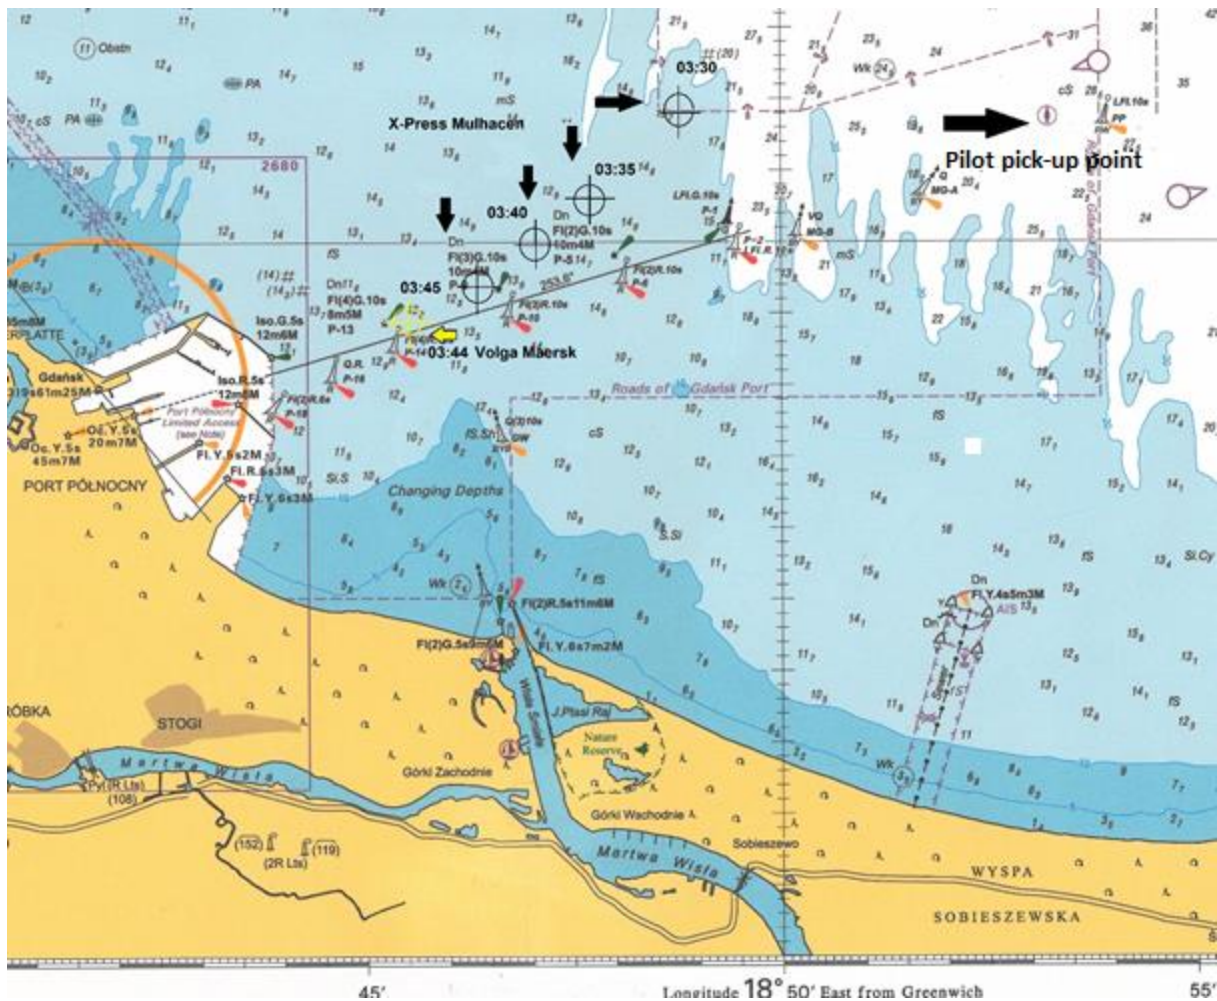
According to the List of Radio Signals, the pilot embarks the vessel entering the Gdansk North Port has the coordinates of 54°25'85N 018°53'25E, which is approximately 6 NM from the North Port breakwater⁵. The pilot, after disembarking from the vessel leaving the port, was about to embark the X-Press Mulhacen vessel at 54°24,8' N 018°46,2'E, at a distance of less than 2 NM from the breakwater, which significantly reduced the time and route of the vessel

exiting with the assistance of a pilot (Figure 1). Reducing the distance reduces the time to act and creates a rush.

Fig. 1 Scan of the BA 2688 chart. Approach route for the pilot of the X-Press Mulhacén vessel.

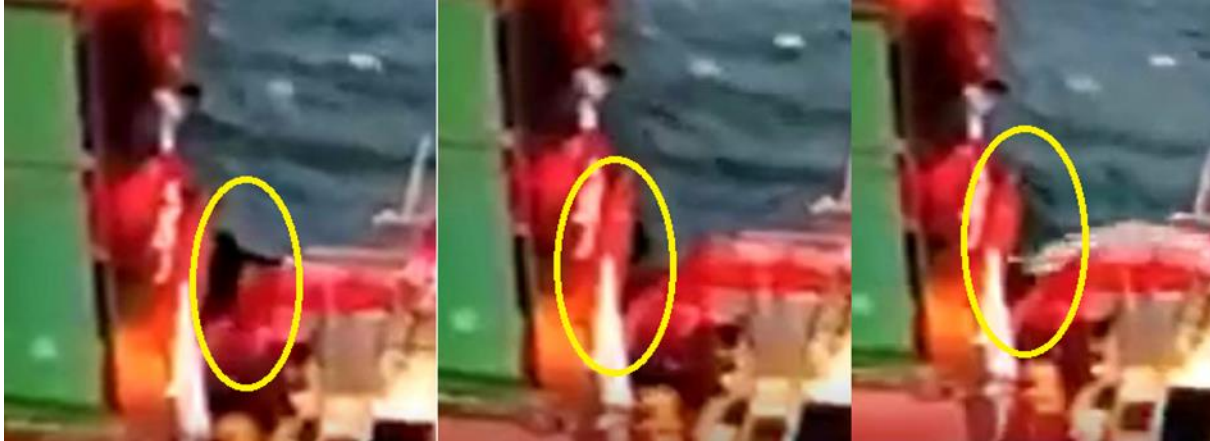
Following the rule in force, the pilot boat sailed around the vessel's stern and approached its starboard side. The pilot stood on a platform located on the pilot boat roof, and the assistant mechanic remained below on the deck. When approaching and parallel alignment of the pilot boat along the ship's side, the pilot tried to climb the pilot ladder. When analysing the video from the ship's industrial camera, the Commission found that the reason for the unsuccessful attempt was improper positioning of the pilot boat due to the lack of stabilised contact with the ship's side. When the pilot grasped, with his left hand, the rope of the pilot ladder, the pilot boat touched the ship's side followed by a slight bounce of the pilot boat at the moment when he put his left foot on the pilot ladder and its slight retraction from the side of the vessel. Then the pilot

put his right foot on the ship's pilot ladder and after removing his right hand from the pilot boat railing, he fell into the water (Pic. 7).

Pic. 7 Pilot boarding X-Press Mulhacen.

Due to a small opening between the pilot boat's curvature and the vessels' side, the pilot fell into the water and not on the pilot boat deck. The pilot boat skipper, who did not see the pilot fall into the water, reacted with a strong backwards manoeuvre only after the mechanic alarmed him about the pilot's fall, which happened only after about 6 seconds.

In the Commission's opinion, the position of the pilot boat was not stabilised alongside the vessel. Neither the pilot nor the mechanic who was already on board at the time of the pilot boat approach to the vessel's side knew the skipper's plan of approach to the vessel's side, and he, in turn, did not see the pilot intending to enter the pilot ladder.

In the Commission's opinion, the reasons for the fall of the pilot embarking on the X-Press Mulhacen vessel was the improper way of boarding the pilot ladder due to the lack of stabilisation of the position of the pilot boat at the vessel's side. The pilot's action was rushed and may have been due to the limited time at his disposal when the pilot pick-up position was much closer to the port entrance head. In addition, the accident was caused by the limited view or, in fact, the lack thereof, of the position from which the pilot enters the pilot ladder from the pilot boat control point by the skipper and the lack of proper assistance for the pilot entering the ladder by the mechanic who was obliged to do so.

At the time of the accident, the pilot had only two body support points that were in contact with the pilot gangplank; what's more, they were on the same side (left hand and left leg), which had an impact on holding the grip and uncontrolled rotation of the body and consequently falling into the water.

At the same time, the Commission recommends introducing internal pilot training and practical exercises with the participation of the pilot boats and their crews. The training program should consider critical scenarios such as "Man Overboard" or a pilot boat capsizing.
