# Contact with buoy by *Navios Northern Star*

Prince of Wales Channel, Torres Strait, Australia | 15 March 2016

**ATSB Transport Safety Report**  
Marine Occurrence Investigation  
325-MO-2016-003  
Final – 23 June 2017

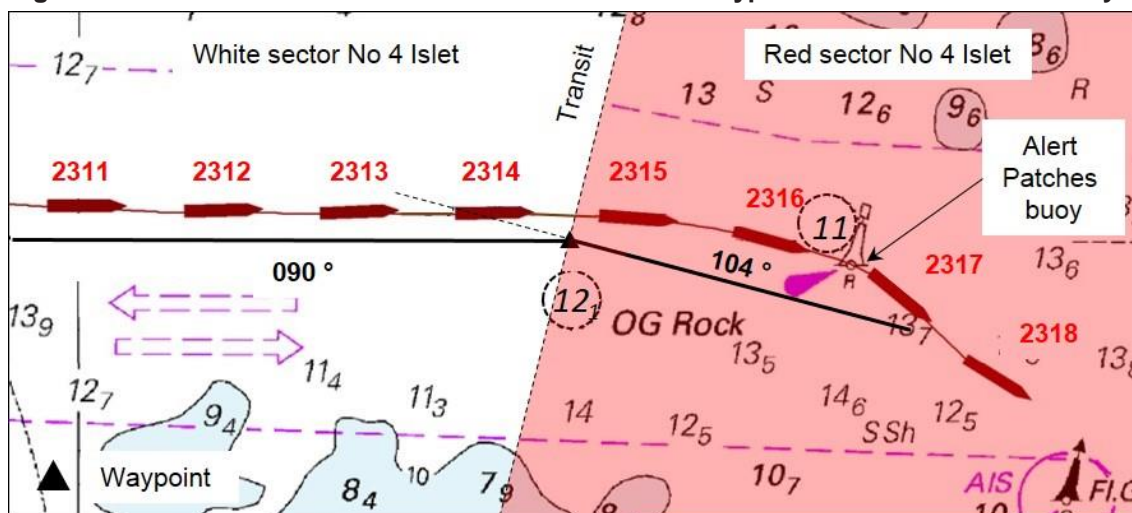
**Figure 5: *Navios Northern Star*’s track to the OG Rock waypoint and Alert Patches buoy**

At about 2312, the third mate advised 7 cables to go to waypoint north of OG Rock (OG Rock waypoint) and the pilot acknowledged the information (Figure 5). The tidal stream at that time was about 1.2 knots x 098° and the wind was from the north-west at force 5 (17 to 21 knots). The ships speed was now steady about 12.5 knots.

Shortly before 2314, the pilot asked the trainee ‘how’s the light going’ (No 4 Islet). The trainee replied, ‘still open’ and 9 seconds later, he informed the pilot ‘this is the place, going red’.

About 25 seconds later, at 2314, the pilot ordered 10° starboard rudder. The ship (that is, its bridge) was now about 2 cables from the OG Rock waypoint and 6½ cables from the Alert

Patches buoy. Shortly after, the pilot ordered 5° starboard rudder and, at about the same time, he was unable to find the echo return of the buoy on the radar's display.

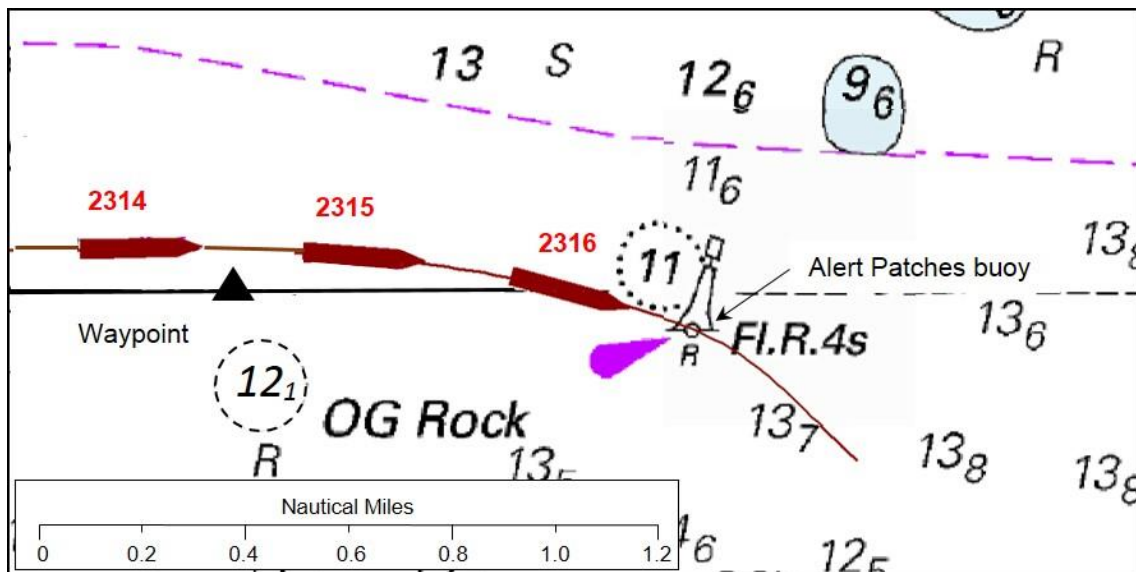
**Figure 7: Rudder angles and distances before contact with Alert Patches buoy**

However, about the same time the pilot ordered starboard 5°, he was unable to find the echo return of the buoy on the radar's display. For the next 2 minutes, he was focused on regaining it. Consequently, during those 2 minutes, the turn was not properly controlled to pass the buoy at a safe distance.

On March 15, as the ship approached the waypoint north of OG Rock, it was north of the charted track, hence the WoP was further west. For the same turn radius and rate of turn, the adjusted WoP was 3½ cables from the waypoint or 8 cables from the buoy. However, it was not until the ship was 6½ cables from the buoy that the pilot gave the first helm order. Additionally, with the ship’s actual speed of 12.5 knots, a RoT of 11.9°/min was required but not achieved throughout the turn (Figure 7).

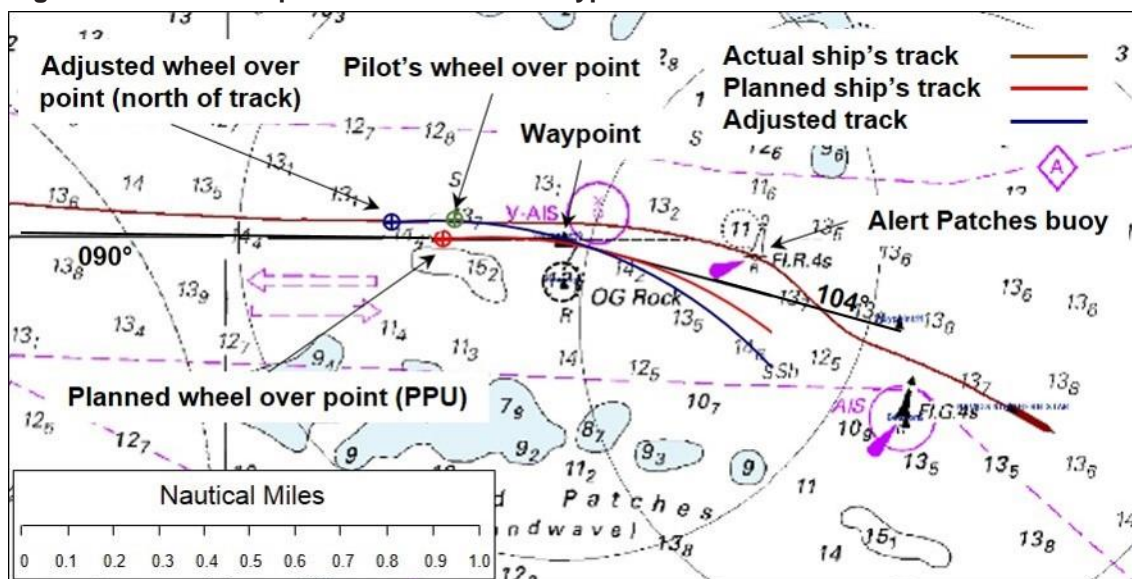
Figure 8: Wheel over point from OG Rock waypoint

The course alteration at the OG Rock waypoint was from 090° to 104°, a 14° course alteration. With the ship's planned speed at 12.2 knots, the pilot's PPU had a default 1 mile radius of turn<sup>27</sup> used to calculate the WoP with a required 11.7°/min rate of turn (RoT). This WoP (Figure 8) in the PPU was about 2½ cables from the OG Rock waypoint (7 cables from the Alert Patches buoy).

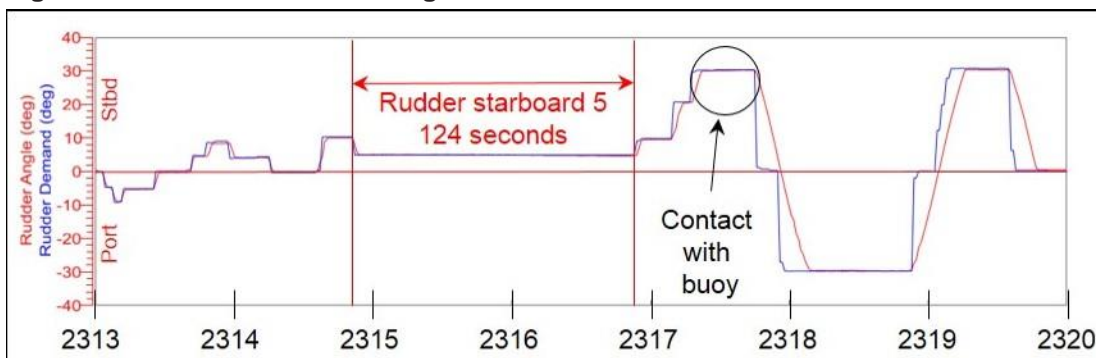
**Figure 9: Rudder demand and angle from 2313 to 2320**

As the ship approached the OG Rock waypoint, the pilot was using the s-band radar to determine the distance from Alert Patches buoy. His usual practice was to use a 7 cable distance from the buoy as his WOP. About the same time he ordered starboard 5° for the course alteration, he was unable to find to the echo return on the radar’s display. The pilot became fixated on regaining the lost echo. For the next 2 minutes (Figure 9) the rudder angle remained at starboard 5°.

The pilot did not monitor the ship’s progress by any of the multiple cues or monitoring tools that were available and he was unaware that the ship was not swinging fast enough to safely make the turn.

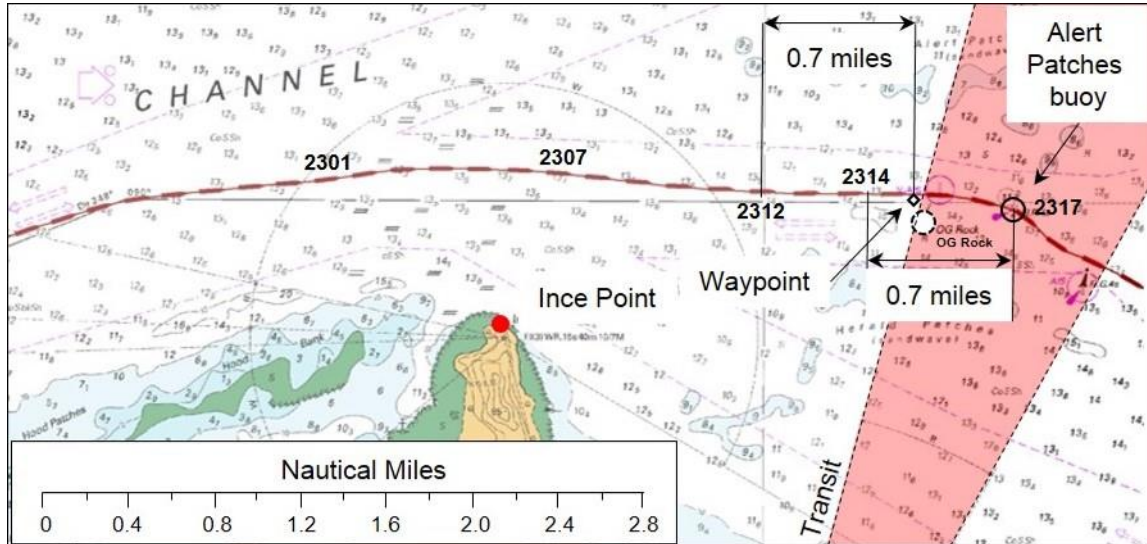
**Figure 10 – Navigational chart Aus 293 showing *Navios Northern Star's* track to OG Rock**

The trainee had expected the ship to be turning when Horned Hill light came into transit with No 4 Islet, just before it was in the red sector. However, the ship's RoT had only just started to increase from 0.0°/min to 2.3°/min.

Further, the pilot did not inform the ship's bridge team, nor the trainee, about not using light sectors or when on a transit at OG Rock nor his plan for altering course. Therefore, the ship's bridge team and the trainee's expectations were different to the pilot's intentions in that situation. As the ship progressed, their comprehension of the situation did not trigger any actions for clarification or correction of the situation.

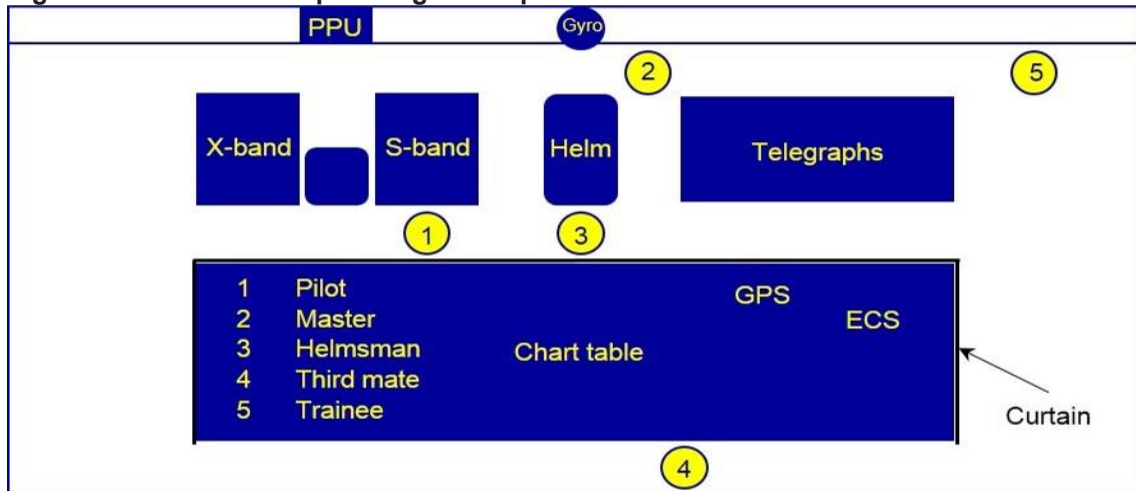
**Figure 11: Pilots and ship's bridge team positions between 2312 and 2316**

The OOW is expected to apply appropriate navigational techniques and principles including placing fixes on the chart, using parallel indexing and clearing indexing<sup>31</sup> on radars, and monitoring electronic systems for alarms and warnings.

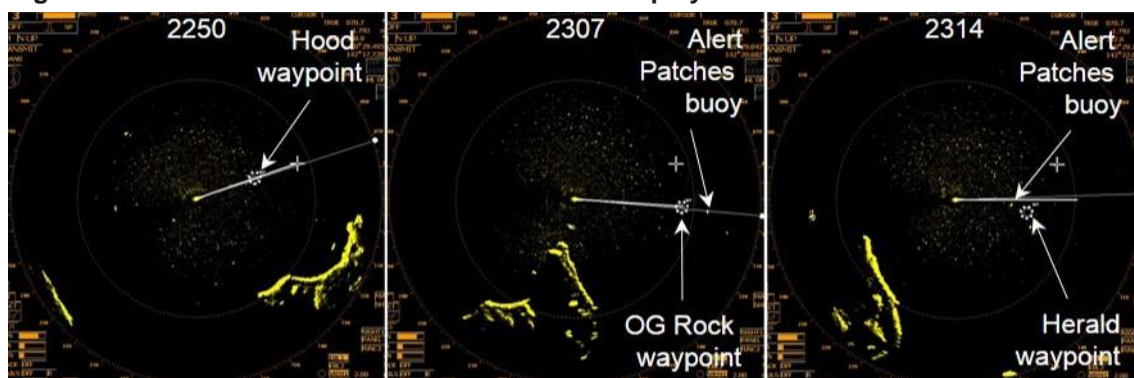
**Figure 12: Navios Northern Star's X-band radar display from 2250 to 2314**

The OOW stated he frequently moved from the chart table to use the ship's x-band radar (the pilot used the s-band radar). However, in the 27 minutes before the contact (2250 to 2317), none of the radar's tools or features including EBLs, VRMs, PIs nor clearing indexes (Figure 12) were used. Further, there was no other indication the x-band radar had been used, including a reduction in range as the ship approached the OG Rock waypoint.

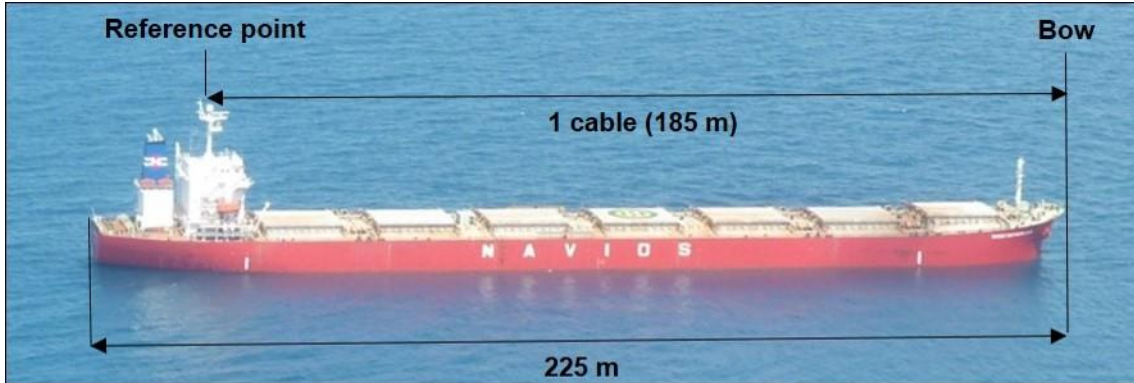
**Figure 14: *Navios Northern Star's* bridge to bow distance**

The radar and GPS distances used during the pilotage were calculated between the ship's reference points (above the bridge) and the waypoints and objects. *Navios Northern Star's* bridge was one cable aft of its bow (Figure 14).

Hence, when the third mate gave 7 cables notice to the pilot, the bow was actually 6 cables from the waypoint and was always nearer to waypoints and objects than appeared on the ship's radar. Therefore, when a ship's bridge is aft, this needs to be taken into consideration when giving ranges from electronic navigational equipment.
