MARINE ACCIDENT REPORT

RIG and INGER MARIE
Collision on 10 July 2014

This marine accident report is issued on 3 March 2015.

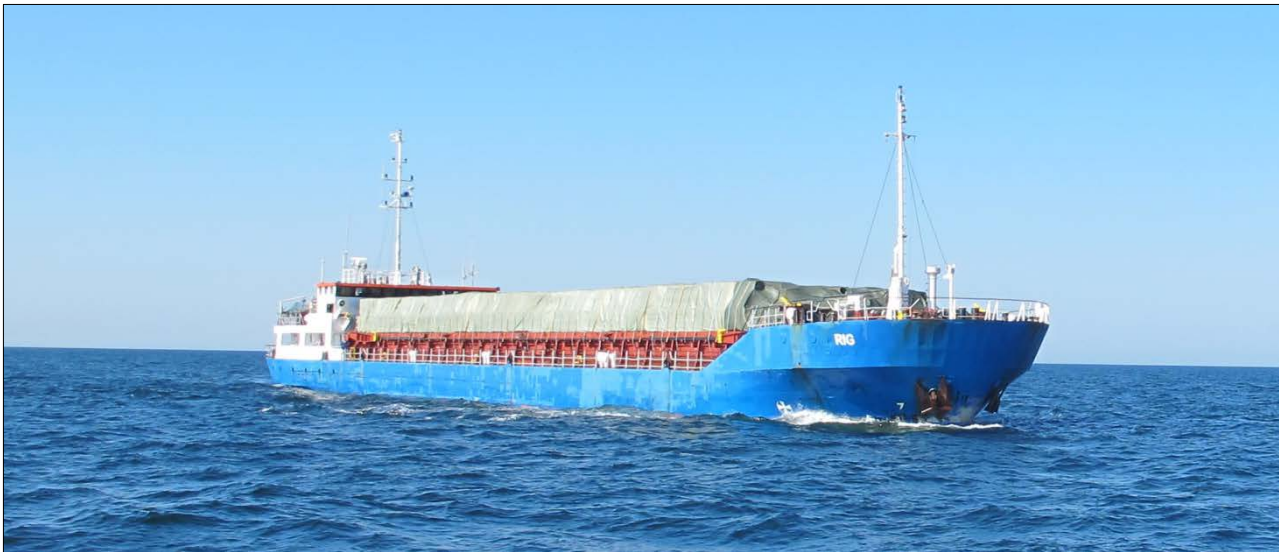
*Figure 6: Picture of RIG's starboard side on the day of the accident
Source: Swedish Coast Guard*

RIG was carrying timber cargo, which in part was stowed on the cargo hold hatches. The cargo did not, however, obstruct the visibility over the bow or the starboard side, while the watchkeeping officer was standing or sitting by the radar on the starboard side. Visibility was to some degree hindered by the relatively small bridge windows and wide frames. The watchkeeping officer might not have been able to see an approaching ship in certain angles on the starboard side if he was not moving around on the bridge and the ship was approaching on a crossing course with no change in bearing.

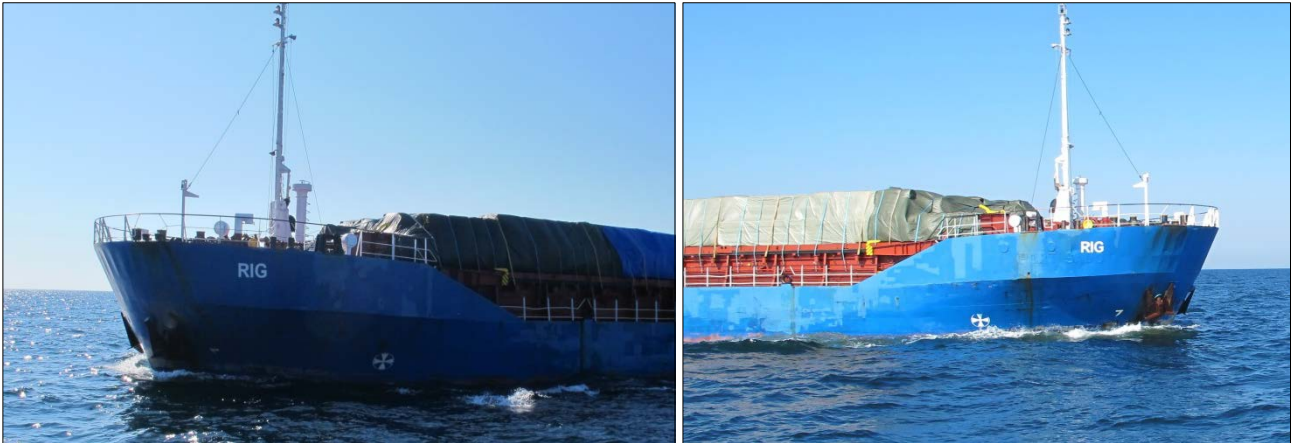
Figure 7: Picture of RIG's bow port and starboard side on the day of the accident
Source: Swedish Coast Guard

As seen in figure 6 and 7, RIG was almost fully loaded and therefore the anchors were close to the waterline. Traces of red paint were only found on RIG's port bow (figure 8). Whether the marks on the port anchor came from the impact is uncertain. The picture in figure 8 was taken four days after the collision when RIG arrived in port and by then most of the residue from the collision might have been washed away.

The traces of red paint indicate that the impact occurred on the port side of RIG, which is consistent with RIG colliding with INGER MARIE after having initiated a hard starboard turn, while in a forward motion. The port anchor on RIG is likely to have been inflicting substantial damage to INGER MARIE's port side hull resulting in the sudden foundering.

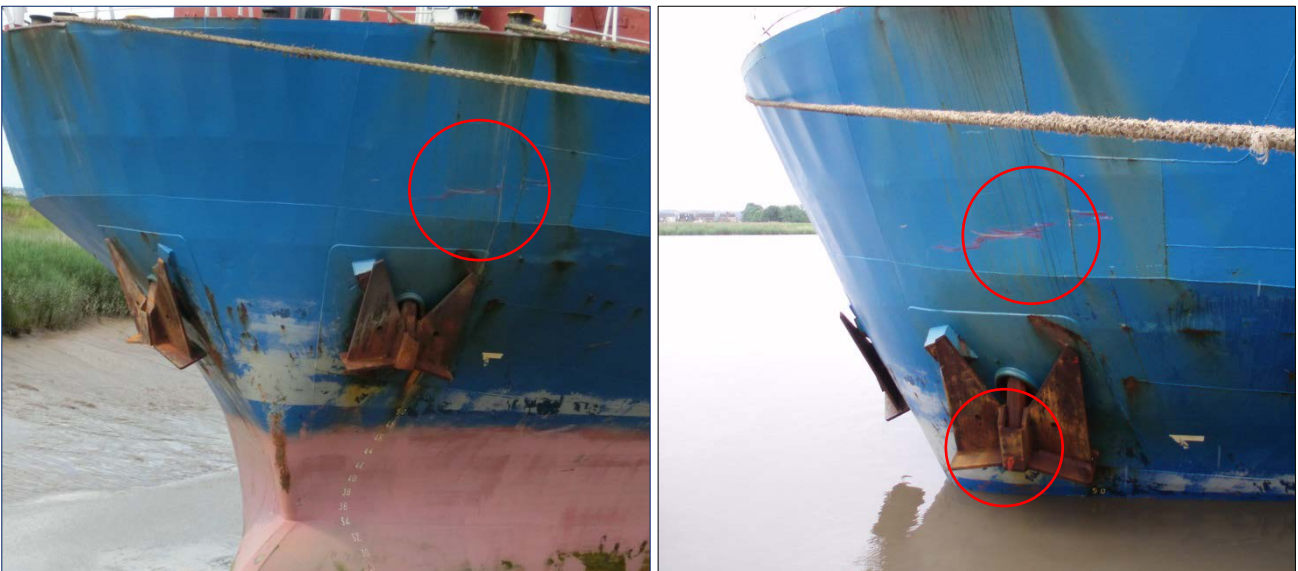
Figure 8: Picture of RIG's bow starboard side taken a few days after the accident
Source: DMAIB

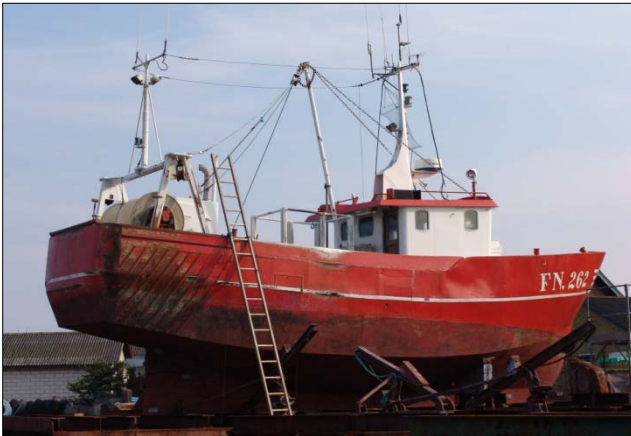
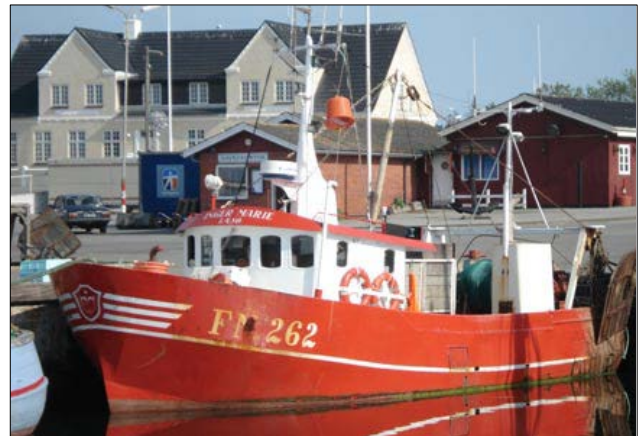
Figure 9: Pictures of INGER MARIE from port side
Source: G. Vejen. Retrieved from www.fiskerforum.dk

As seen in figure 9, the skipper would have had a limited view ahead of the vessel's port side while situated aft by the doorway. If the skipper was preoccupied with sorting the catch and the bearing to the RIG was not changing and in a blind sector, then the risk of collision could go unnoticed for an extended period of time. INGER MARIE held a constant course of 245° and speed of 8 knots, which makes it likely that the vessel was underway to its home port of Østerby on the island of Læsø. Considering INGER MARIE's distance from the fishing ground at the time of the collision, the skipper was likely in the process of sorting the catch when the collision occurred.

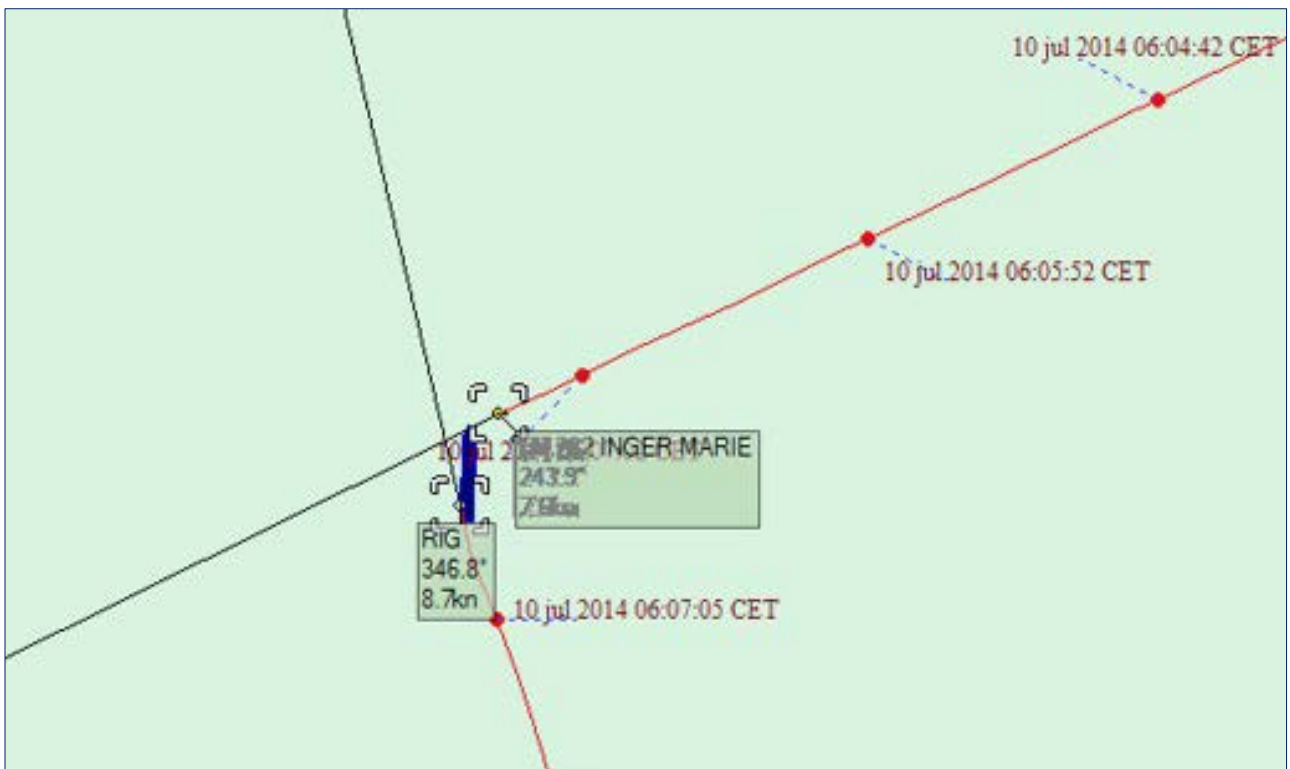
It can be seen in figure 11 below that RIG was in a starboard turn moments before the collision and that INGER MARIE was apparently still on a steady course. Before the turn, the AIS on RIG was transmitting with an update frequency of approximately 10 seconds before the turn. During the turn, the update frequency increased. Therefore, the AIS data is considered a close approximation of the actual situation.

Figure 11: AIS track from RIG and INGER MARIE moments before the collision
 Source: Danish Maritime Authority
