Bundesstelle für Seeunfalluntersuchung
Federal Bureau of Maritime Casualty Investigation
Federal Higher Authority subordinated to the Federal Ministry
of Transport and Digital Infrastructure

Investigation Report 405/20

**Allision with a quay wall by
the tanker NORTHSEA RATIONAL
in Hamburg
on 25 November 2020**

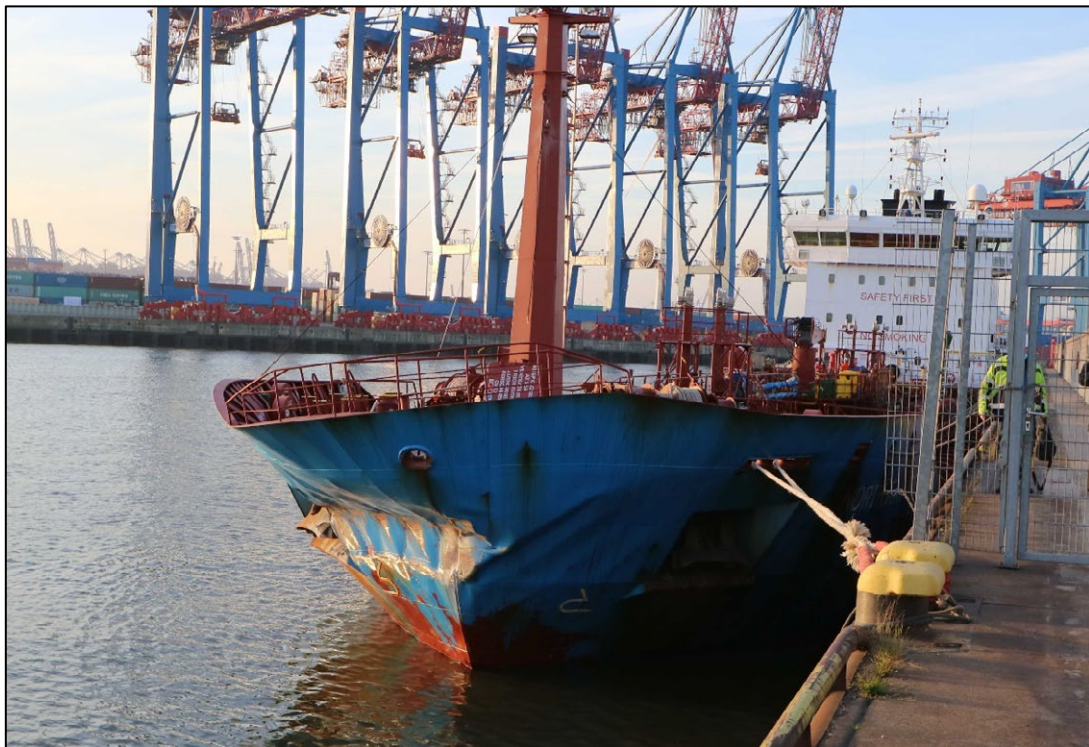
Figure 3: NORTHSEA RATIONAL – damage to the bow after the allision

The allision caused heavy damage to the NORTHSEA RATIONAL's forecastle, which made it necessary to call at a shipyard. The quay wall also suffered heavy damage. Nobody was injured and there was no damage to the environment due to the event.

The impact with the quay wall was at an angle of about 60°. Therefore, most of the damage to the ship was on the starboard side of her bow.

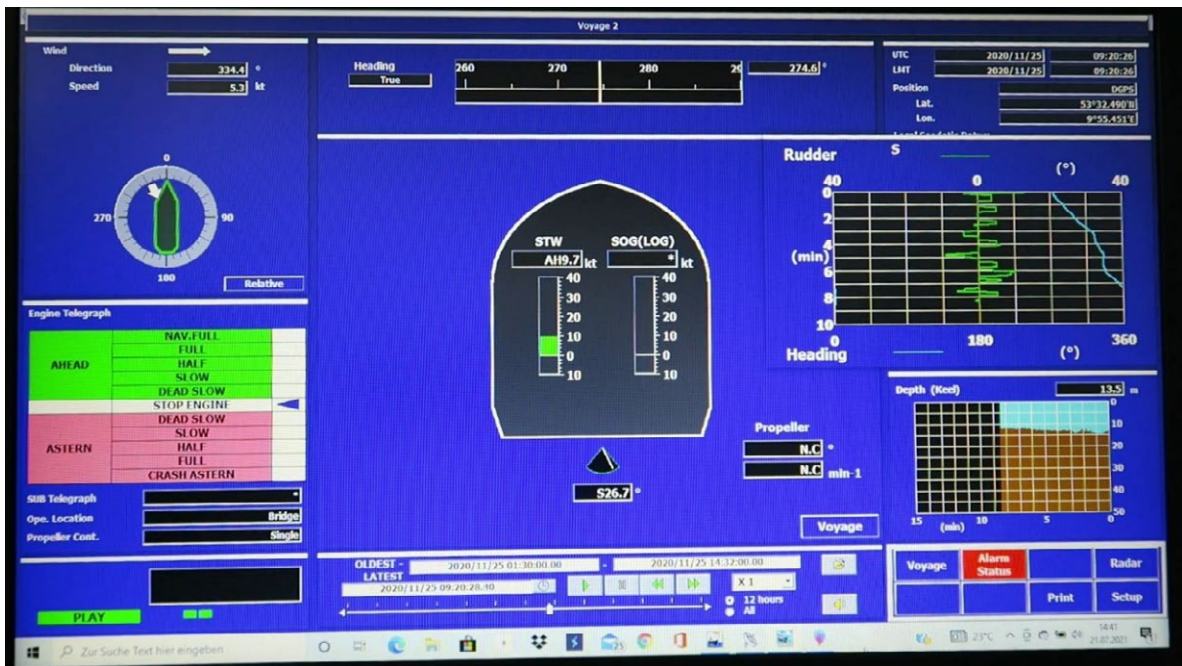
Figure 4: Still frame from the VDR playback at 102028

Figure 4 gives an impression of how the playback software presents the data. The figure shows the point at which the rudder position to starboard was at its greatest (26.7°). The STW is 9.7 kts.

Time at which the rudder position to starboard was at its greatest after the malfunctioning of the steering gear control system.

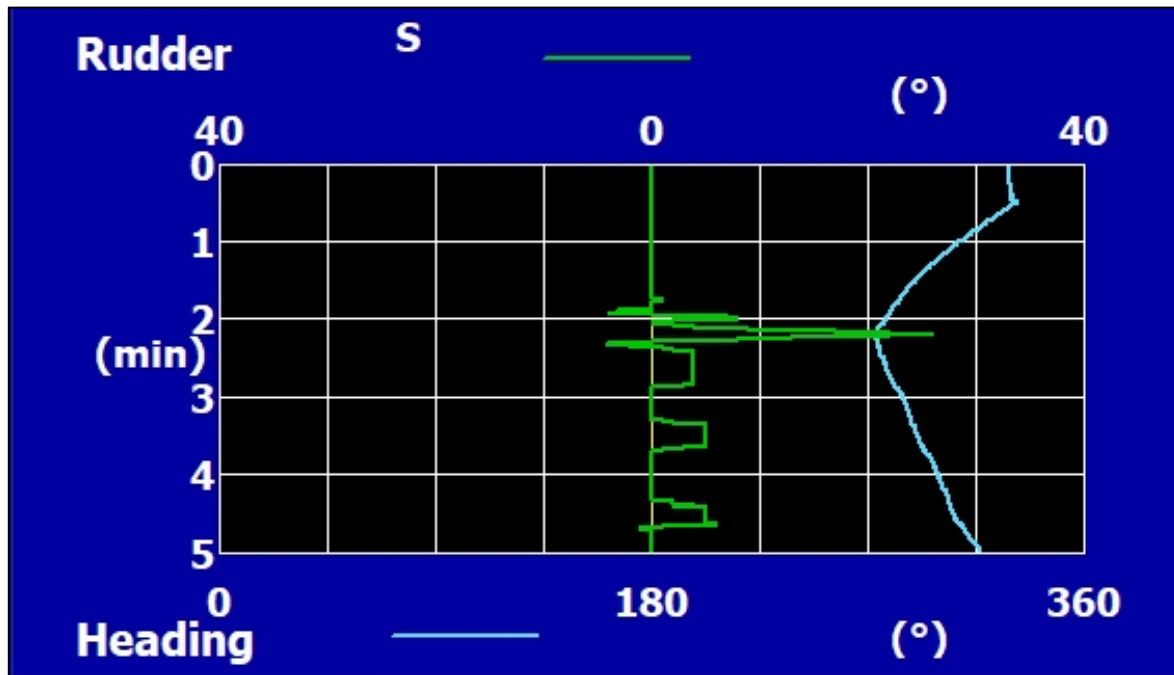
Figure 5: Rudder positions and courses about three minutes before and two minutes after the malfunction

to starboard, another smaller deflection to starboard (about 8°) followed by a deflection to port (about 4°) were recorded. The rudder then remained in a near-midship position.

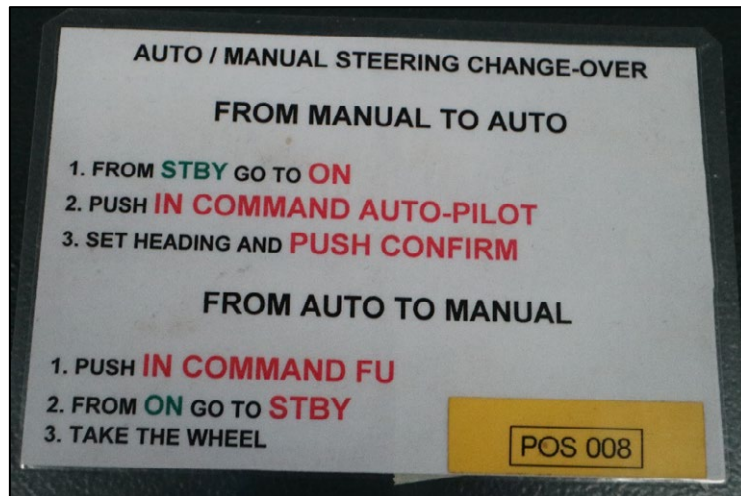
Figure 17: Instructions for the switching procedure

The instructions for the switching procedure found on the central console in the bridge (see Figure 17) corresponded to the procedure described above.

That the instructions on the central console for the procedure for switching from autopilot to FU steering and vice versa do not address the problem described can serve as evidence of this. In this respect, the crew can be credited with the fact that switching with a strong deviation between the current rudder position and the position of the tiller is rather unusual in the opinion of the investigators. The sharp deviation on the day of the accident only resulted from the brief failure of the relay and the resulting strong rudder deflection; it was not influenced or triggered by the helmsman. However, if the bridge team had been aware of the problems described above, it would have been able to actively intervene and retrieve the steering.
