Saga Sapphire

SYNOPSIS

At 1020 on 29 March 2012, two crewmen fell 22m into the water from *Saga Sapphire's* No 5 lifeboat while the ship was secured port side alongside in Southampton. They sustained minor injuries.

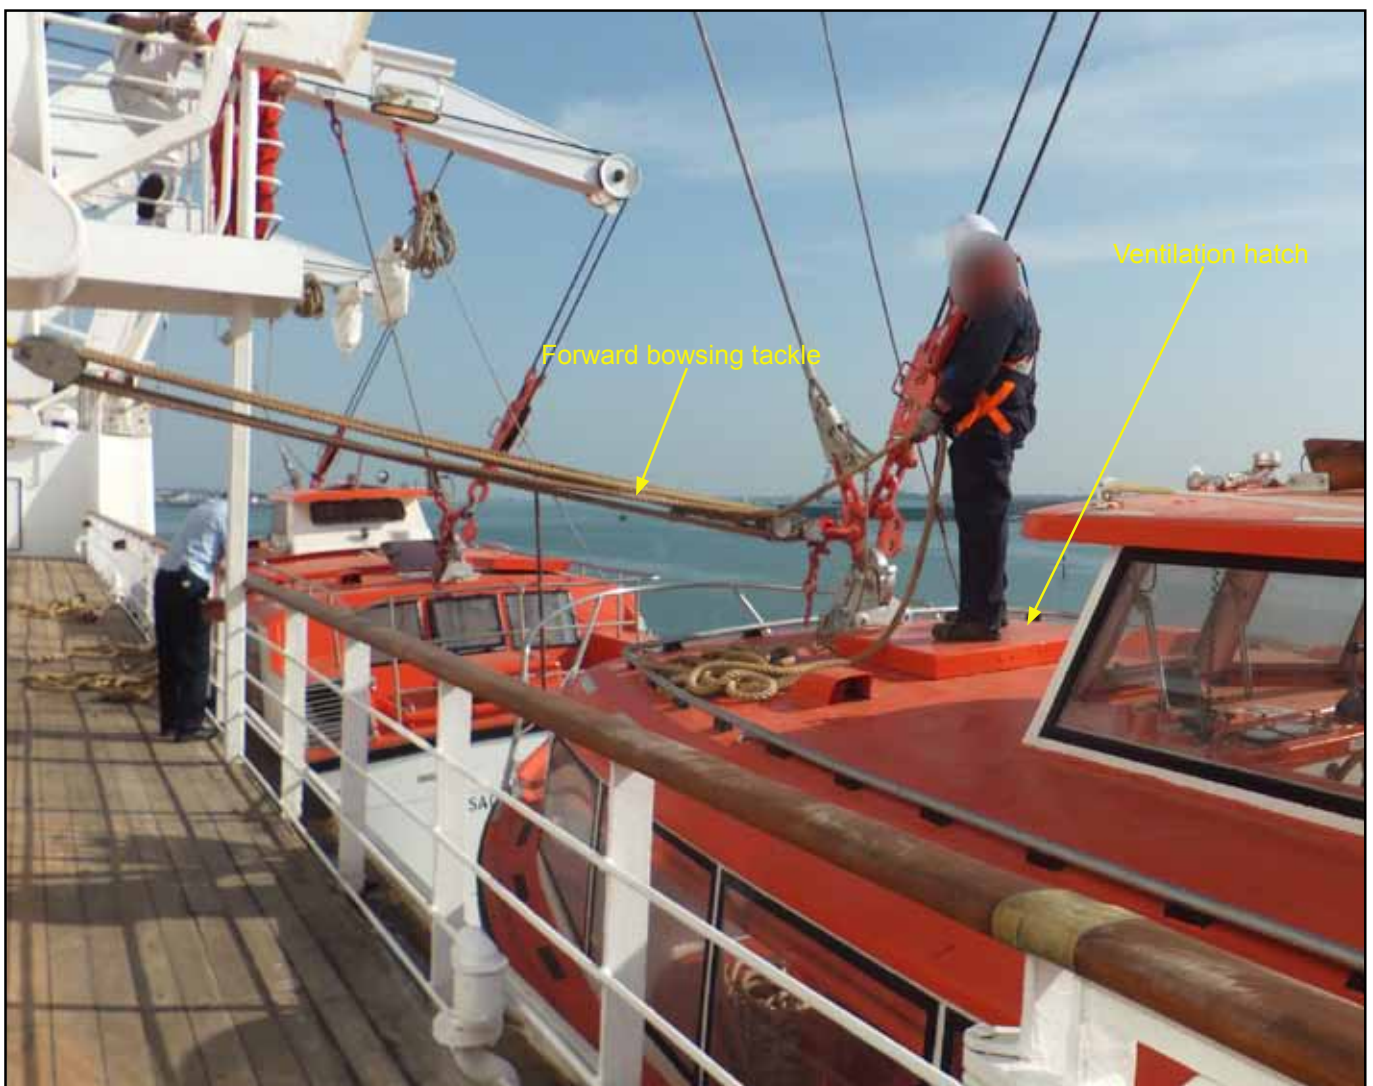
Figure 3: Access to bowsing tackles from the tender's coach roof

To access the bowsing tackle connection points, the lifeboat preparation crews had to stand on top of the tenders' coach roofs (**Figure 3**) and on the top of the open lifeboats' stem and stern compartments (**Figure 4**). While the crews wore safety helmets, safety shoes and solid lifejackets, none of them wore a safety harness and tether.

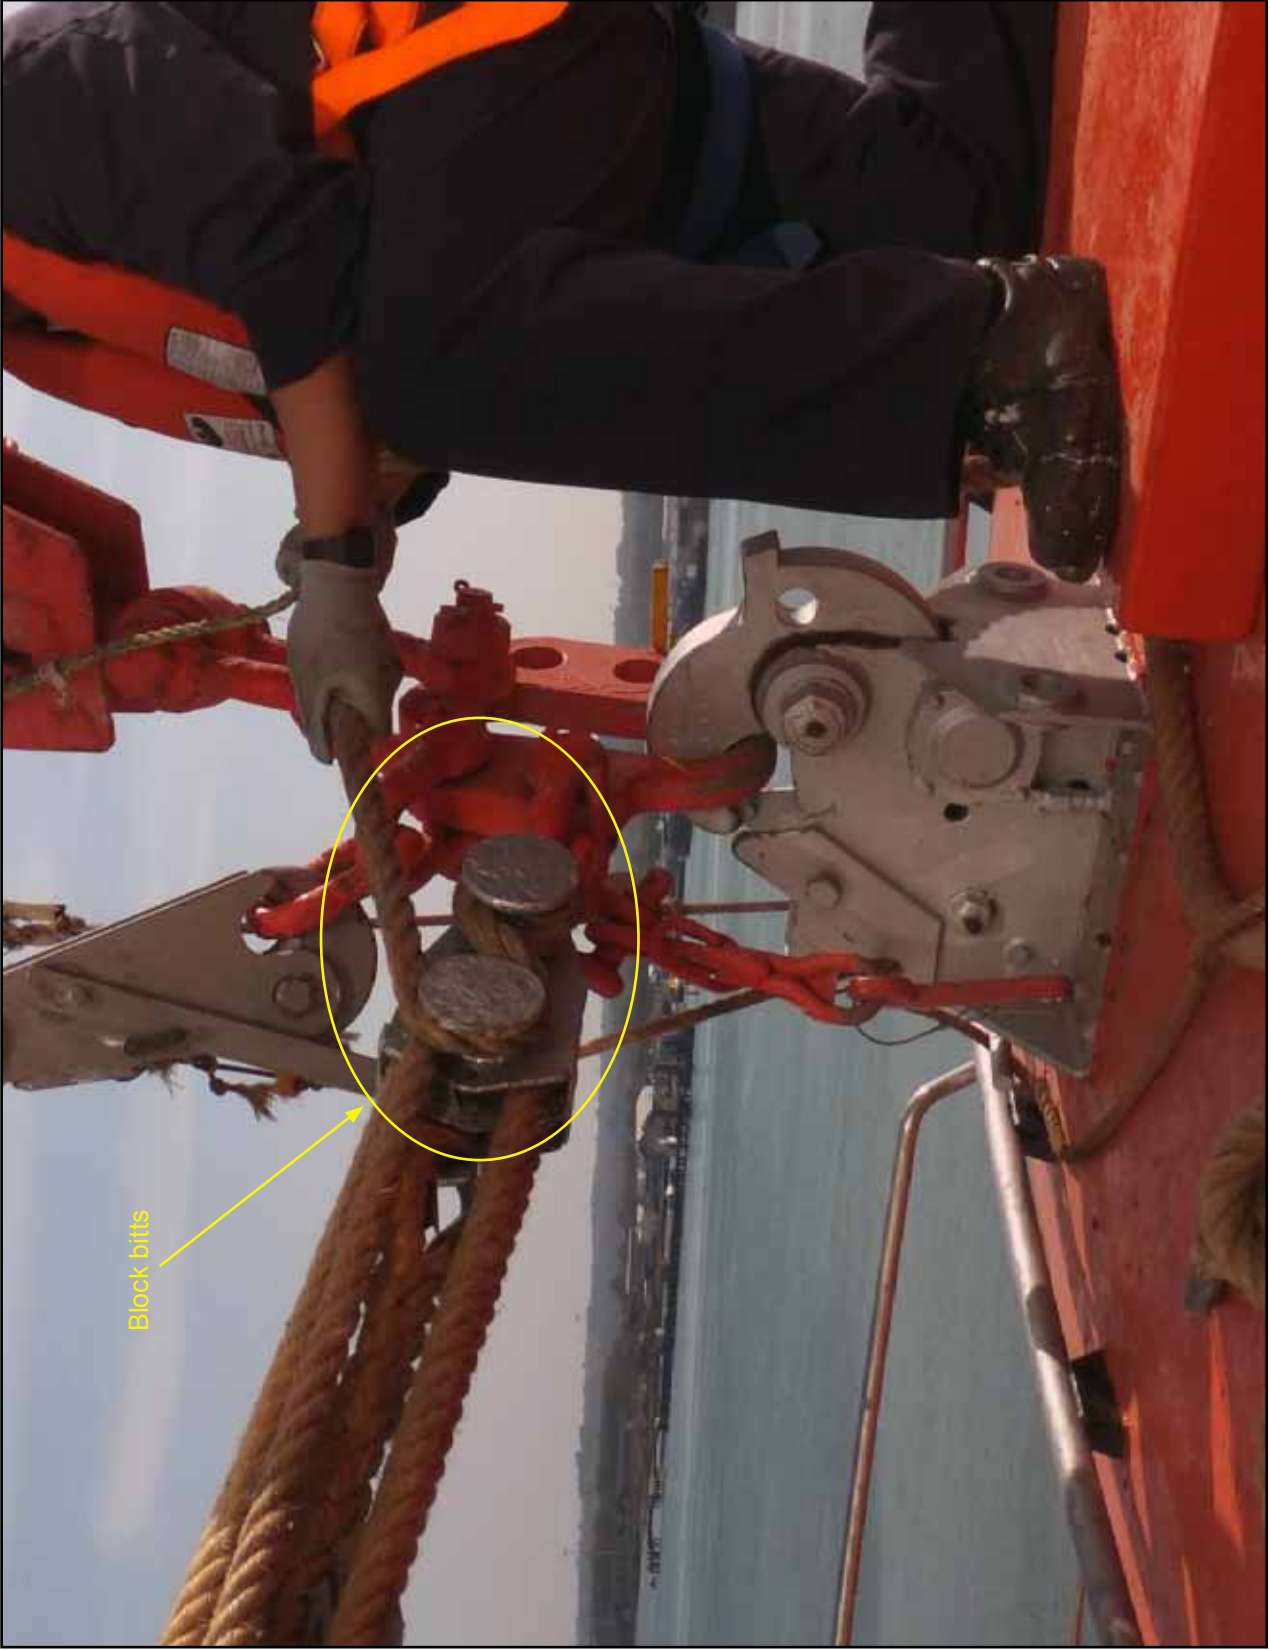
Figure 7: Bowsing tackle rope on the block bits

Freely running ropes and blocks are essential for the efficient and safe operation of the bowsing arrangement so that the system can be properly controlled. The use of the oversized ropes, first identified during refit in Palermo, compromised that safety. This was recognised by the master, who instructed them to be changed. However, insufficient priority was given to this. The management of the rope changes was inadequate and there was no involvement of the ship's safety management team, whose responsibility it was. No one was clearly nominated to take control of the changes and there was no process in place to confirm they had been completed. The dangers manifested themselves when the first cook was only able to put one figure-of-eight turn around the forward bowsing block bitts on No 5 tender. It was this which allowed the rope to come easily off the bitts and initiate the accident.

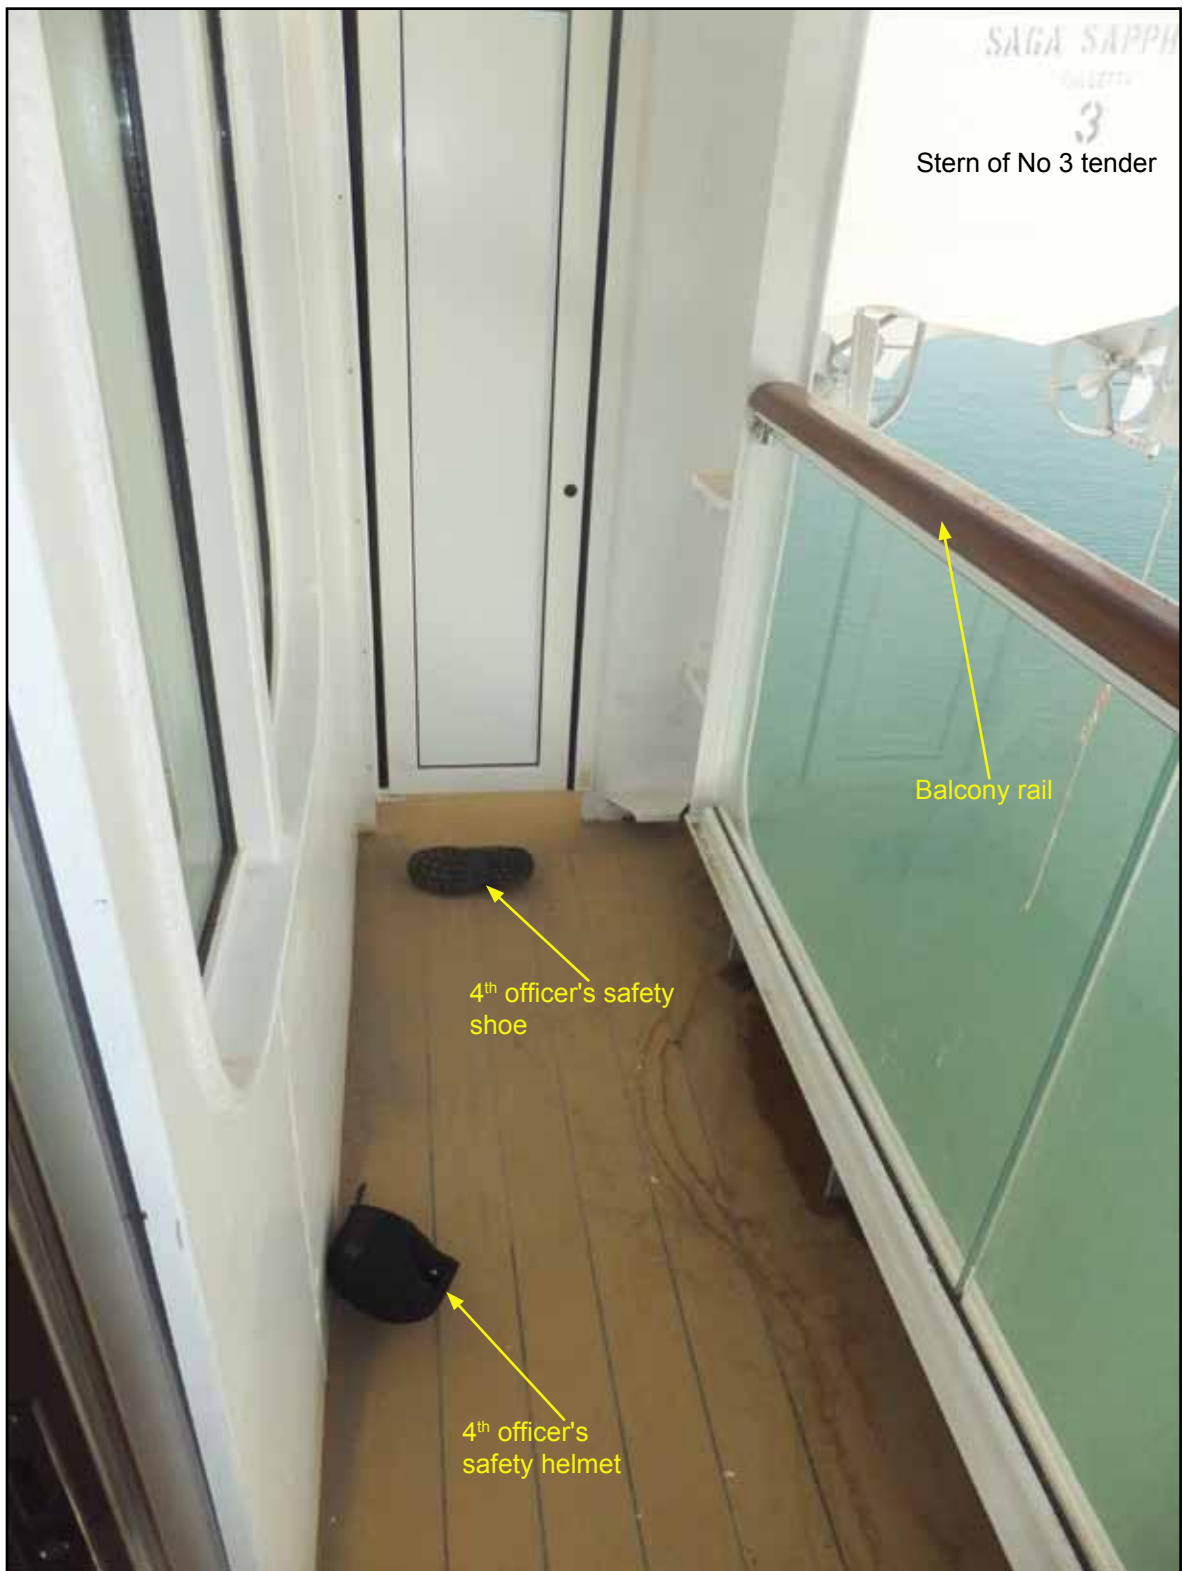
Figure 8: Balcony rail of cabin 8036

The fourth officer's and first cook's attempts to prevent themselves from falling over the tender's port side were unsuccessful. The fourth officer fell first and made contact with the balcony rail of cabin 8036 (**Figure 8**), one deck below the tender's position. His safety helmet and right safety shoe landed on the balcony deck and he then fell about 22m into the water. As his lifejacket auto-inflated, the fourth officer surfaced just as the first cook entered the water. As the latter surfaced, the fourth officer swam towards him to check his condition and to provide reassurance that they would be rescued. At the same time, a lifejacket and two lifebuoys were thrown into the water and each man managed to grasp one of the lifebuoys.

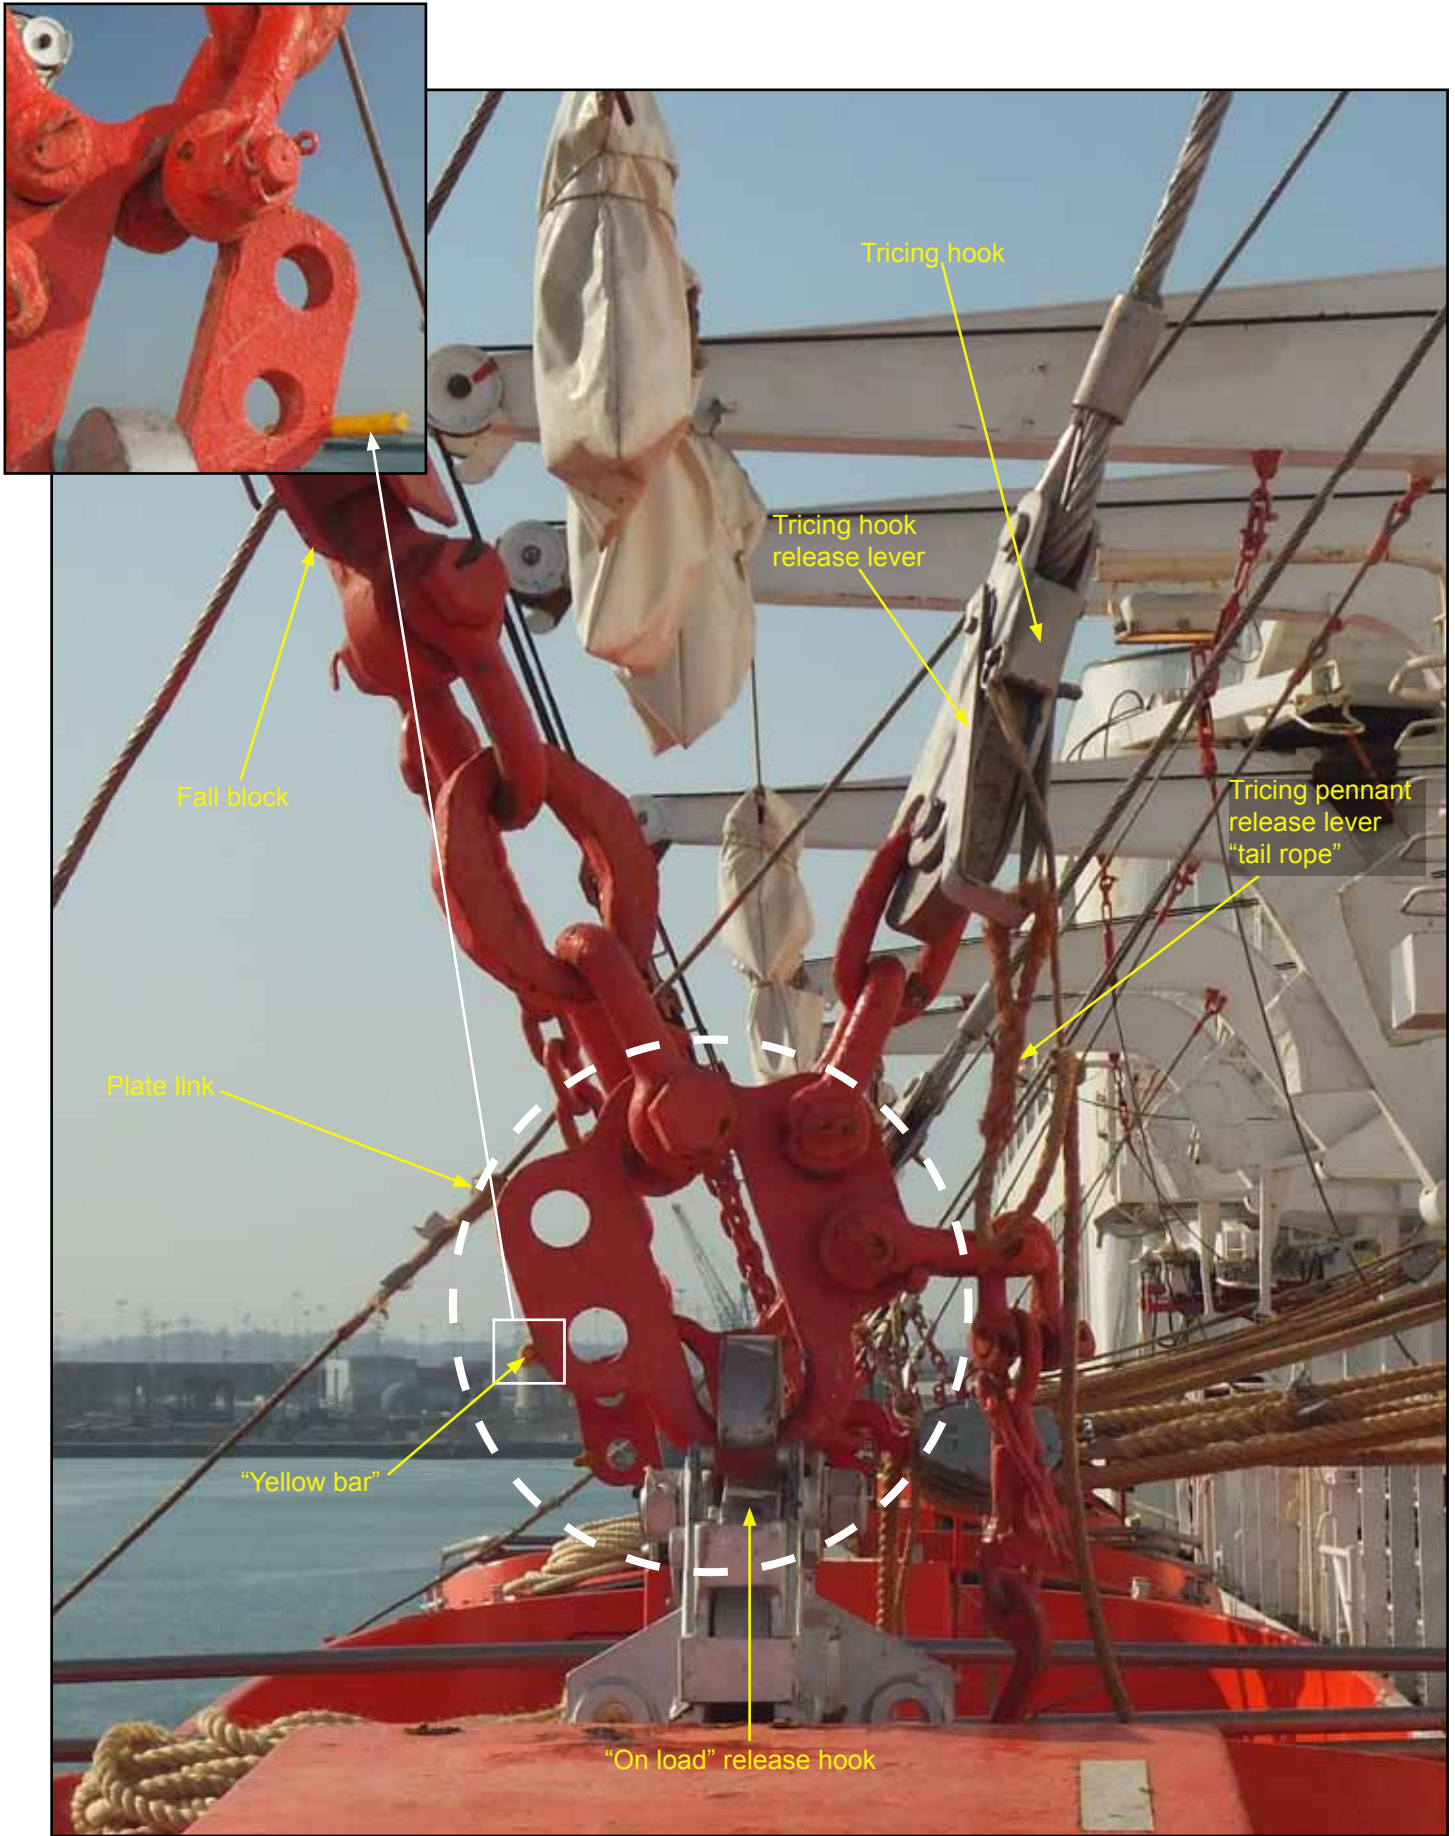
Figure 14: Tricing hook, plate link and "yellow bar" arrangement

The interim procedure to use the existing bowsing block arrangement, but securing the tail rope to the "yellow bar" which has been welded to the plate link of the boats, is potentially unsafe. The bars were added after the blocks entered service. There is no record of them being load-tested and they may well be unfit for the purpose for which they are now being used. If this securing method is to continue, the bar's SWL requirement should be identified and it should be appropriately load-tested and approved.

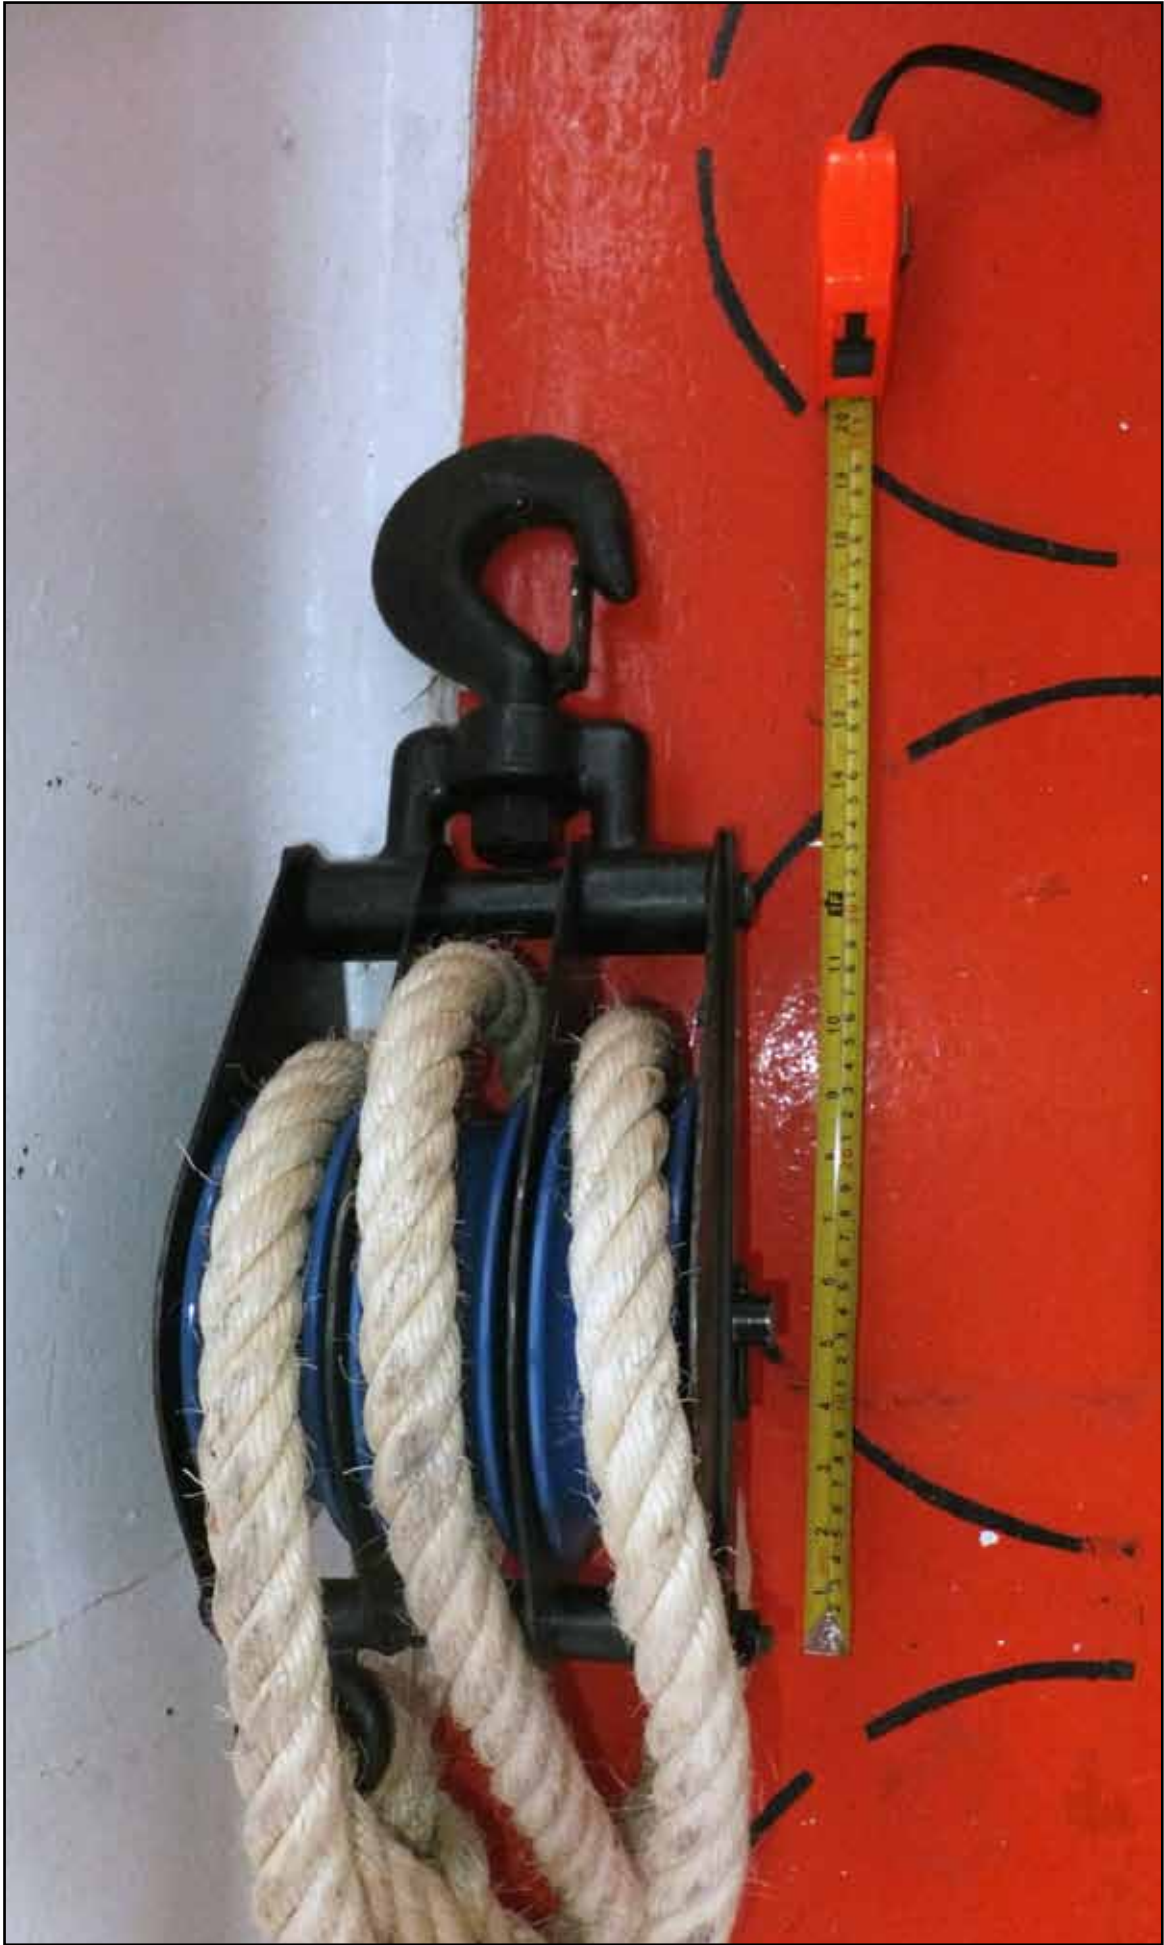
Figure 19: Three-fold bowing tackle block

Following the accident, three-fold tackles, providing a mechanical advantage of six, were ordered to replace all the original equipment (**Figure 19**). However, they proved to be extremely heavy and were not fitted with any securing arrangements, so they were also abandoned in favour of the original design.

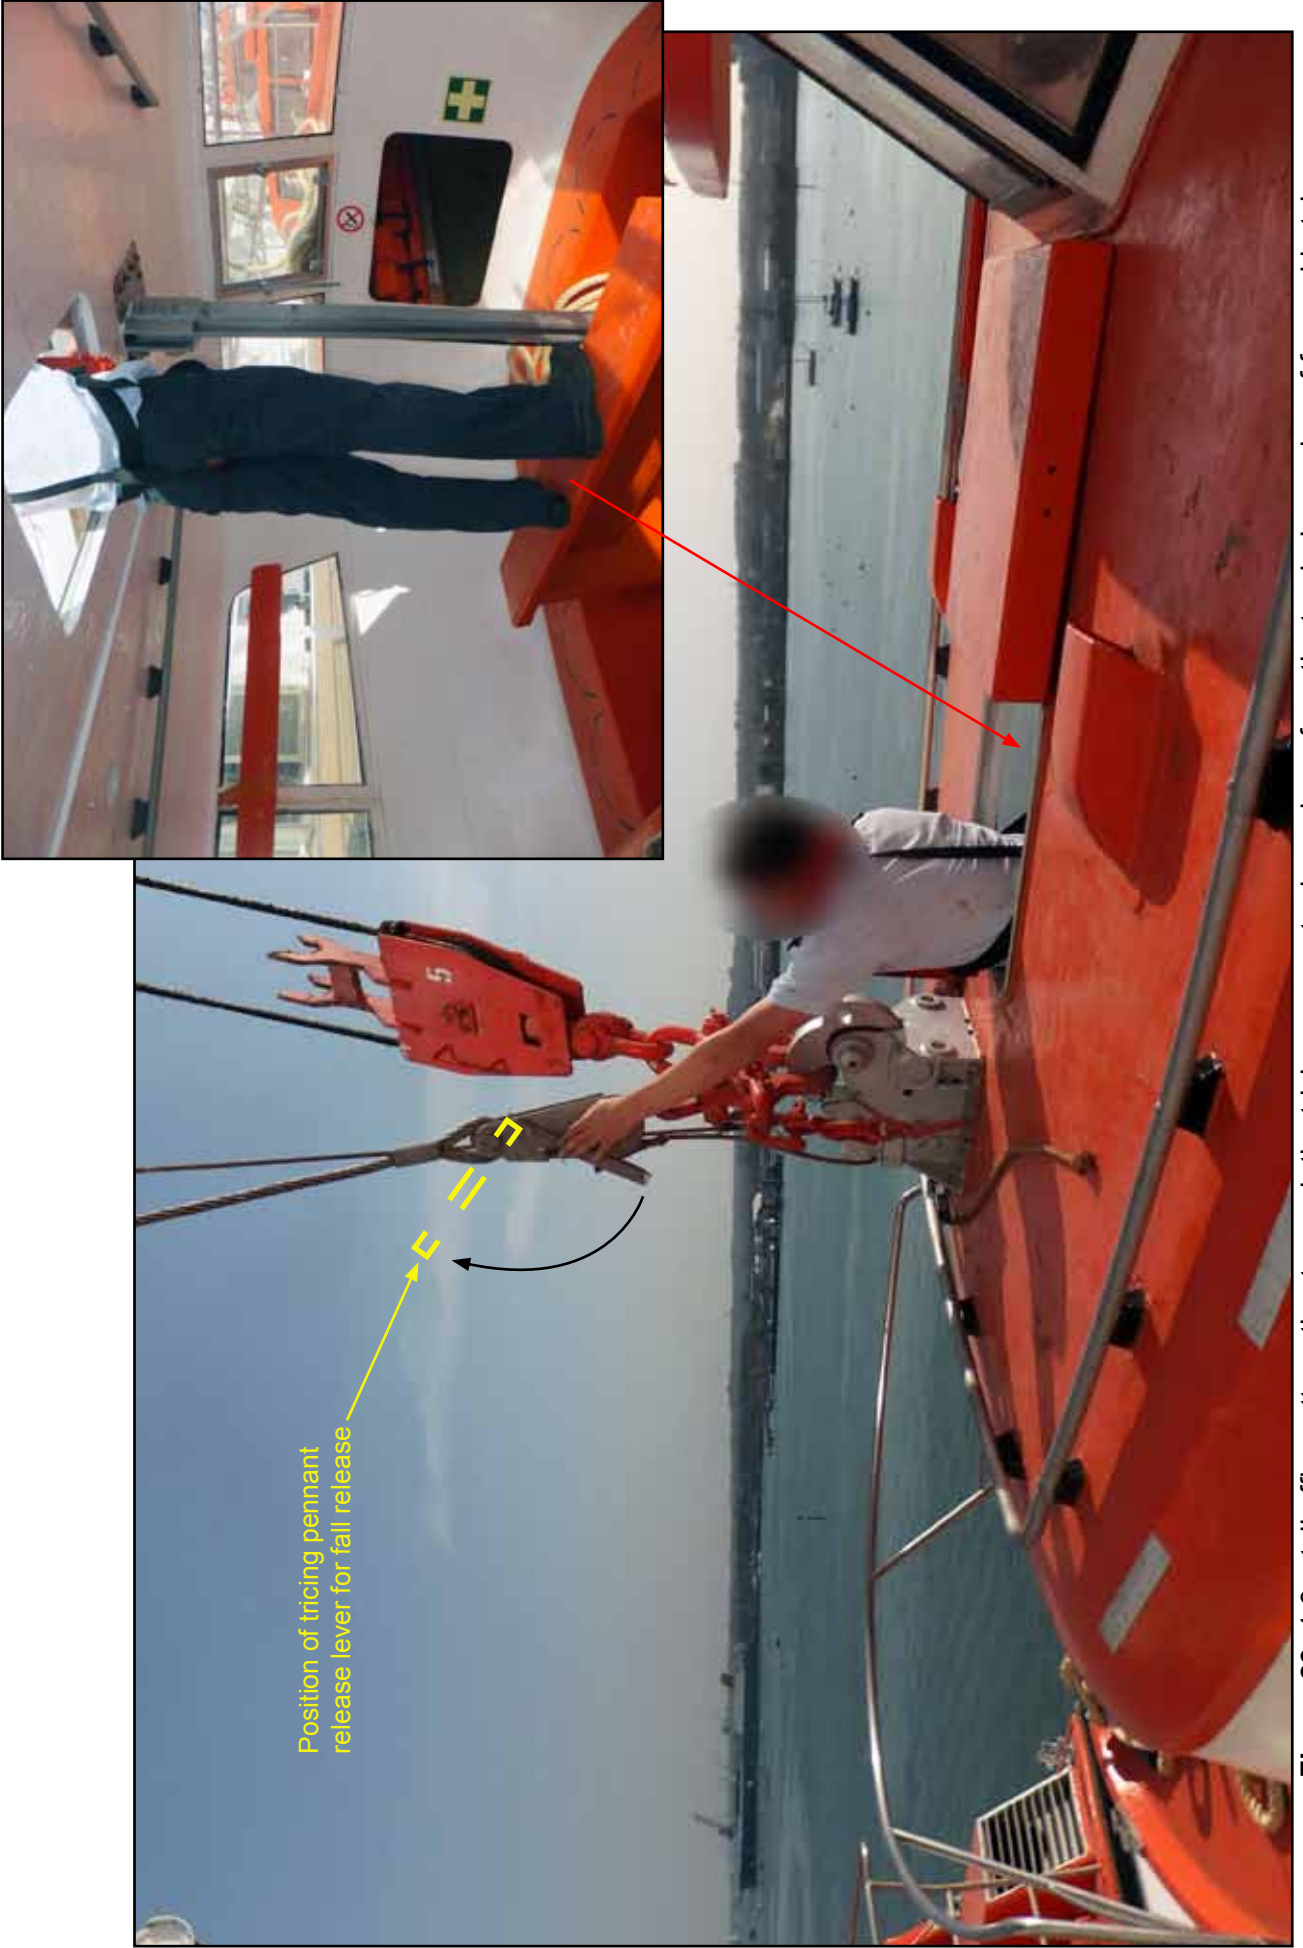
The same issue was also observed when the lifeboat crew attempted to operate the tricing pennant hook release lever from within the open lifeboat, while standing on the forward bench seat. Again, because of crew height limitations, in most cases it was not possible to do so safely.

Figure 23: 1.9m tall officer attempting to reach the tricing pennant release lever from the tender's coach roof forward hatch
