## *Final report RS 2016:10e*

KERTU – Grounding at Landsort, Stockholm County, on 29 October 2014

Reference no. S-178/14

29 November 2016

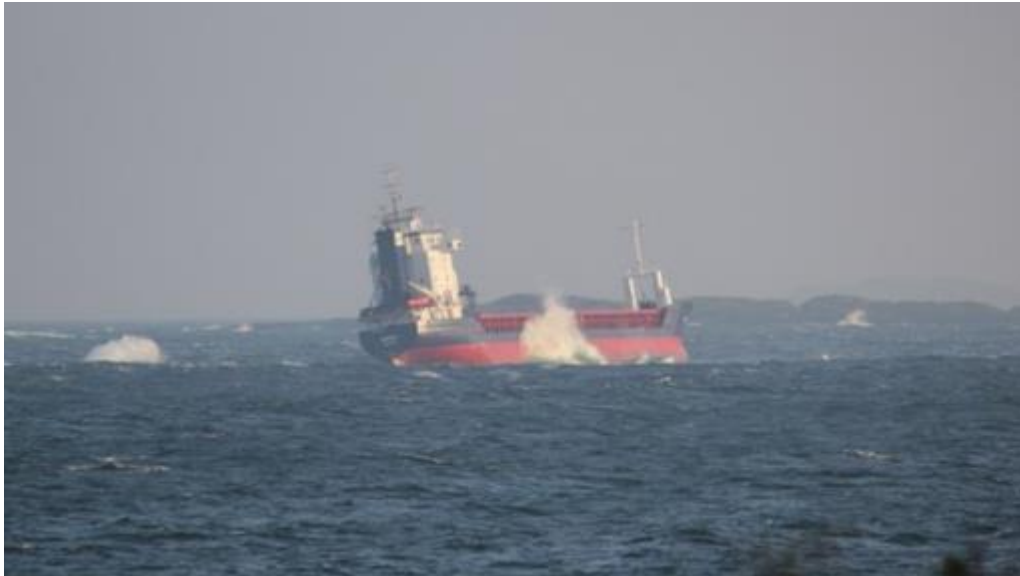
Figure 1. KERTU aground. Photo: SVT.

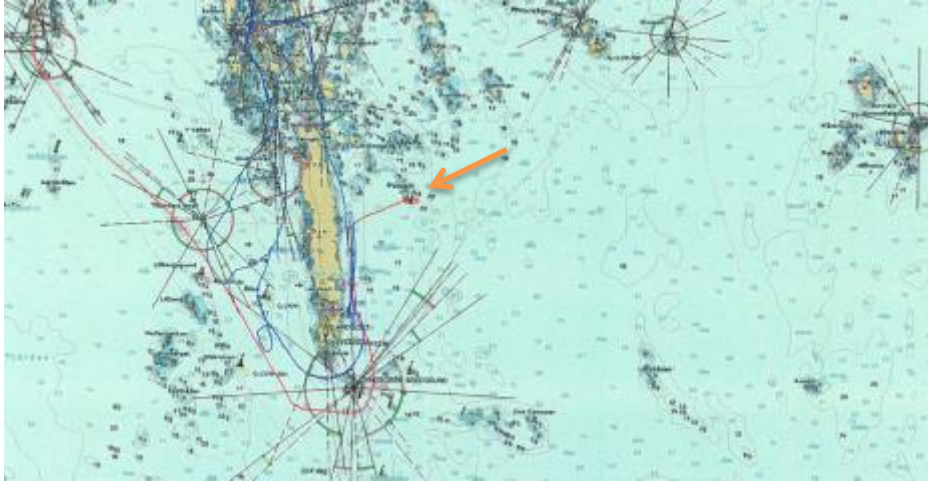
Because of this, his concentration was not focused on KERTU over the following few minutes. AIS recordings show that KERTU turned to a heading of 067° and then, some minutes later, grounded hard at a speed of 9.8 knots at 4:15 a.m. by the reef “Fudden”, east of Landsort.

Figure 2. The area around Landsort. The red track is KERTU's. The blue track is the pilot boat's. The arrow mark the position of the grounding. The islands to the right in the image are Gunnarstenarna.

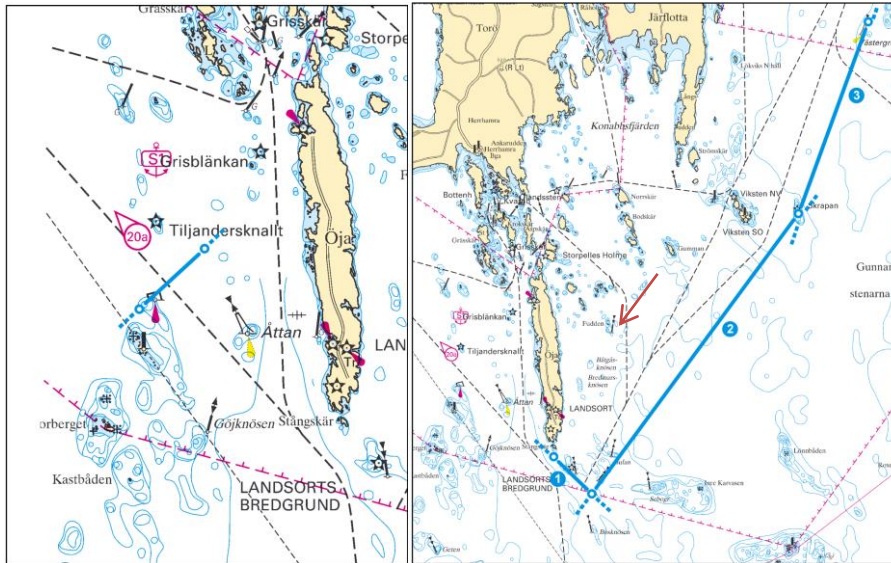
In this case, the pilot deemed it necessary for safety reasons to find shelter on the eastern side of Landsort and therefore disembarked at a position inside of the compulsory pilotage limit. The significant wave height was up to three metres in this area at that time, which means that the highest waves were about five metres high.

Figure 3. Compulsory pilotage limits to the west and east of Landsort. The arrow shows where the grounding took place.

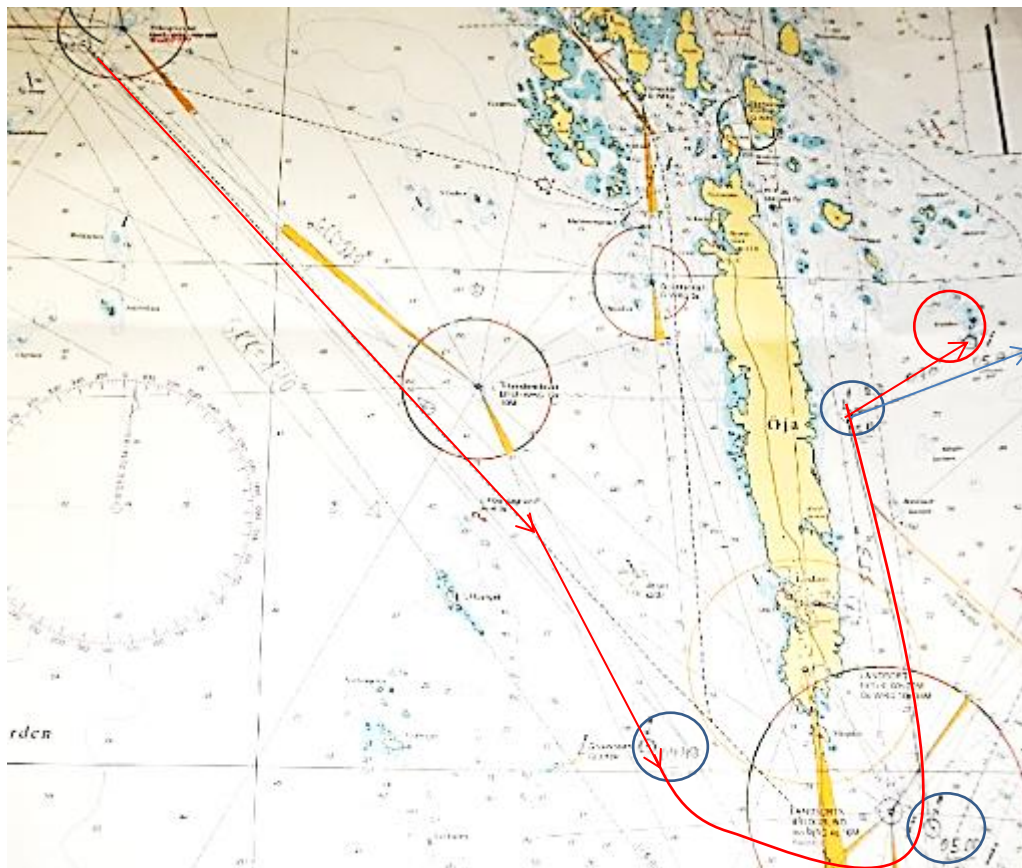
Figure 4. The vessel's chart of the area and her route and planned route. The blue arrow indicates the planned route following the planned disembarkation of the pilot to the east of Landsort. The blue rings show the positions plotted on the chart and the red ring shows where the grounding took place.

When SHK was on board KERTU, the routeplanning and associated correct position information was found drawn on the paper chart. It was established that the course over ground (COG) found in the

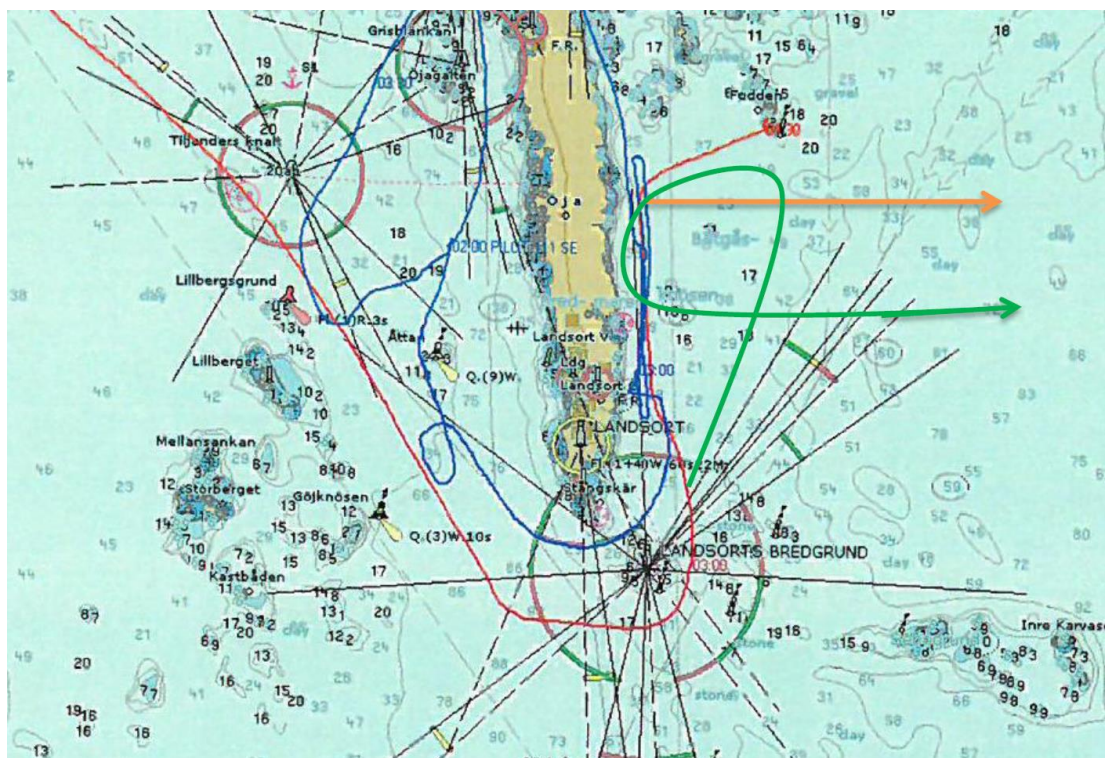
Figure 7. The picture shows KERTU’s track in red. The pilot boat’s track is blue. The change of KERTU’s course following disembarkation recommended by the pilot is marked in orange. The green track shows the route the pilot proposed following the accident for pilot disembarkation in the event of heavy seas with westerly and south-westerly wind.

The pilot has presented a proposal to the investigation with respect to the future disembarkation of pilots on the eastern side of Landsort. The proposal involves a vessel being able to turn to port in towards Landsort and that the pilot leave on a southerly heading, after which the vessel would then turn to port towards the east and reach the open sea south of Gunnarstenarna as indicated in the sketch below. This would mean that the vessel is given more space to make its turn out towards the open sea after the pilot has disembarked the vessel, compared with the opposite approach that was used during the event in question. (See the green track in Figure 7, below.)
