# **STATE COMMISSION ON MARITIME ACCIDENT INVESTIGATION**

## **FINAL REPORT 54/14**

**M/V MARICHRISTINA**

Grounding of the vessel while approaching the Świnoujście anchorage  
on the day of 11 December 2014

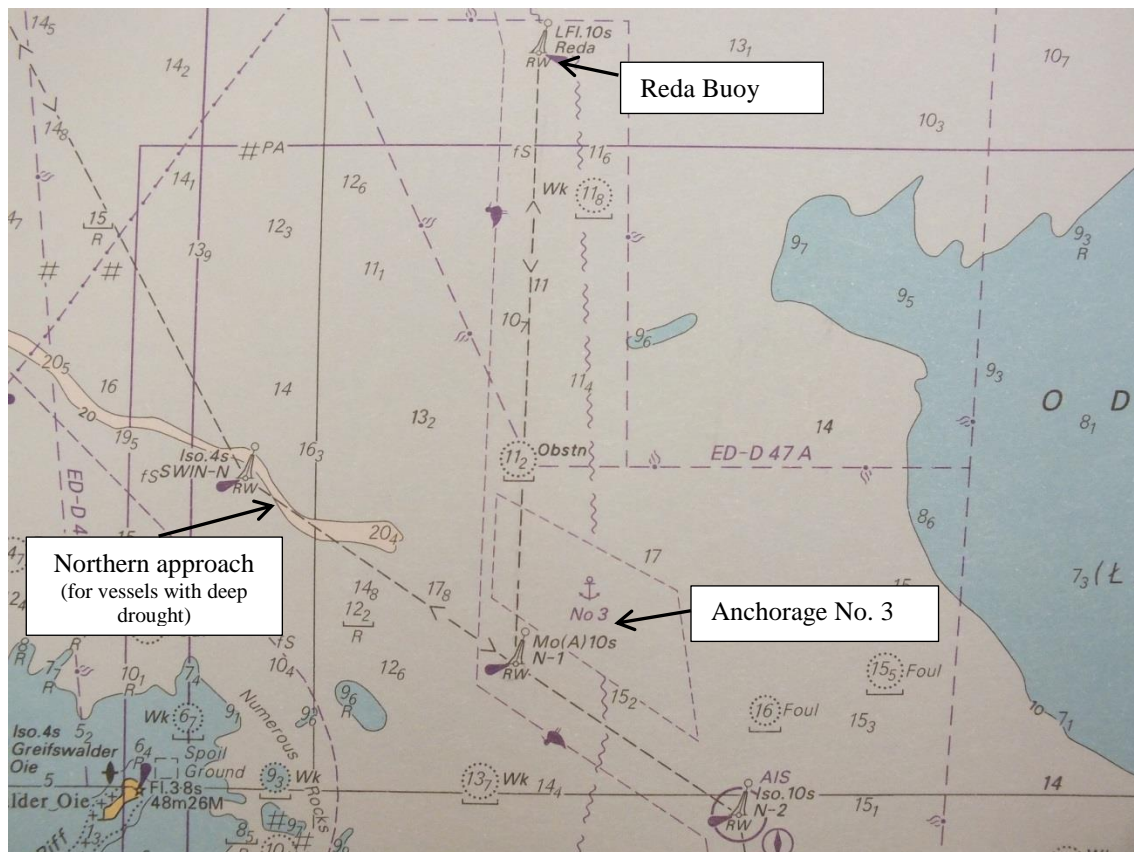
Photograph 2: Part of the BA 2150 chart – northern approach to the Bay of Pomerania

At 23:55 the vessel changed from sea speed to full manoeuvring speed (66 rpm). The master ordered the boatswain to prepare the anchors. The vessel was sailing with the speed of approximately 10.9 knots by a southerly course leading to shallow water where the depth at places was as small as 10.7 m and there was a single obstacle at the depth of 11.2 m (Photograph 2).

The navigator officer who has prepared the voyage plan, has indicated in its right column a wrong depth of 15 m at the waypoint no 61, and has not made a remark (has not checked) that the depth in the section between waypoints no 61 and 62 fell well below the draught expected for a vessel for approaching Świnoujście. In the opinion of the Commission, it was particularly reckless and unprofessional to mark the route of the vessel over the obstacle placed 11.2 m under water<sup>3</sup> (shown in the central part of Photograph 2).

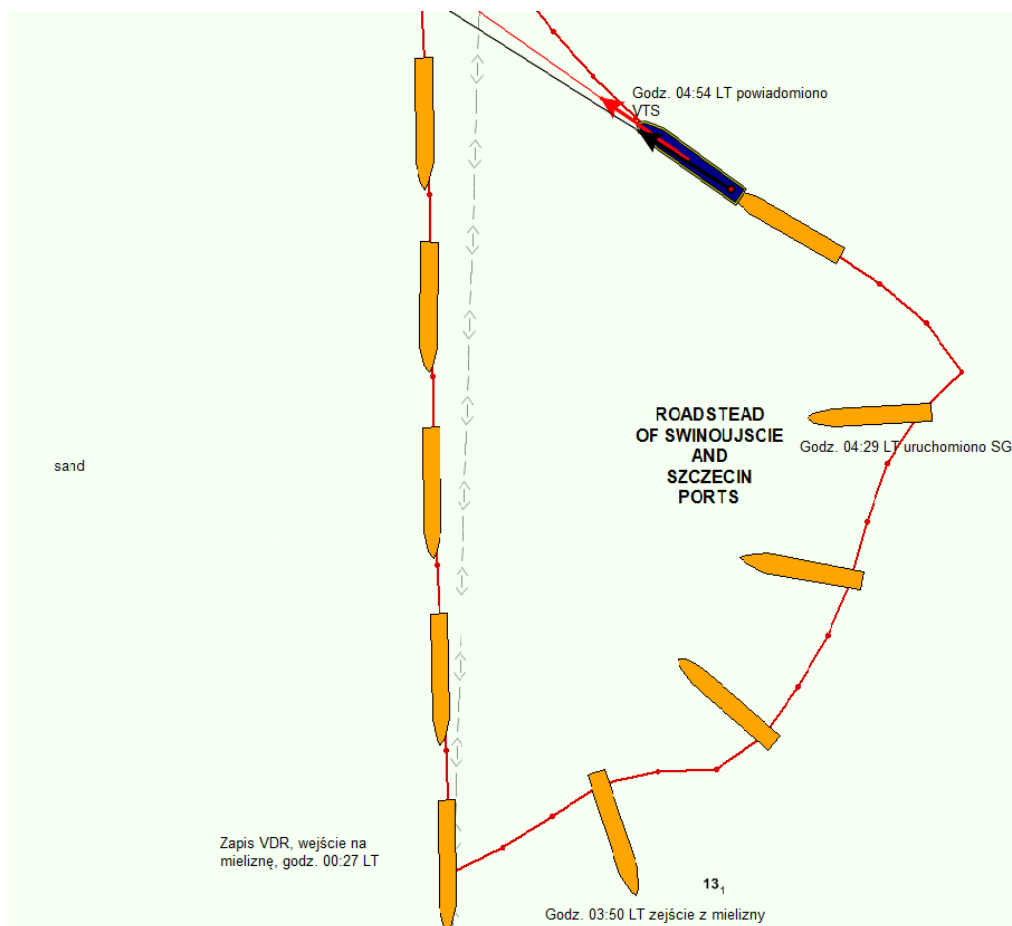
*Annex 2: Recording of the vessel's movement before entering the shallows and after refloating taken from the ship's VDR using the NavCruiser Pro application (electronic chart DE316004.000 Waters East of Ruegen)*

At 4:54 the watch officer of "Marichristina" reported to the VTS that the vessel refloated on her own and now she was trying to go north off the area where she was stopped and then she would go by the approach fairway west of the SWIN-IN Buoy and to the anchorage No. 3.

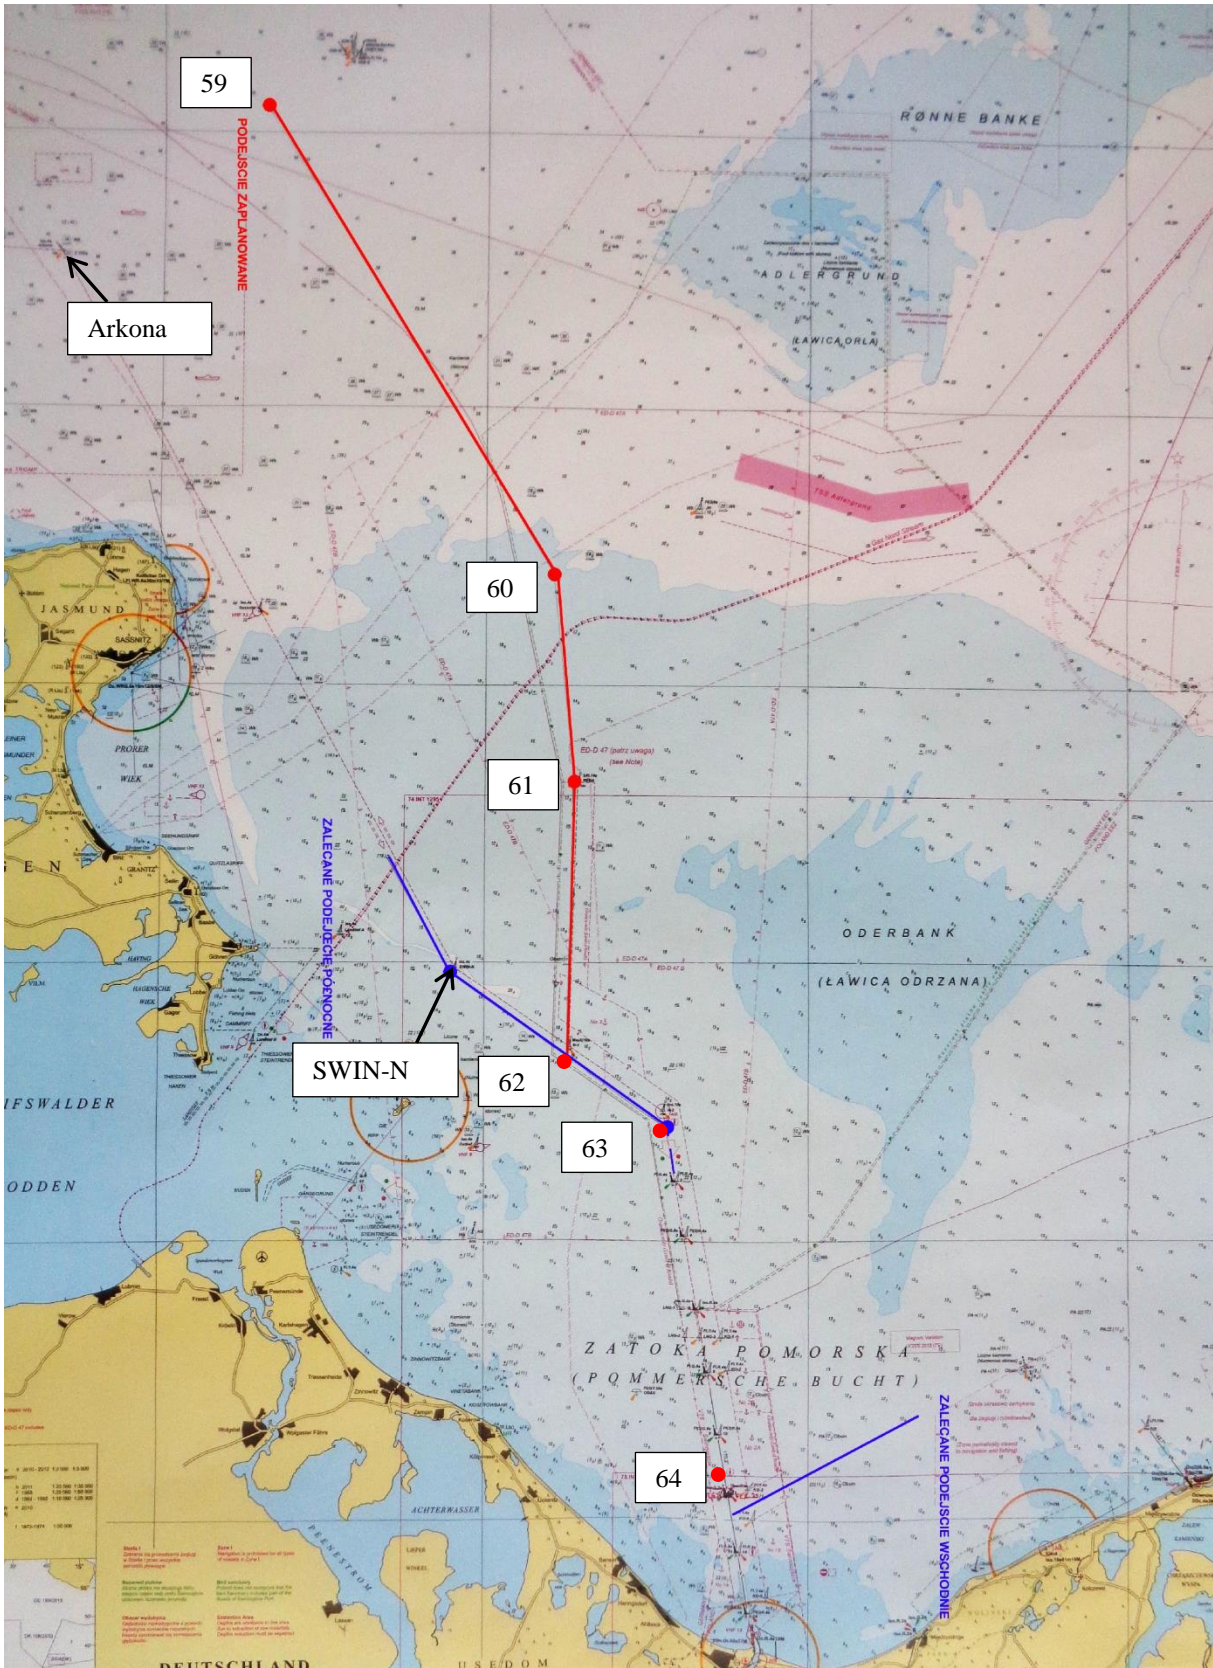
Photograph 4: Marichristina route planned by the crew (red line) and two approach routes recommended by sailing directions (blue lines)

The approach planned in such a way, particularly its part between the waypoints no 61 - 62, must have resulted in the grounding of the vessel with a draught of 12.8 m (according to the calculation of the crew, but in fact over 13 m) a few miles south of the Reda Buoy.

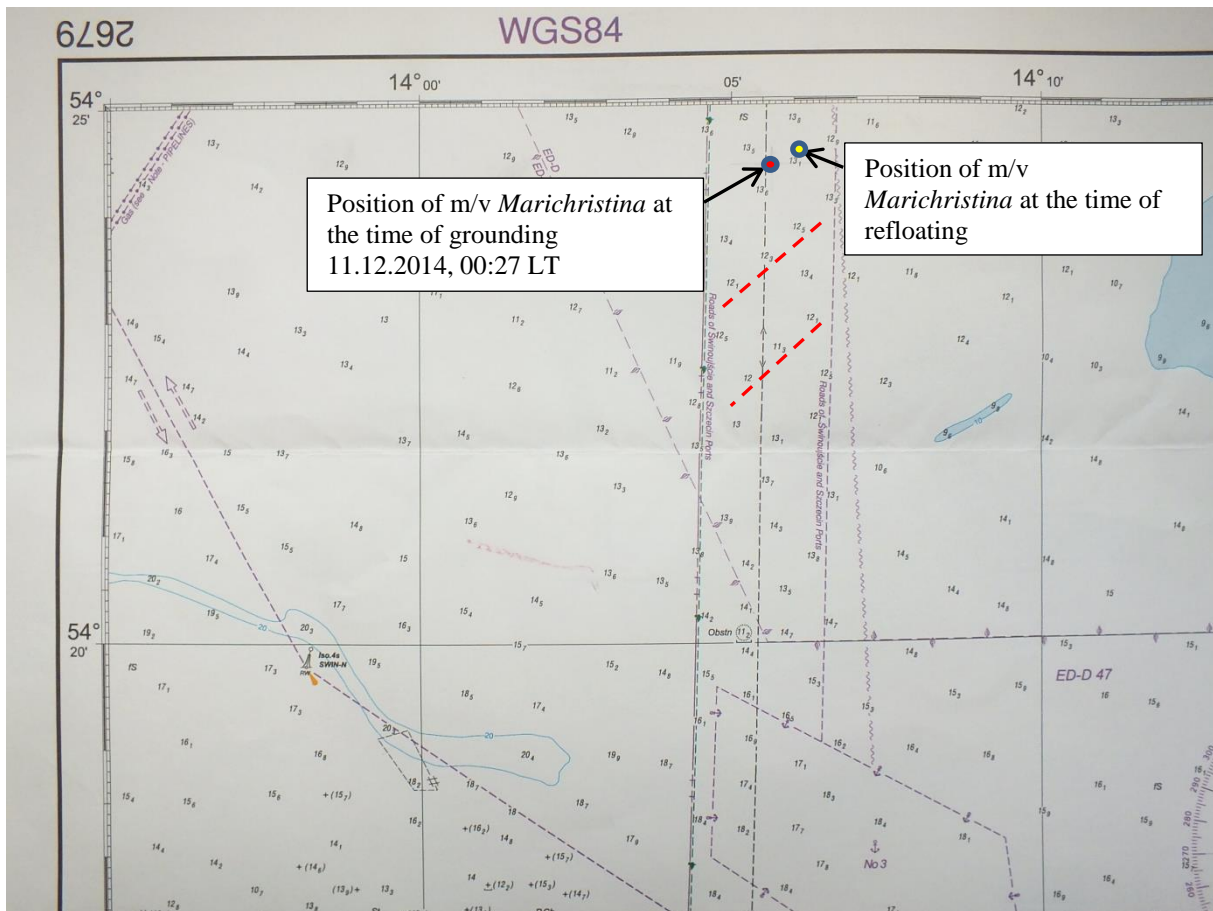
Photograph 6: Part of the approach chart BA 2679 with marked positions of the vessel at the time of grounding and refloating and depth thresholds crossing of which was impossible for the vessel

In the Photograph 6 dotted red line indicates two thresholds, with depths accordingly of 12.5, 12.3, and 12.1 m and 12.1, 11.3, and 12 m which the vessel would not have been able to cross even if the level of water had been average.

The “Marichristina” stopped on a sandy sea bed of the Bay of Pomerania 2 nautical miles south of the Reda Buoy and was drifting (as indicated in the Photograph 6) under the influence of a strong wind, rubbing its bottom against the sea bed for nearly 2.5 hours, about 2.5 cable-lengths in a northeasterly direction, to the deeper water and regained full buoyancy. It was then a strong south-western wind which was an external factor helping the vessel to refloat.
