**MARINE ACCIDENT AND INCIDENT  
INVESTIGATION COMMITTEE**

**[Investigation Report No: 182A/2015]**

**Serious Marine Casualty**

**Collision in dense fog between “Dinah Borchard” and “Eurocargo Patrasso” at Venice Coast-Adriatic Sea, on the 8<sup>th</sup> of December 2015**

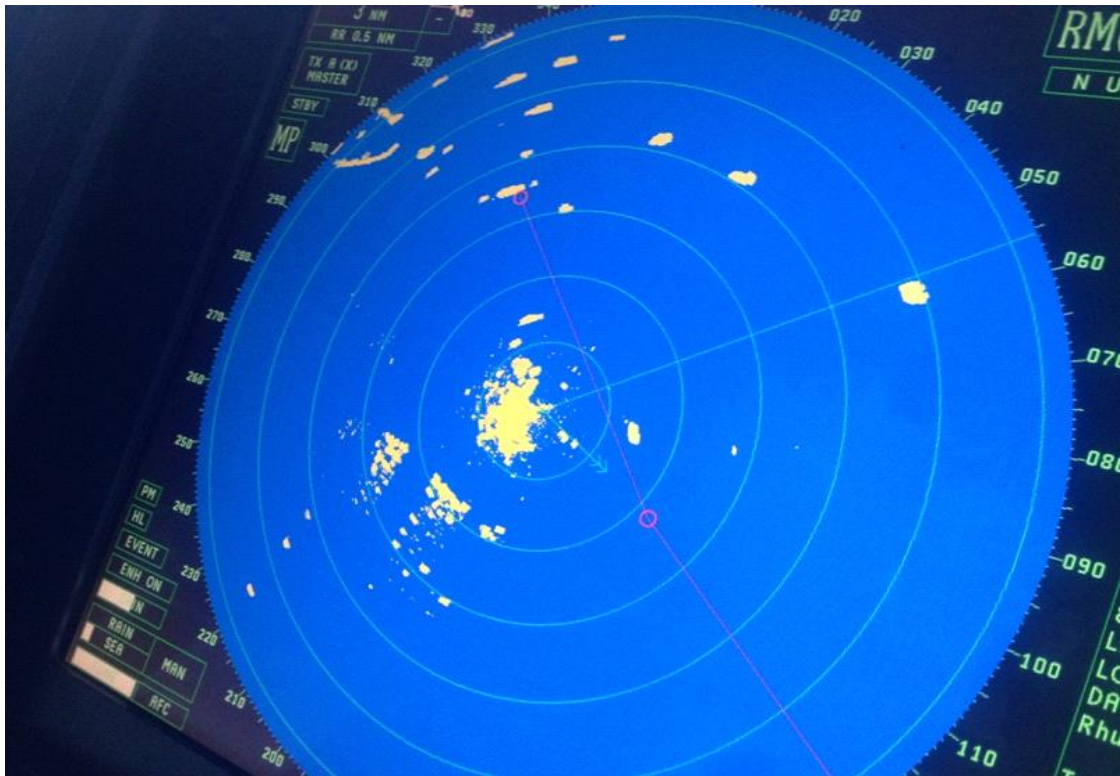
The Master of the “Dinah Borchard” stated that extended clusters around the centre of the Radar screen, covered echoes of other vessels in the vicinity (see Radar photos). It is generally accepted that a competent Radar Operator will recognize a true target (as opposed to clutter returns) if it scans at the same target for at least 5-10 scans. It is assumed that, clutters in the center of the screen obscuring the vessel ahead of own vessel, most probably resulted by failure to adjust the gain and anti-clutter properly. Therefore, it is assumed that inadequate skill of Radar Operators of the “Dinah Borchard” was a factor in the accident.

Figure 1: M/V “Dinah Borchard” Radar screen (after the collision – clutters around the vessel)

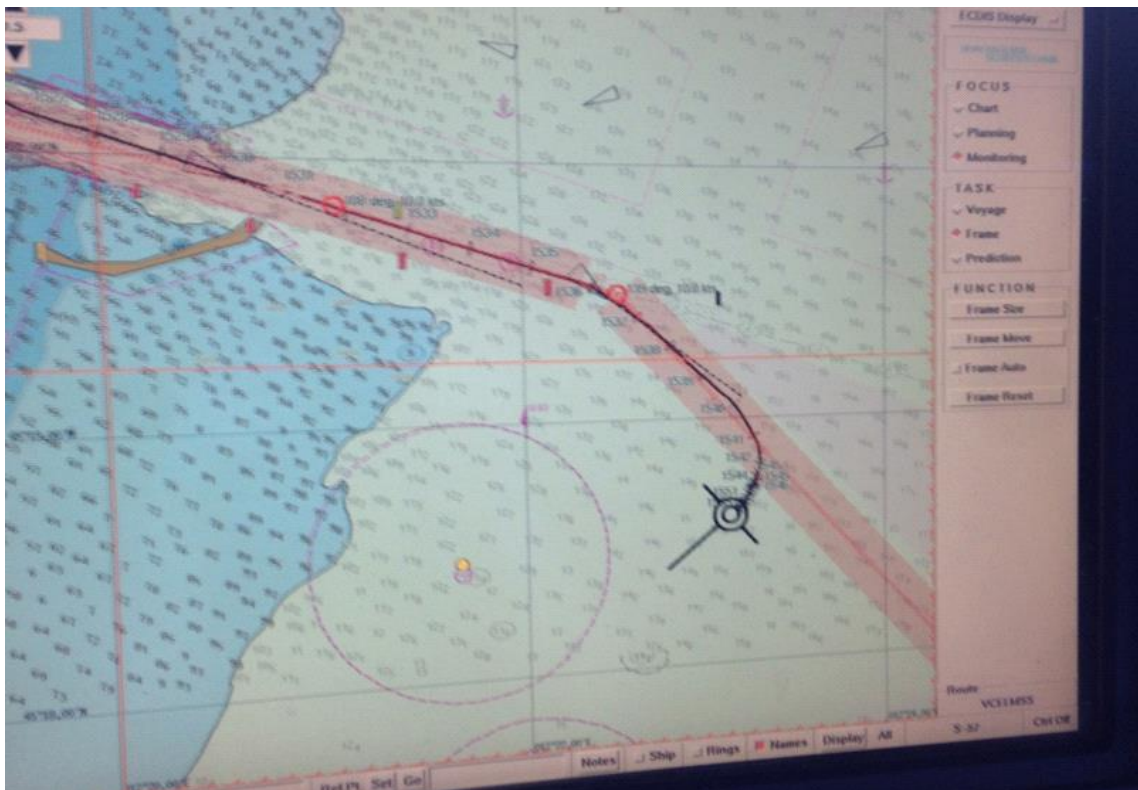
Figure 2: M/V “Dinah Borchard” ECDIS display (Pilots left from both vessels at Porto di Malamocco Breakwater. About 6-7 minutes later collided.)

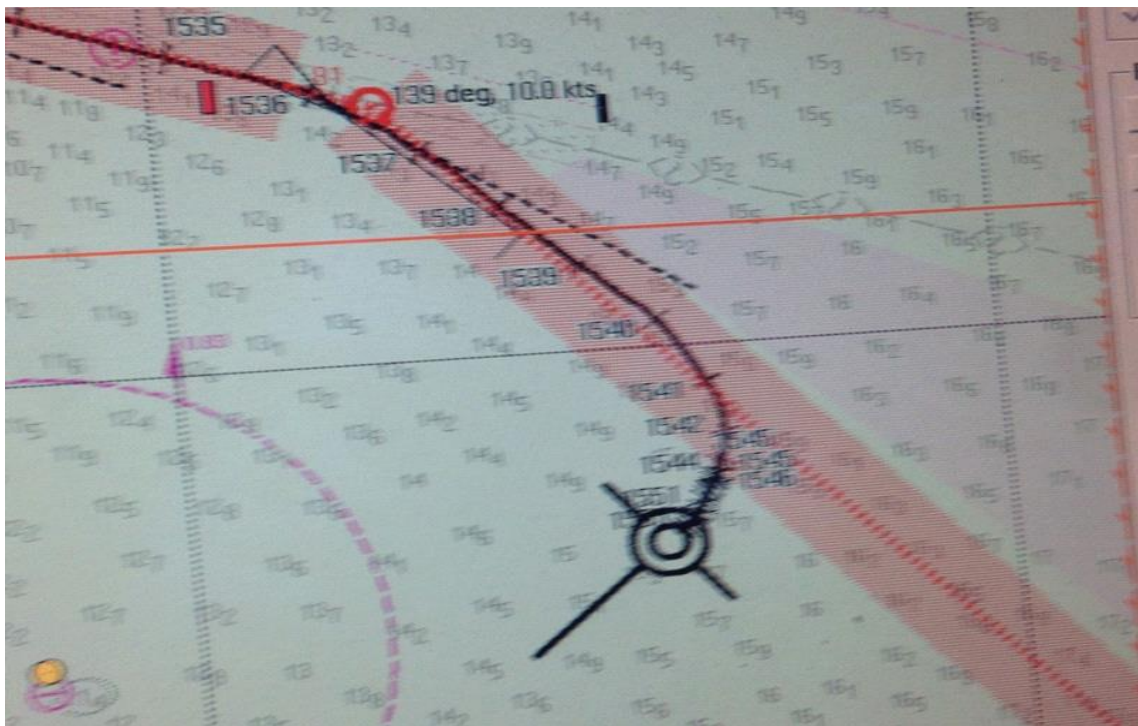
Figure 3: M/V “Dinah Borchard” ECDIS display (Collision occurred between 15:36-15:37)

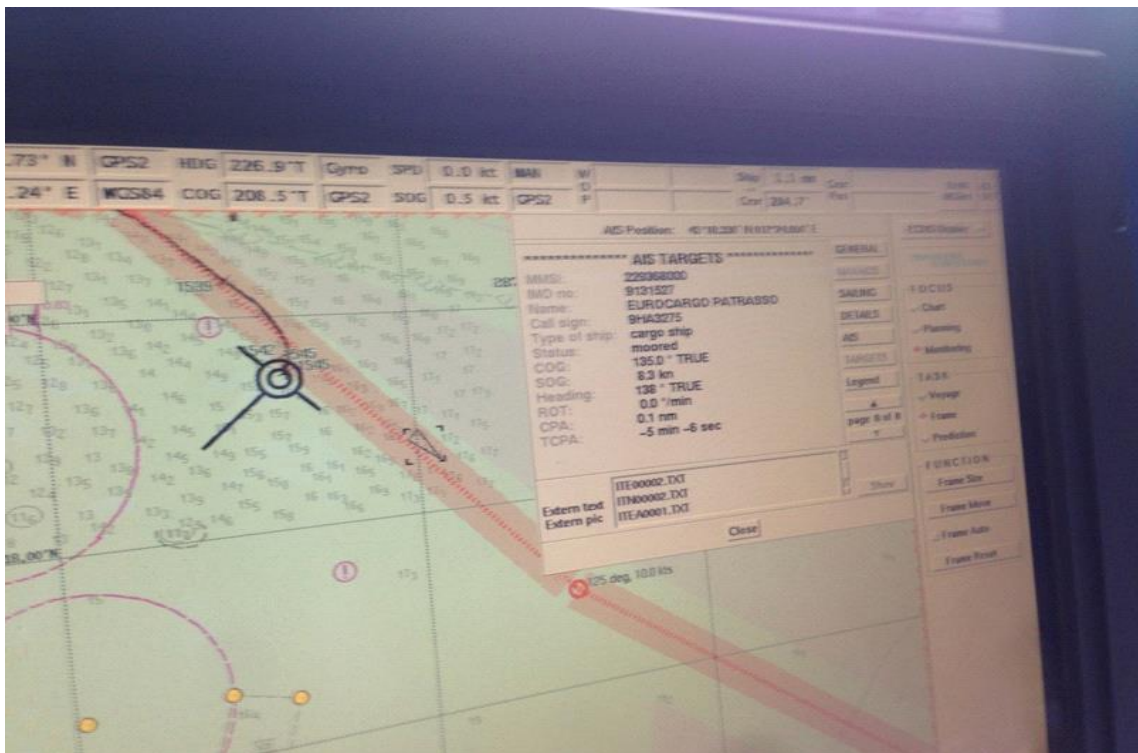
Figure 4: M/V “Dinah Borchard” ECDIS&AIS display (after collision, AIS target EUROCARGO PATRASSO moored)

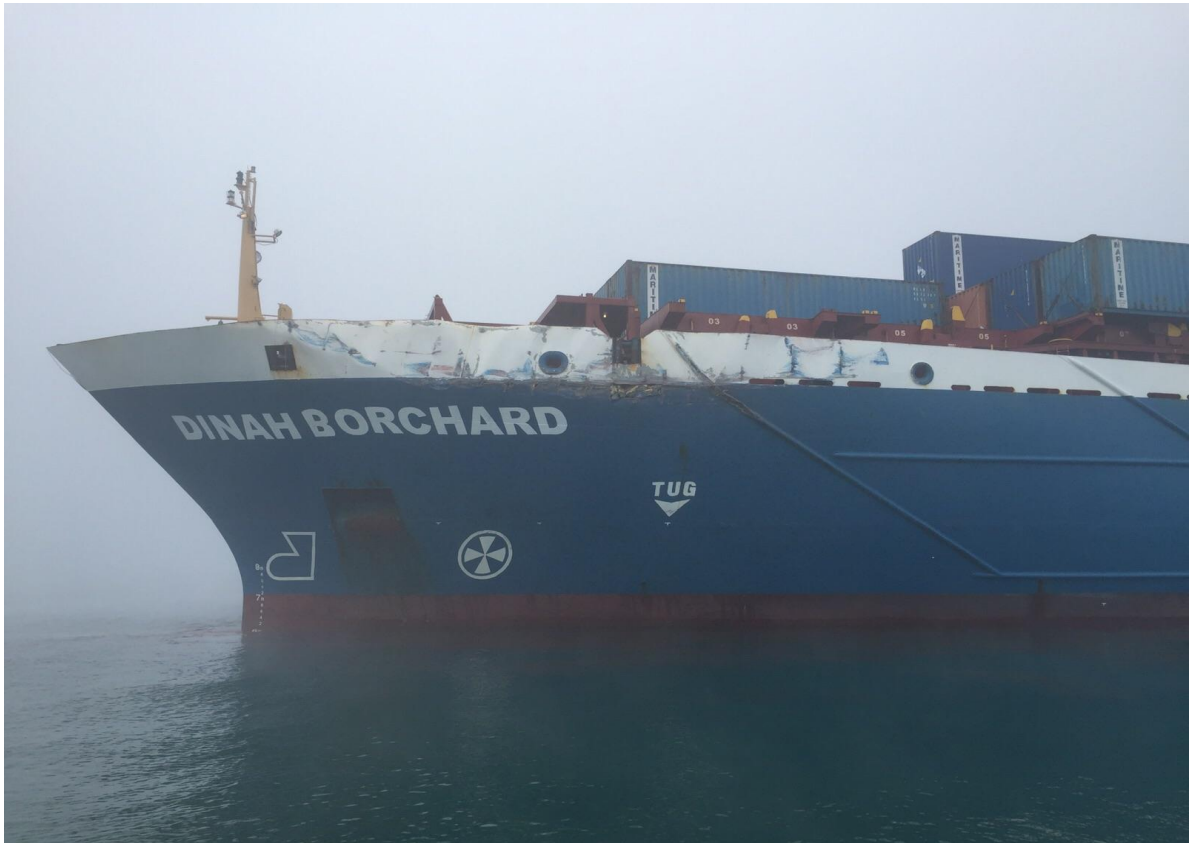
Bow area at main deck level damaged from frame #178 to 157.

Bulwark in the aforementioned area length appr.15m.

- a) Shell plating deformed i.w.o. rope store, bosun store, paint store at connection to main deck with one crack at frame 162, and two small ones frames 174-175 and 171-172.
- b) Navigation light port side forward of accommodation bent.
- c) Scratches and indents on port side aft.

**Figure 5: M/V "Dinah Borchard" Port side shell plating deformed ( i.w.o. rope store, bosun store, paint store at connection to main deck with one crack at frame 162, and two small ones frames 174-175 and 171-172)**

29. “Dinah Borchard” - On 9/12/2015, ship’s class carried out “Hull damage survey- Collision survey”, resulting in imposing a condition of class with due date 14/12/2015 i.e. before sailing from Venice.
