**REPUBLIC OF CYPRUS
MARINE ACCIDENT AND INCIDENT
INVESTIGATION COMMITTEE**

Investigation Report No 201A/2018

Very Serious Marine Casualty

**Fire, Explosion and Stranding of the Oil / Chemical Tanker
“ATHLOS” on 29/12/2018 off the Southern Coast of Cyprus**

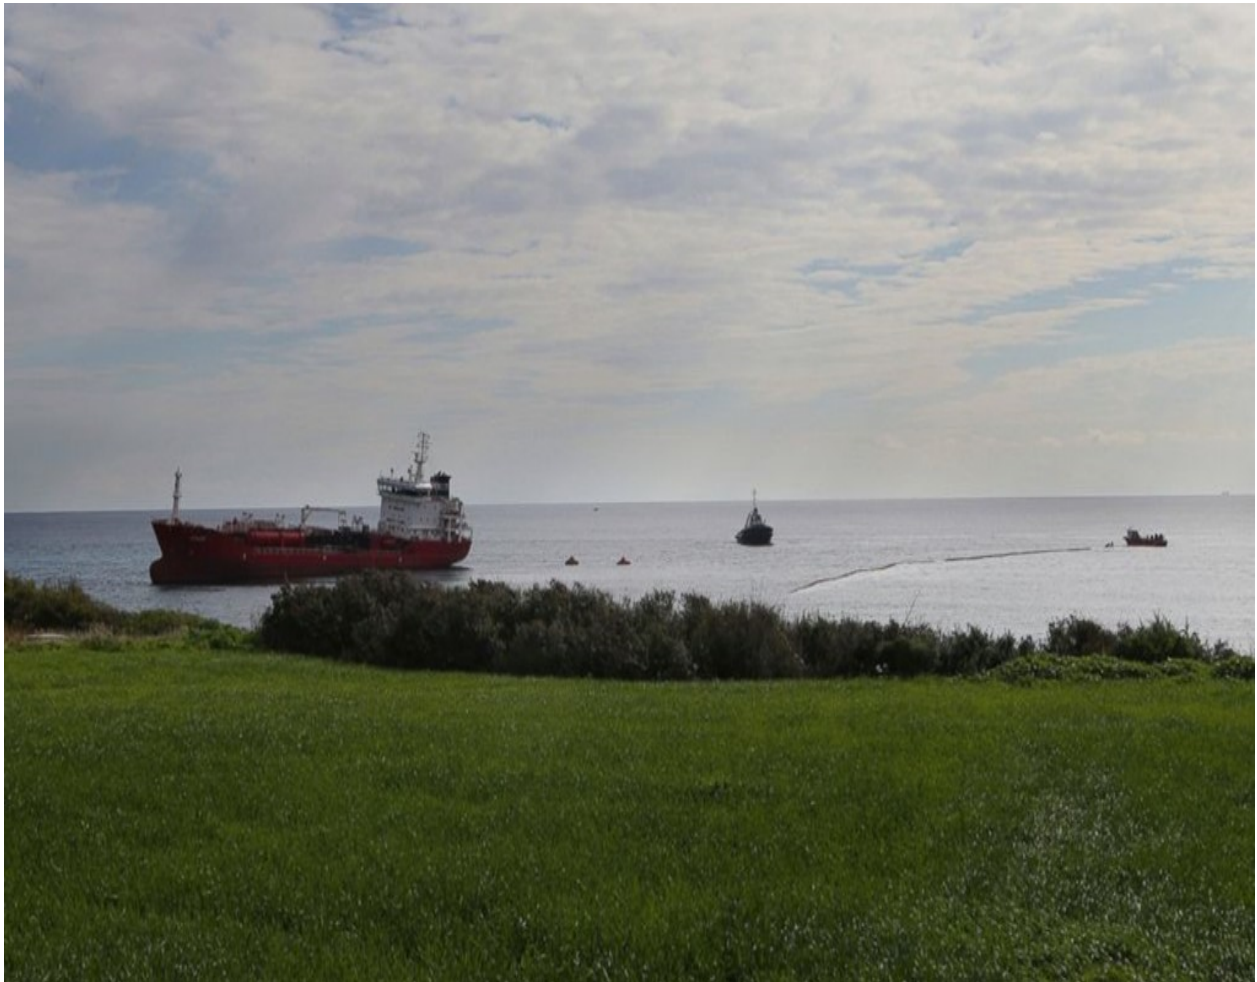
Vessel stranded 200m from shore, with 5 degrees list to port. Two Life-Rafts were thrown into the sea. An Oil-Collection Boom and a Tug-Boat standing by to contain potential pollution.

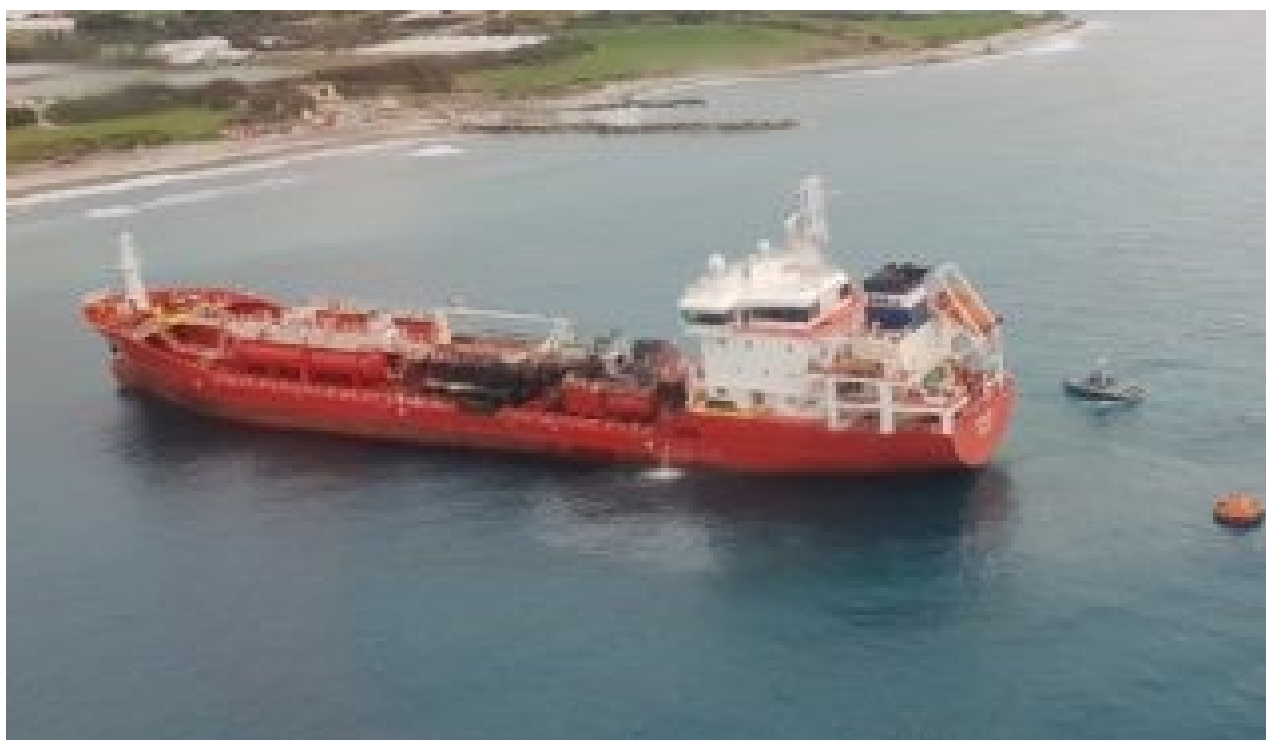
“ATHLOS” stranded 200m from the shore, with 5 degrees list to port.

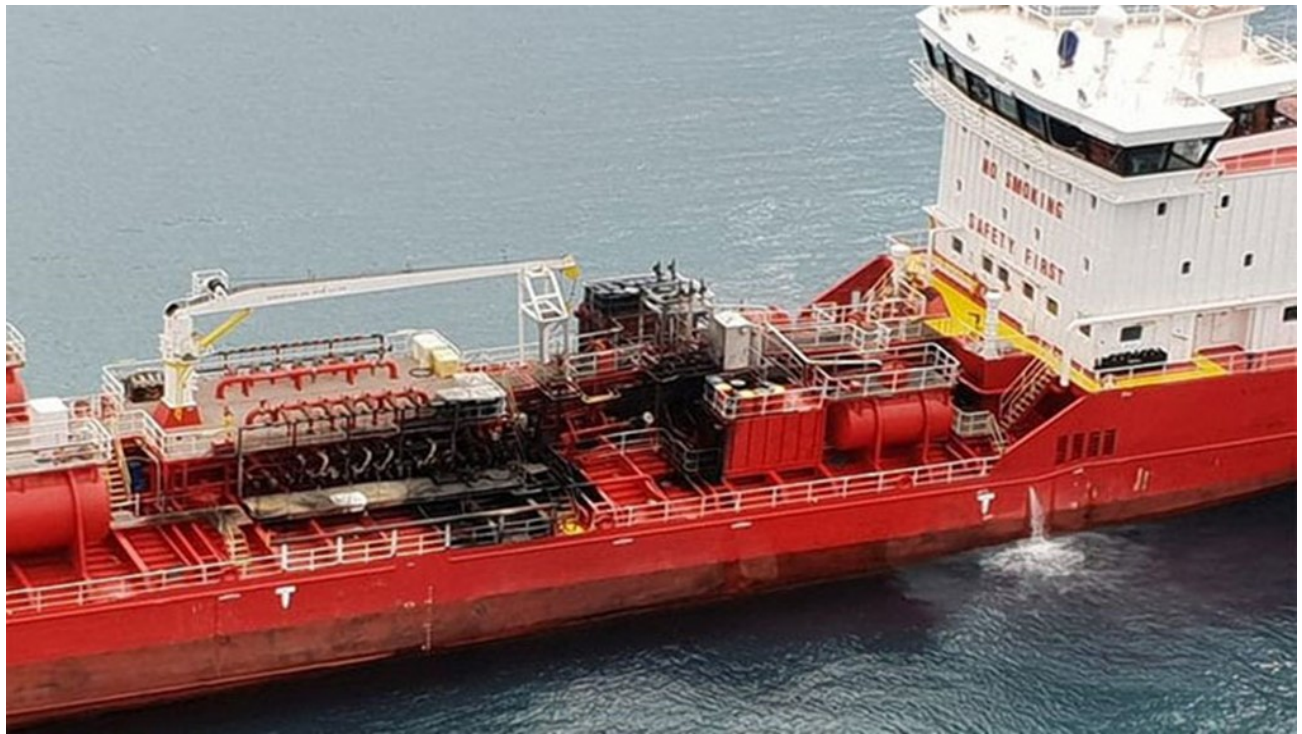
Preliminary damage findings, were summarized as below:

-Cargo oil tank No. 5 port/stbd side and adjacent Tanks 4 and 6 were damaged with corrugated bulkheads to have been severely damaged/partly collapsed.

-Double hull external plating had no visible damages.

-Double bottom (ballast) tanks were externally examined by diver as far as possible and appeared to be in sound condition. Double bottom tank tops were not accessible.

-Main deck plating, in way of cargo holds 4- 6 port and stbd was severely damaged with holes and openings in various positions. Pippings, deck fittings and equipment also deformed and damaged. Main deck plating and transverse frames in way of tanks 5 and 6 stbd visibly buckled upwards.

-Deck longitudinals and transverse beams in way of Cargo oil tanks 4-5-6 port and stbd, were damaged, bend, partly detached and deformed, in various positions throughout the affected cargo tank top plating.

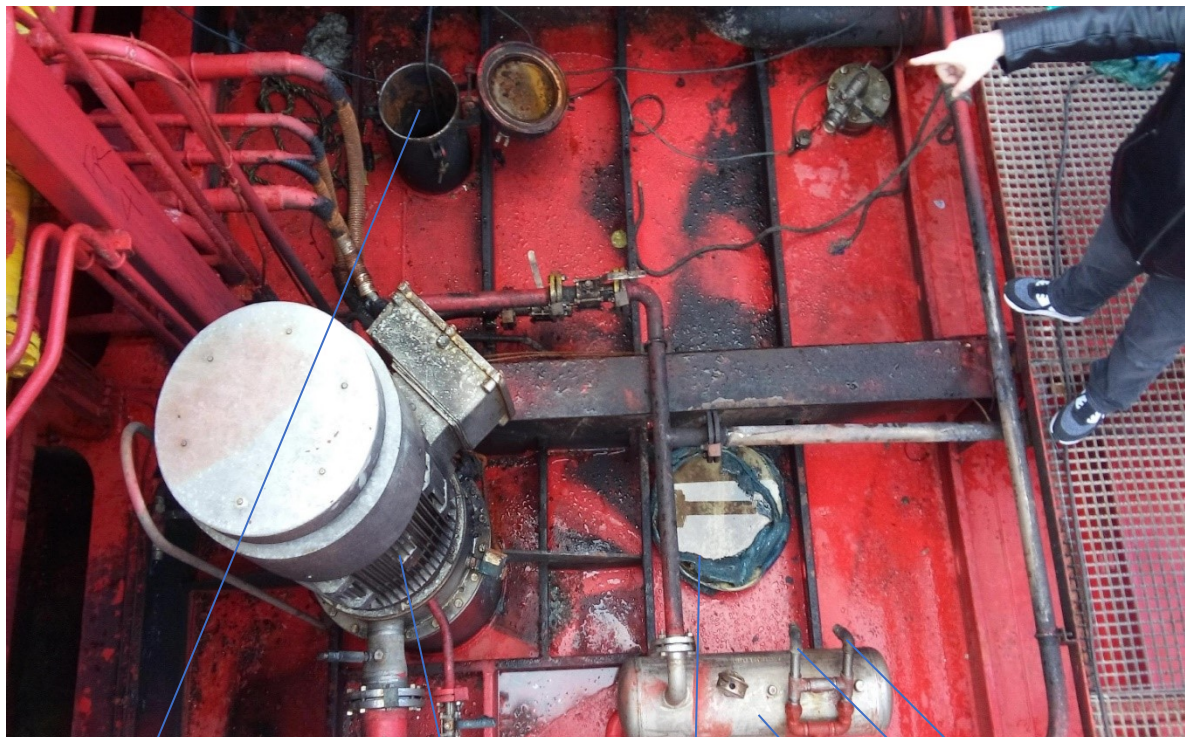
1)There is evidence that the initial fire was developed in the plastic bucket. It is unlikely that the adjacent cargo pump, provided the ignition source for the fire. The fire broke out, due to an accumulation of air /gas in the plastic bucket or from static electricity generated by the suspension of electrical continuity of the Ejector's de-aeration pipes.

2)The plastic bucket could not be grounded and presented another source of static electricity. When petrol is mixed with water /moisture which may existed in the plastic bucket, a static charge may have been generated between them.

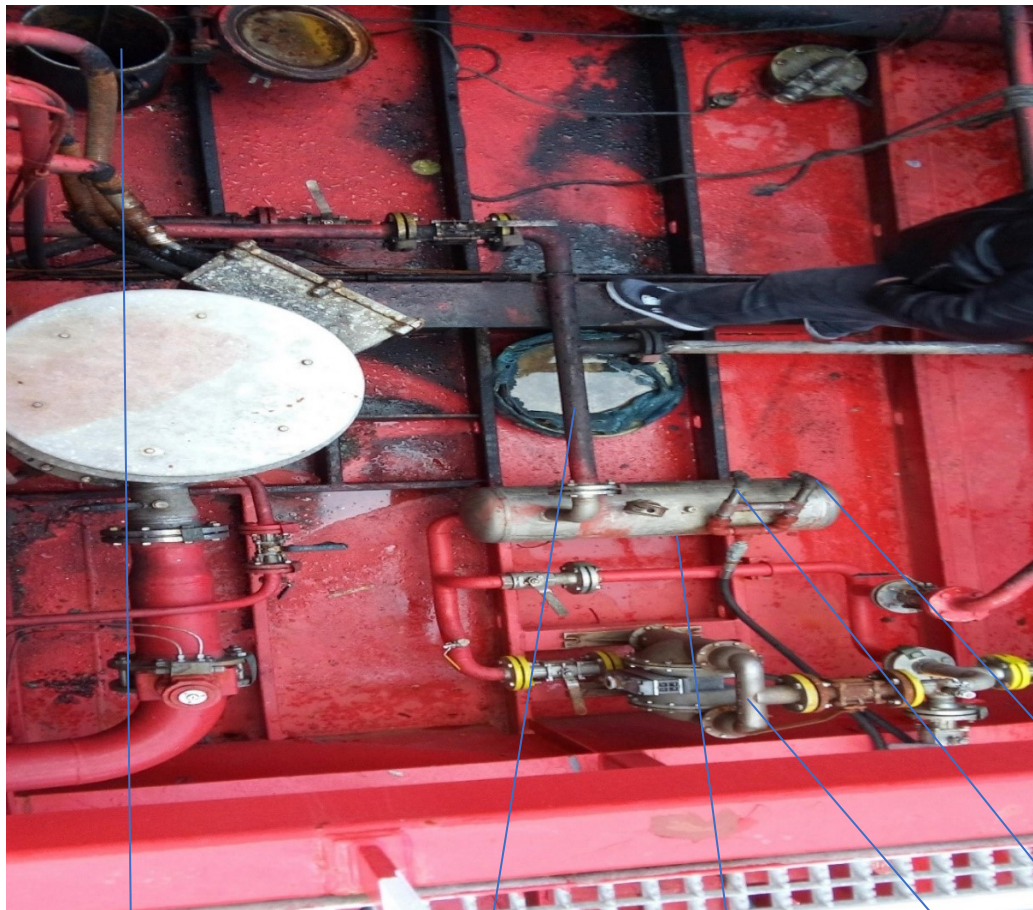
The inappropriate arrangement for the de-aeration of the Vacuum Ejector and the placement of inappropriate equipment (plastic bucket), in a hazardous environment, in the presence of hydrocarbons, of a tanker's cargo area was a contributing factor to the accident.

The installation by the ship's construction shipyard of not-approved, uncertified for use in a hazardous environment and defective equipment for cargo tanks stripping (Vacuum-Ejector), was a factor to the accident.
