REPORT: M/V “CARNIVAL GLORY”

R-022-2020-DIAM

Casualty Date: DECEMBER 20th, 2019

**MARINE INVESTIGATION
REPORT
COLLISION BETWEEN
MV “CARNIVAL GLORY”
&
MV “CARNIVAL LEGEND”
At COZUMEL, MEXICO**

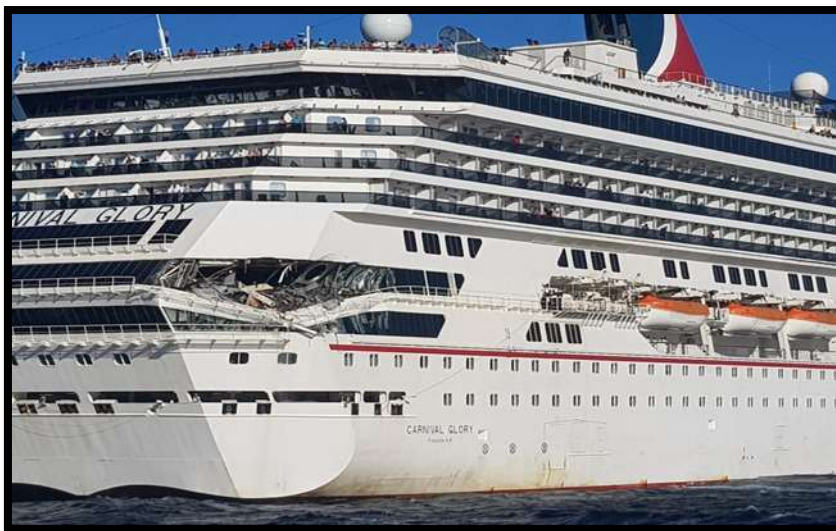
The company stated the plan, in order to complete the temporary repairs at NOLA, adding the pillars on deck 4 and deck 3 partially damage (Figure 2, 3, 3.1 & 3.2), steel plates, repairs minors damage and continue with permanent repairs in Grand Bahamas shipyard or another shipyard, perhaps for a week, and provide the all proper permanent rectification and repairs to the upcoming weeks.

Figure 2: Affected area of Carnival Glory (deck 4 and deck 3 partially damaged)

3. Temporary repair plan submitted/provided by Owners representatives thoroughly discussed and necessary repair steps discussed/agreed.
4. Affected structural members at Deck No.3 & 4 assessed and additional structural reinforcements held as found necessary which included fitted of steel plates at side shell area to provide proper weather tightness and on completion all found "satisfactory".

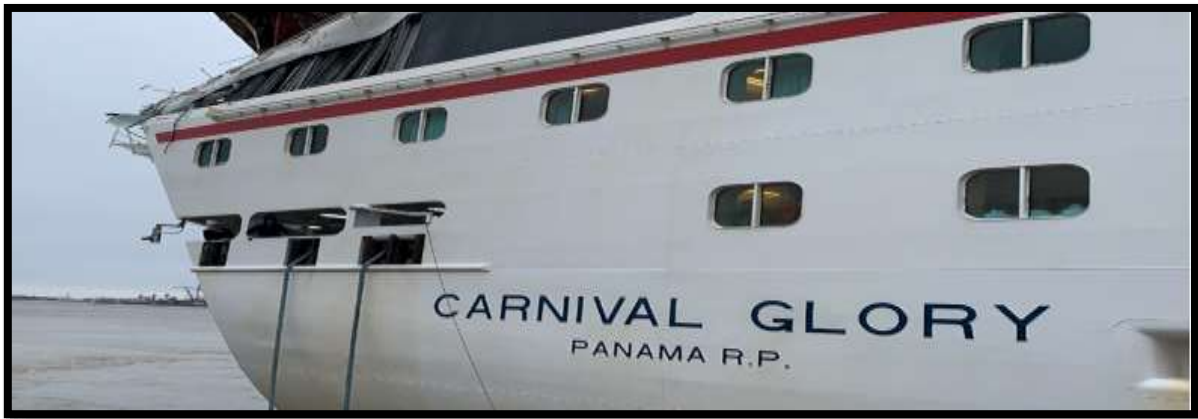
The Condition of the ship and its equipment shall be maintained to conform with the provisions of the present regulations to ensure that the ship in all respect will remain fit to proceed to sea without danger to the ship or persons on board. After Allision, vessel suffered significant damage to aft decks 3, 4 Dining room.

Figure 3: Affected area of Carnival Glory (deck 4 and deck 3 partially damaged)

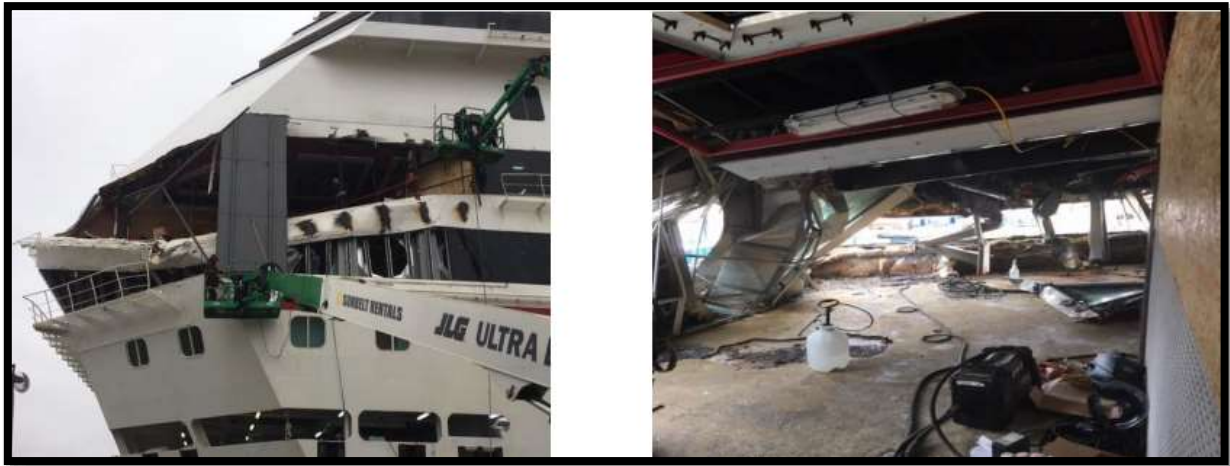
Figure 3.1 Temporary Repairs

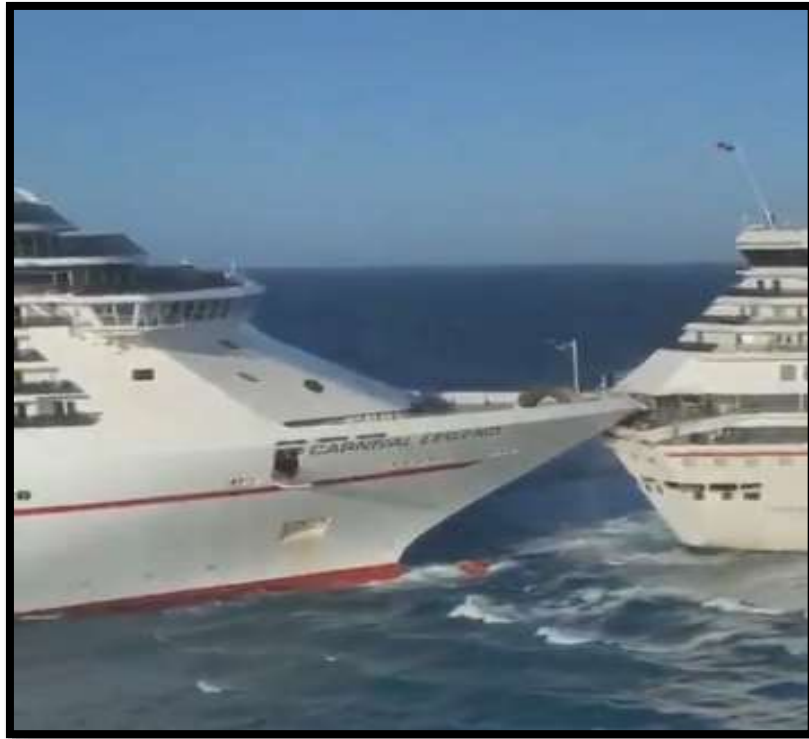
At 08:49, the vessel was safely alongside at pier 2, starboard side alongside. As result of the collision, six (6) guests³ reported minor injuries; the aft of MV Carnival Glory sustained structural damage to the starboard quarter affecting deck 4 and 3 of Platinum Dining Room. The MV Carnival Legend received minor damage to the bow and the pier did not sustain any damage.

Figure 3.2: Affected area of Carnival Legend (suffer minor's structural damage on the bow (portside)).

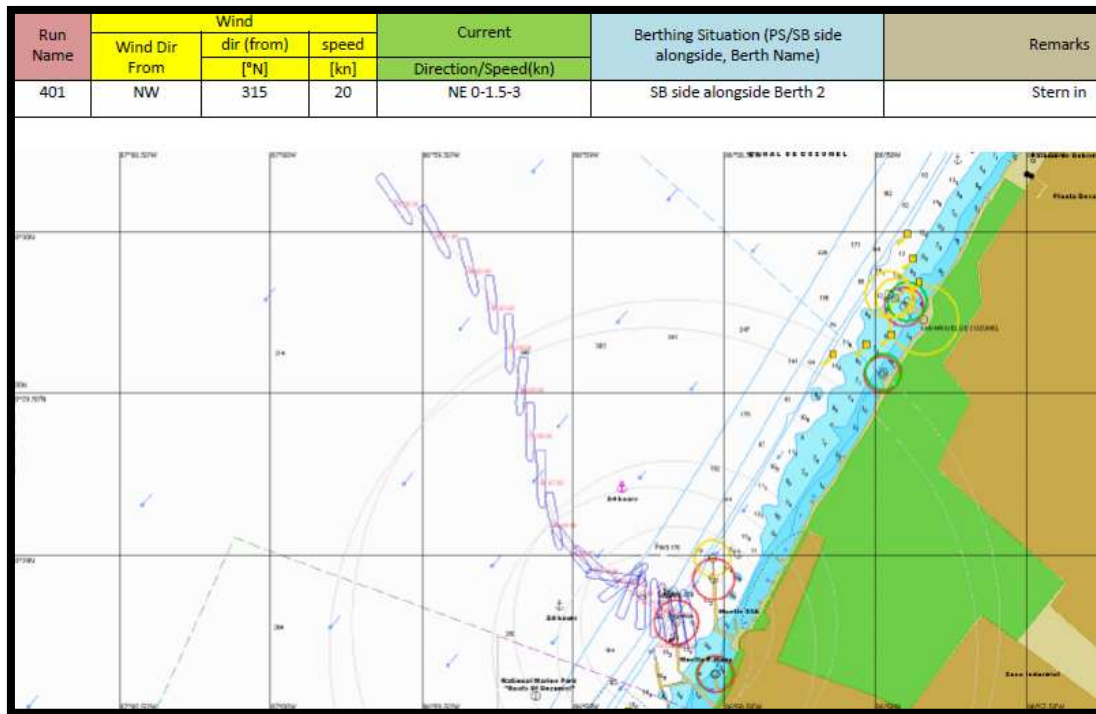
Figure 4: The simulation on CSMART (Stern) The nautical team’s final comments included “not recommended going stern in at pier 2 under those conditions.”

On July 2017, CSMART conducted a port study of Cozumel, by using an XL class ship model and a Dream class ship model. The study identified that the arrival maneuver performed with current to the northeast (NE) and the wind from northwest (NW) was very challenging. The XL class ship model (azipod propelled) was used for the simulation at pier 2 starboard side alongside, with an operational envelope of NE current up to 3 knots and wind from NW with a speed of 20 knots. The risk assessment final score showed a “4” or major risk.

3. When carrying out stern docking maneuvers at pier#2 with a NW wind incidence of 20 knt and a NE current of 3 knt, the study carried out by the CSMART must be taken into account, in which it indicates that this type of maneuver for these conditions is considered high risk.

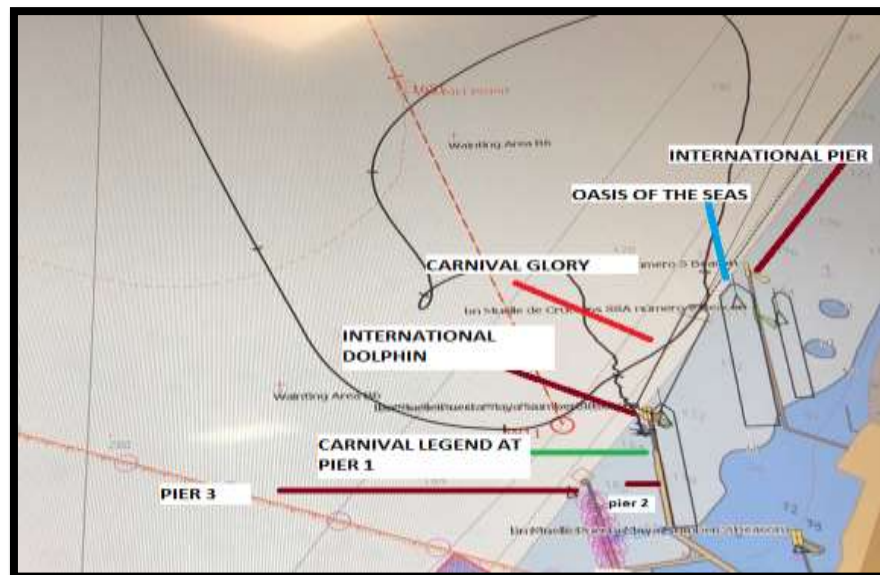
Figure 5.2: Time of the IMPACT (collision): 07:46:10 LT with Carnival Legend ,VDR Transcript, ENC : MX509225

07:46:00 STBD quarter collided with the Carnival Legend Bow. The Bridge Team, at this point, did not realize of the impact with the Carnival Legend.
