Less serious accident with bulk carrier CL Tomo (IMO No. 9908279), registered in Panama, bulk carrier Melinda (IMO No. 9623881), registered in the Marshall Islands and the chemical tanker PS Houston (IMO No. 9388209), registered in Malta, that occurred on 1 October 2021 in Klaipeda State Seaport, the Republic of Lithuania

SAFETY INVESTIGATION REPORT

No. (L-21/38) 1A-176
29 June 2022

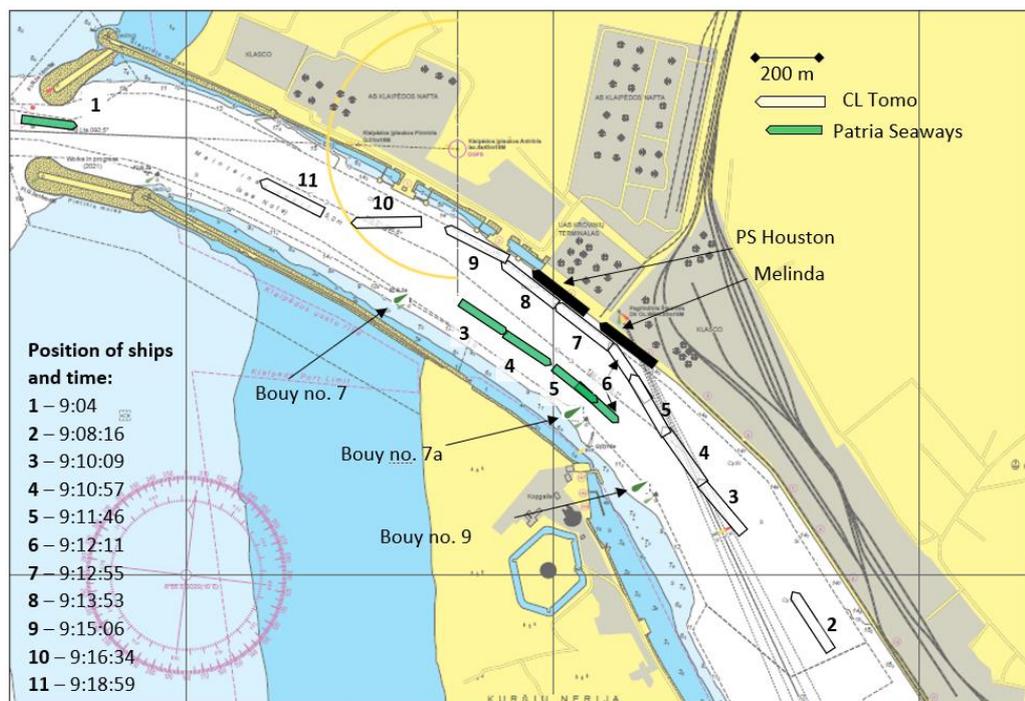
Fig. 2. Movement of CL Tomo before and after the accident

At 9:04 Patria Seaways entered Klaipeda State Seaport at the speed of 8,9 knots (position 1, Fig. 2).

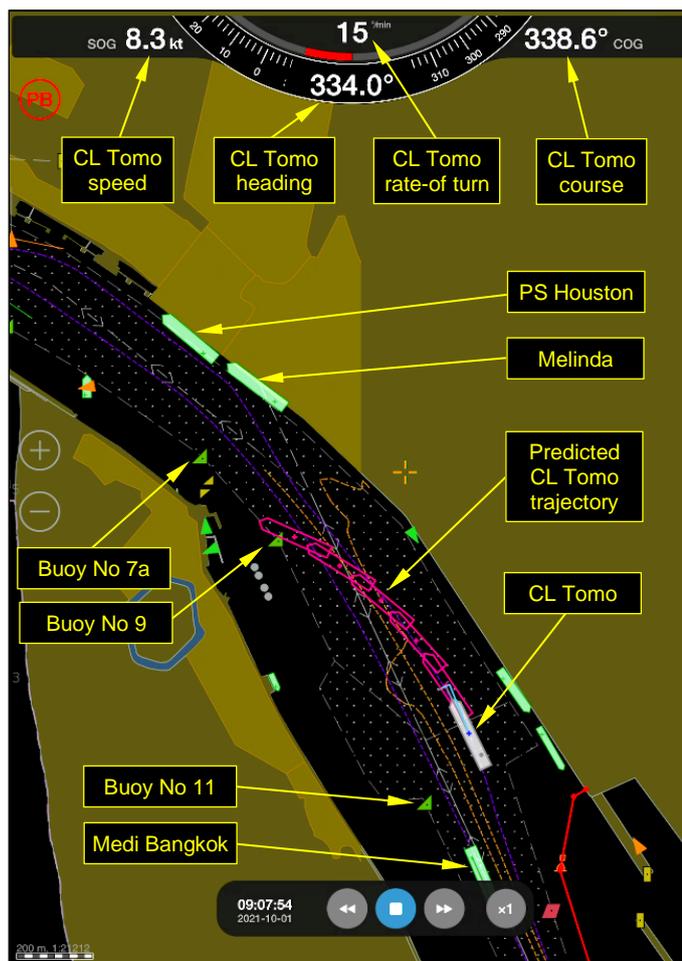
Fig. 8. View, displayed on the CL Tomo's pilot's tablet at 9:07:54 (composed using video record, provided by the SE Klaipeda State Seaport Authority)

Pilots of Klaipeda State Seaport use portable navigation equipment they bring to the ship. This equipment consists of a tablet computer, the software Wartsila Pilot Pro and a wireless Pilot Plug data repeater connected to the onboard ship's AIS⁷ equipment with integrated GyroPilot v3. Using this equipment, the tablet computer monitor provides information about the speed of the ship, the rate-of-turn, and the predicted position of the ship being steered. Fig. 8 shows the view, displayed on the CL Tomo's pilot's tablet at 9:07:54.
