Investigation report

**Contact with two bridges by the sea-river vessel ANDRE-MICHEL 1
on 2 October 2021,
on the Rhône diversion canal at Donzère (Drôme),
one casualty**

**Bureau d'enquêtes sur les événements de mer
Bureau d'enquêtes sur les accidents de transport terrestre**

Investigation report published: december 2022

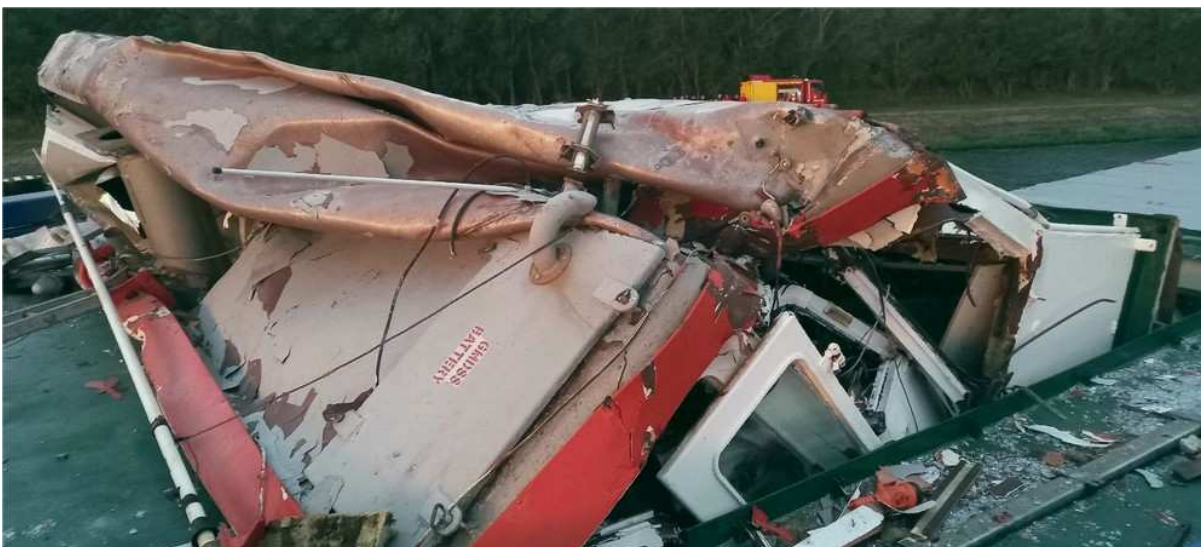
Tearing out and tilting of the wheelhouse, with roof compression - Source: VeriTech

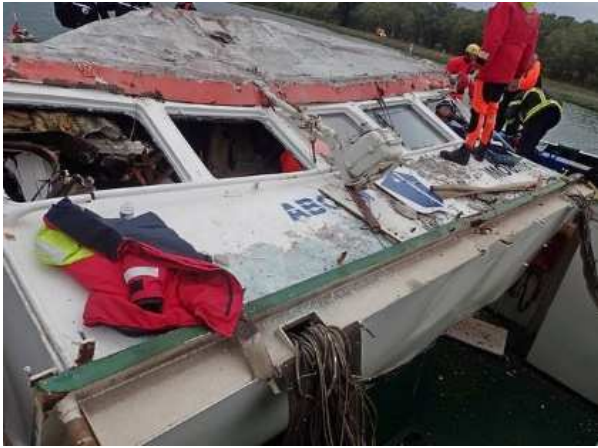
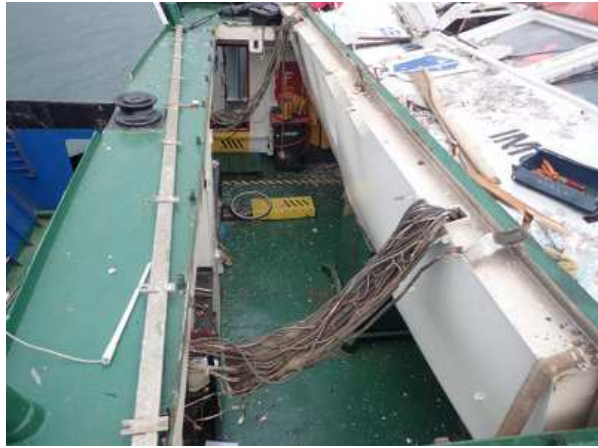
Front views of the wheelhouse

The upper part of the wheelhouse was crushed, the metal sheet was wrinkled, the whole wheelhouse was torn off and tilted backwards, deforming it and trapping the river pilot, who was trapped between the steering console and the rear console at the moment of impact, causing his death. The master, located in a space in the wheelhouse where he had more room, was only slightly injured and regained consciousness a few minutes later when crew members pulled him from the wreckage.

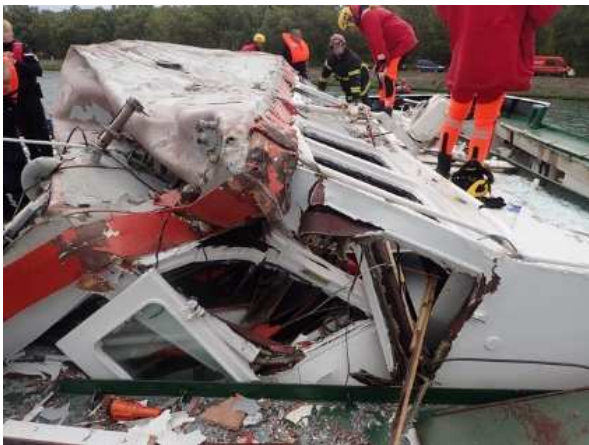
Starboard front view of the wheelhouse

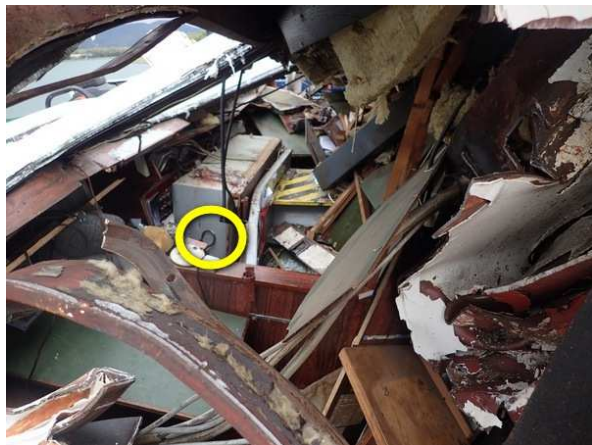
port forward interior view of the wheelhouse
Emergency hydraulic control (see 3.8)

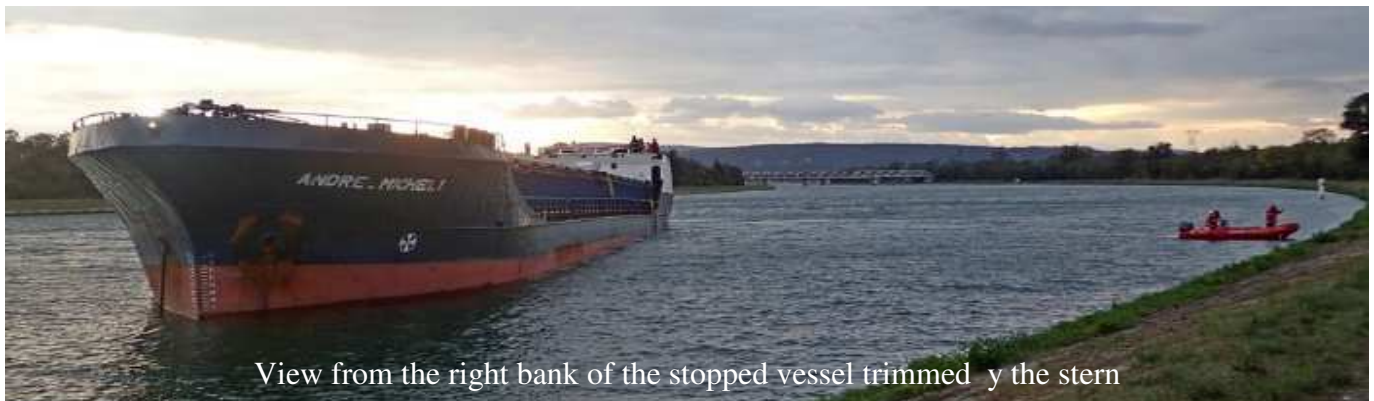
View from the right bank of the stopped vessel trimmed by the stern

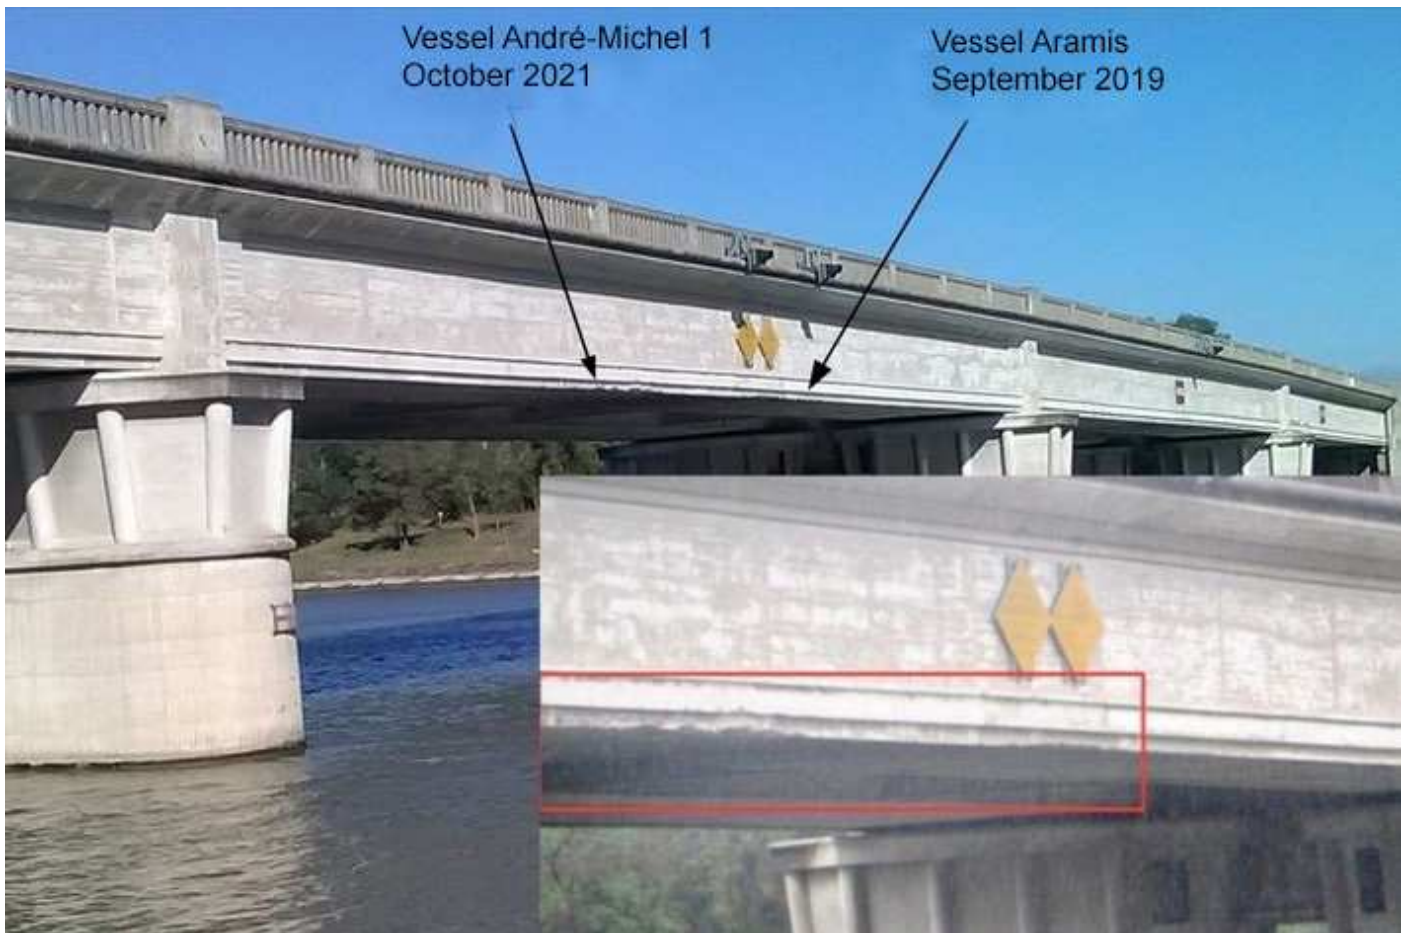
In continuation of this point of impact, the gendarmerie noted visible chafing marks under the entire bridge deck.

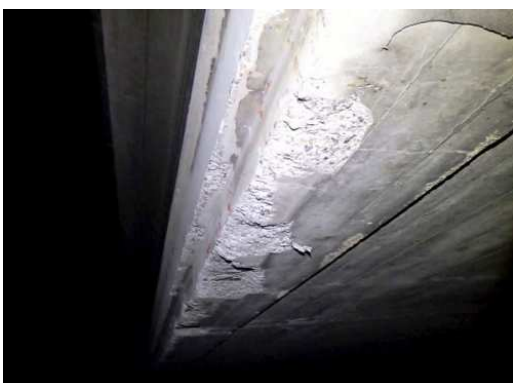
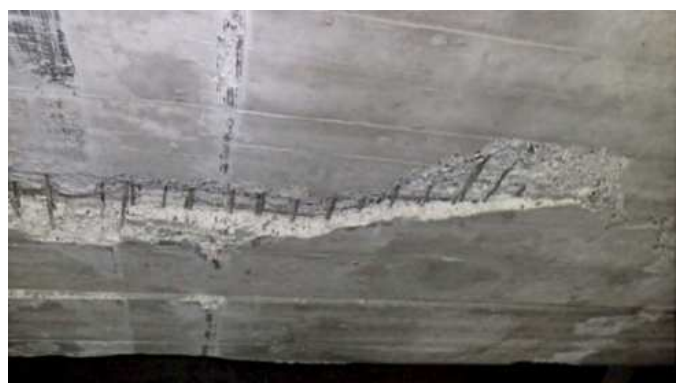
Source: DIR CE

The inspection carried out by the road manager highlighted the presence of several spalling and splintering with exposed deformed and oxidised reinforcement. These disorders do not call into question the stability of the structure but must be the subject of a specialised repair, among other maintenance work to be carried out on the structure.

The road manager explained that it is possible that the Vessel, after hitting the bridge deck beam, sank into the water as a result of the impact and then, on her upwards movement, hit the slab forming the underside of the deck.

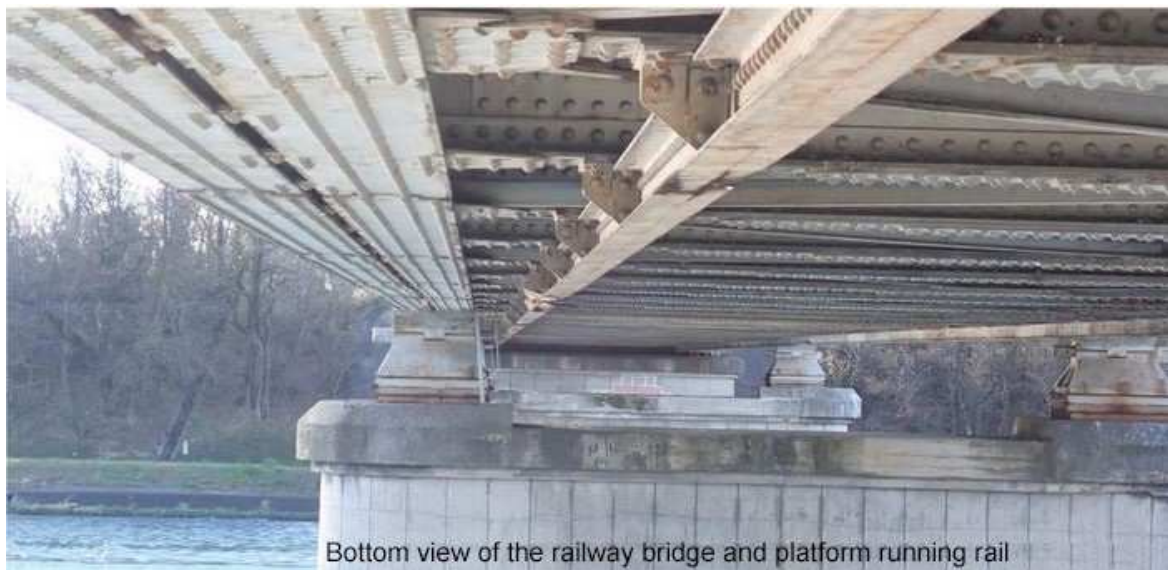
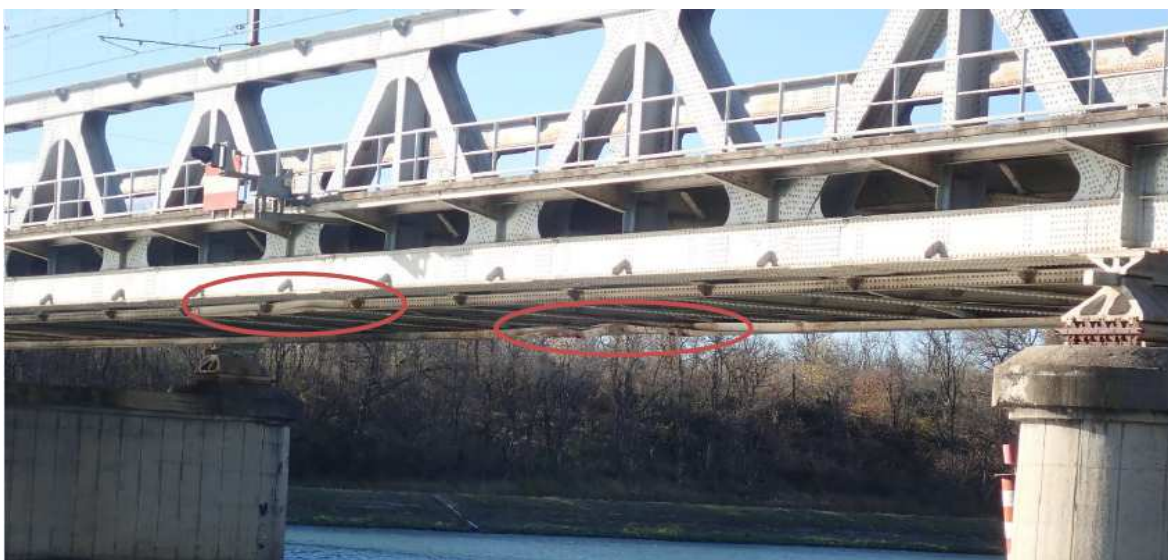
Source: *SNCF Réseau*

As for the railway bridge, the gendarmerie noted that a metal crossbeam is bent in the south-north direction, although it is not possible to say whether this is the result of the ANDRE-MICHEL 1 accident.

The expert visit carried out by *SNCF Réseau* shows, at the level of each of the bridge's two navigable channels, impact points that can be attributed to a boat colliding with the bridge deck. The impacts are located at the level of the track of the platform used for inspections and maintenance of the structure.

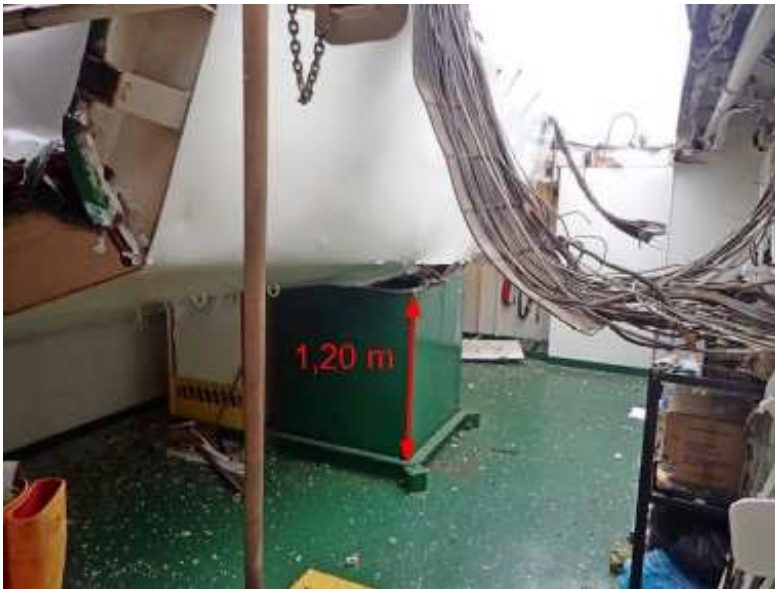
After the accident, it was found that the wheelhouse was partially lowered, the remaining stroke was measured at 1.20 m.

View of the telescopic tower of the wheelhouse after the accident with a remaining stroke

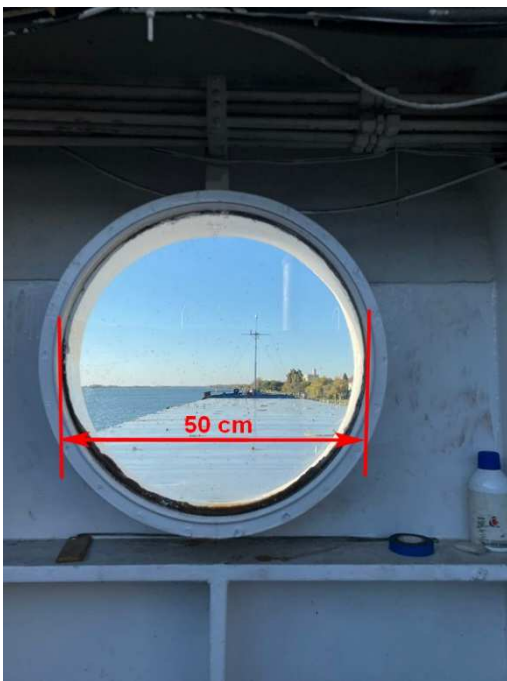
View from the second porthole from the port side, vessel not trimmed.

These portholes are the only means of seeing the vessel's bow from the wheelhouse in the lowered position.

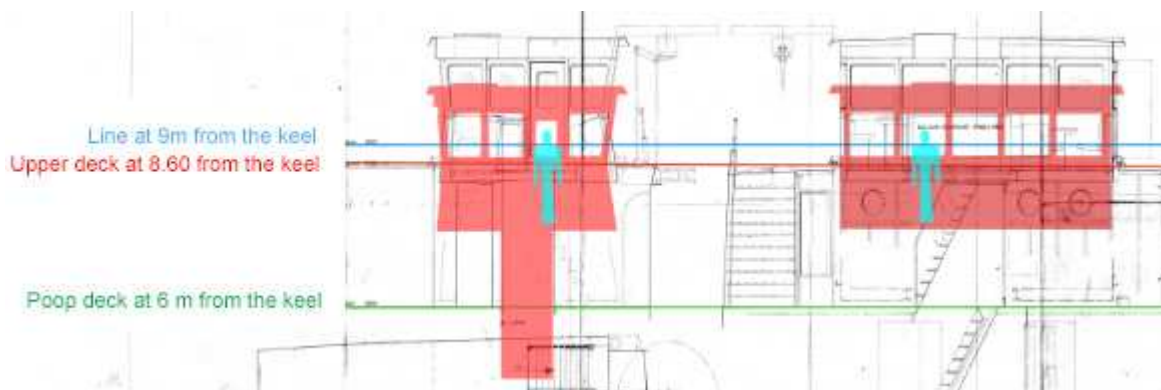
Modelling of the position of the wheelhouse at the time of the accident, with 1.20 m of remaining stroke. The different levels are related to the vertical distance to the keel plate. Plan transmitted by ABCRM, captioned by BEAmer and BEA-TT

It was found after the accident that the wheelhouse was not fully lowered, with 1.20 m of stroke remaining on the hydraulic cylinder. The vessel's air draught at the time of the accident would have been approximately 6.75 m, with an available clearance of approximately 6.35 m, for the road bridge, at the location where the vessel passed, as well as for the railway bridge. The wheelhouse was therefore not sufficiently lowered.

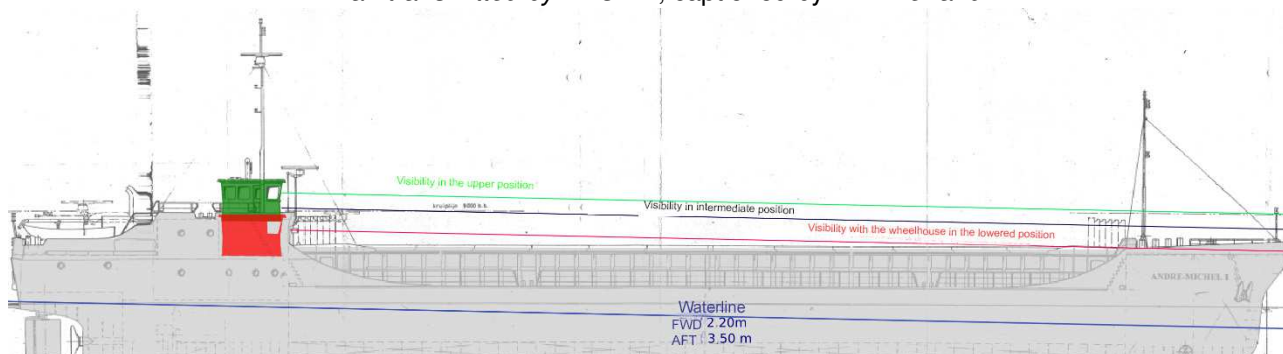
The vessel, therefore, has a visibility problem from the wheelhouse when it is in the lowered position. In addition, it should be noted that when the wheelhouse is in an intermediate position, it is not possible to get out of it.

*Modelling of visibility in the upper, lower position with draughts taken after the accident. The intermediate visibility corresponds to the position at the time of the accident. Plan transmitted by ABCRM, captioned by BEAmer and BEA-TT
A larger version of this diagram is shown in Appendix C.*

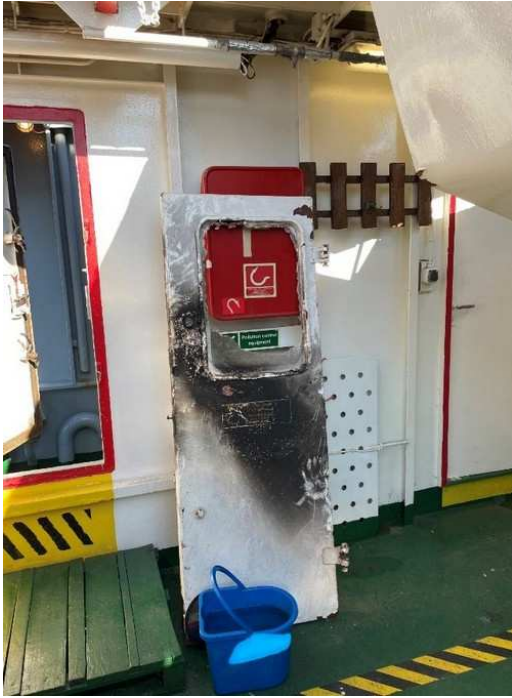
According to the photos below, the access door to the accommodation was well closed and the doors of the wheelhouse were found intact, not warped.

Starboard door of the bridge after removal and after cutting with a blowtorch. This door is also visible in the photos in 2.4

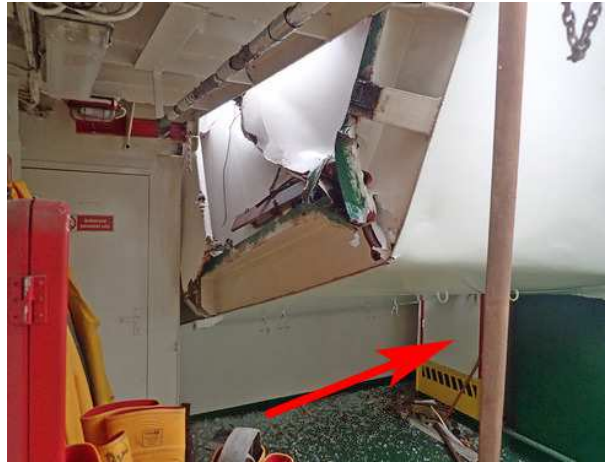
Access door to the accommodation. Source: gendarmerie

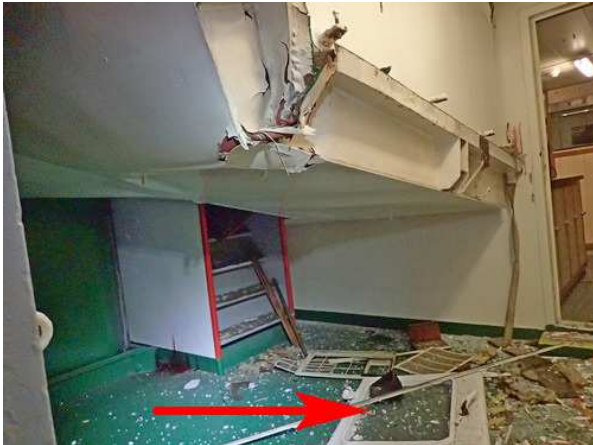
Port side wheelhouse door after removal – source: gendarmerie and BEAmer / BEA-TT

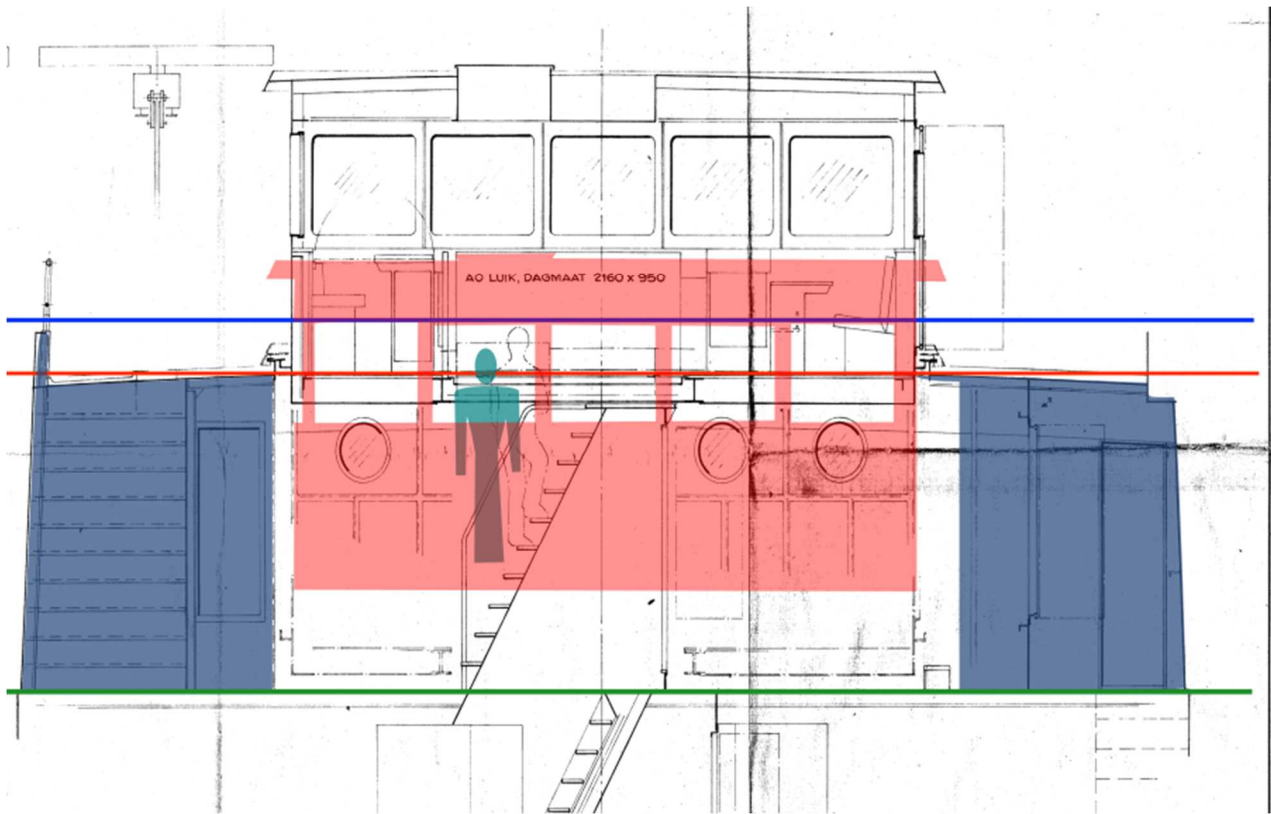
The river pilot could have lowered the wheelhouse by another 40 cm or so, while still retaining some visibility.

*Illustration of visibility with a lowered wheelhouse, half of the window inserted in the upper deck.
Plan transmitted by ABCRM, captioned by BEAmer and BEA-TT*
