Final Report

Man Overboard

Supply Vessel LEO 38

And Tanker AGIOS NIKOLAS

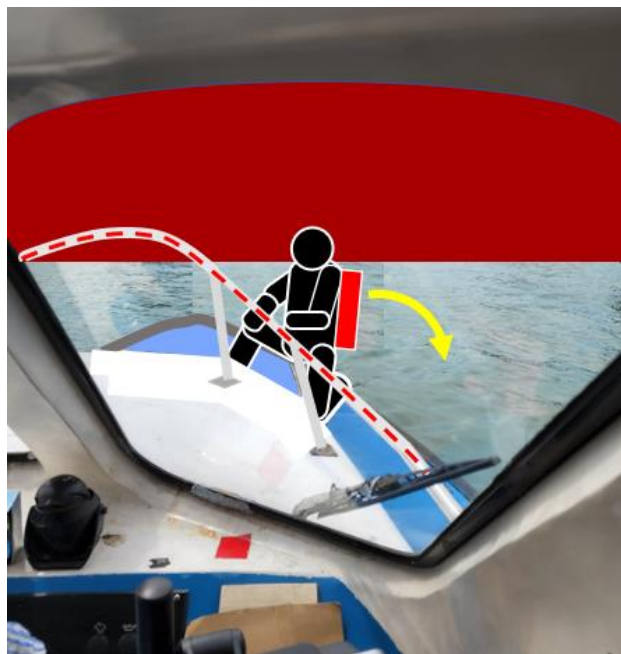
- 1.1.12 About a minute later, around 2120H, with LEO 38's starboard bow still touching the bottom platform, TECH-2 descended to the bottom platform. According to the Skipper, nothing seemed to be amiss, like any other personnel doing the transfer, TECH-2 waited for a few seconds before crossing over. When TECH-2 stepped onto the bow of LEO 38, TECH-3 commenced his descent at about the same time.
- 1.1.13 According to the Skipper and TECH-3, when TECH-2 set both feet onto LEO 38, LEO 38 experienced some swell causing it to sway and roll¹⁵. TECH-2 was seen squatting and attempting to balance himself (without holding the safety handrails at the time) but eventually fell backward into the sea (See **figure 5**).

Figure 5 – Illustration of view from the Skipper's conning position, depicting TECH-2's approximate position when squatting down before falling overboard (in the direction of the yellow arrow) – Not to scale (Source: TSIB – annotation by TSIB)

- 3.1 TECH-2 lost his balance and fell into water during the transfer from AN to LEO 38 when LEO 38 swayed and rolled due to the sudden swells caused by a passing vessel and TECH-2 was carrying a backpack which weighed about 10Kg.

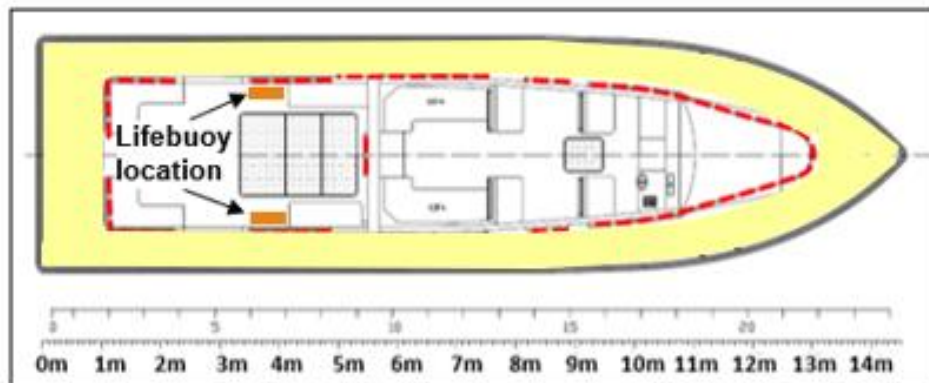
Figure 11 - Plan view of LEO 38 with highlighted yellow indicating the main deck coated with anti-slip paint (Source: Owner of LEO 38 – annotation by TSIB)

- 2.1.4 Prior to the occurrence, the AM had safely transferred to AN and the Skipper confirmed the boat was in a near-stationary condition when waiting for the three technicians to transfer. As the boat's deck was painted with anti-slip paint, it is unlikely that TECH-2 had slipped and fallen into the water.

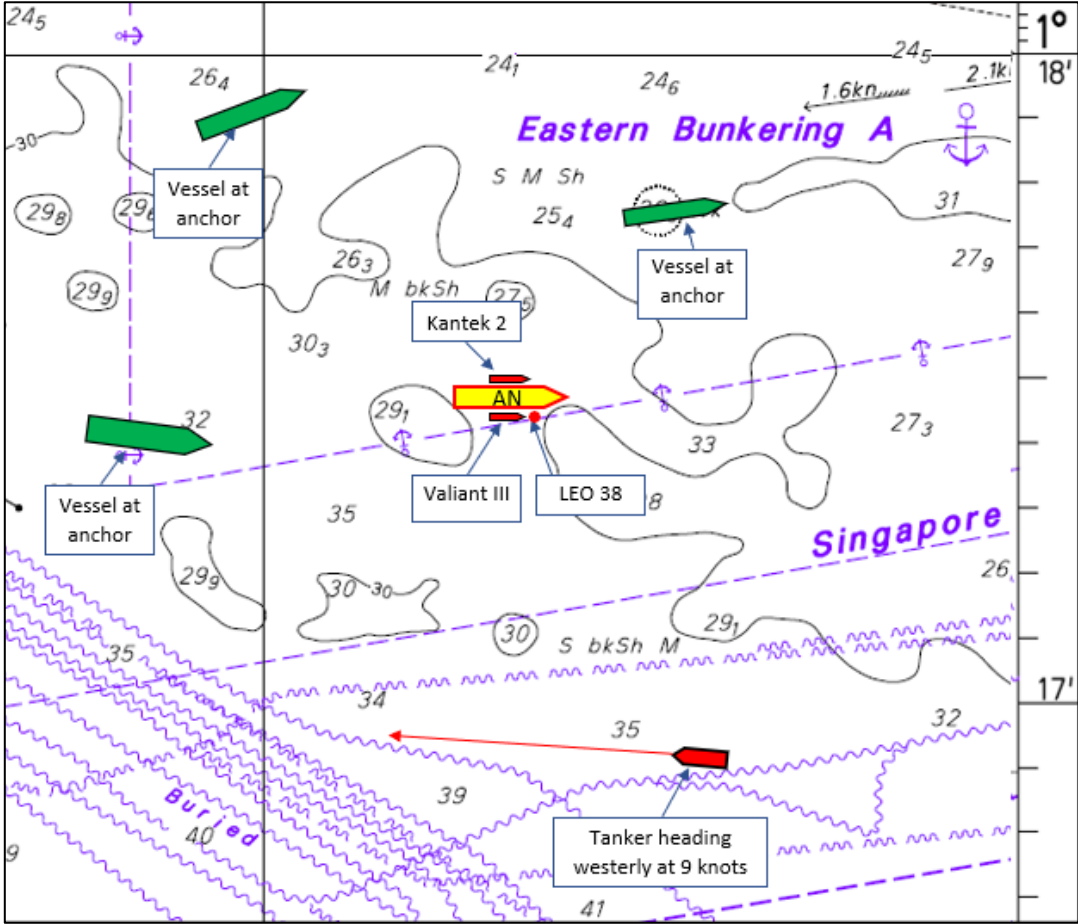
1.5.3 Prior to the occurrence, at about 2119H, with AN and several other vessels at anchor within the anchorage, a West bound tanker²⁷ with a speed of about 9 knots was passing at about 0.55 nautical mile to the south of AN (See **figure 14**).

Figure 14 – AN at anchor while a west bound tanker (in red) was passing south at about 0.55 nautical miles (not to scale).

- 2.1.6 The swaying and rolling of LEO 38 was due to the sudden swells which were likely caused by a passing vessel. Notwithstanding, the investigation team held the view that, as far as practicable, efforts must be made to carry out transfers on the leeward side.

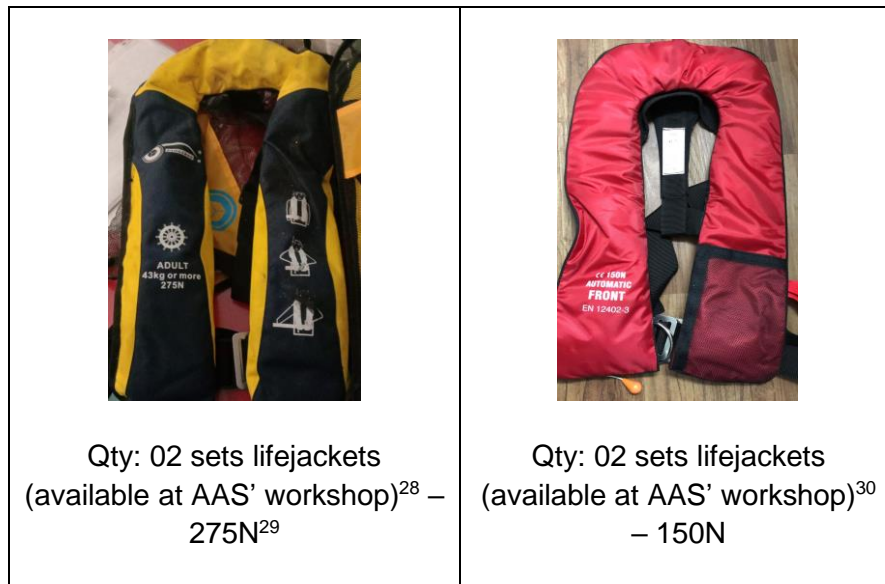
Figure 15 – The different types of lifejackets in AAS' inventory

- 1.6.4 AAS clarified the reason for the different types of lifejackets, i.e. they catered to the individual's preference for the size and weight of the lifejackets and that they were procured at different times. The investigation team further gathered that AAS was not aware of the difference in activation method of the lifejackets in their inventory.
- 1.6.5 On the day of the occurrence, TECH-1 and TECH-3 did not take any lifejackets with them from the workshop. All three technicians were carrying a backpack

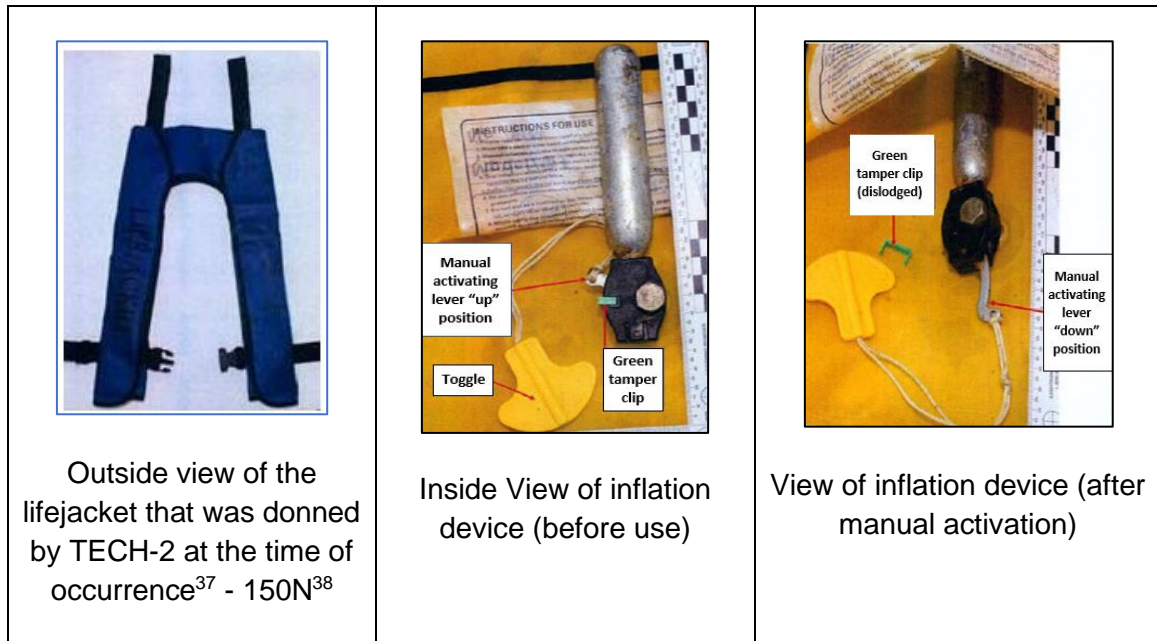
- (i) On the exterior section of the lifejacket, a label titled "Instructions for Use" indicated the following:
 - a. the lifejacket was to be used with a 33g CO₂ cylinder;
 - b. for manual inflation, pull the toggle at the base of the lifejacket; and
 - c. for automatic inflation, inflation would begin automatically after immersion in water for 5s.
- (ii) On the interior section, the inflation device was connected to a manual activating lever. The following was found on the inflation device and gas cartridge:
 - a. A gas cartridge was found screwed onto the inflation device. The cartridge was found to be intact and weighed 145g.
 - b. A green tamper clip was found secured onto the inflation device and the manual activating lever in a "up" position, indicating that the device had not been used.

Figure 16 – Lifejacket donned by TECH-2 and its inflation device.

- 2.2 TECH-2's lifejacket
- 2.2.1 The inspection and test confirmed that the lifejacket donned by TECH-2 was in a working condition, and of a manual inflation type i.e. requiring manual activation by the user.

5.1.1 To consider in its review of the existing PMC 34 of 2020, recommending users to use a working SOLAS type-approved lifejacket or a lifejacket meeting international ISO 12402 of at least performance level 150 with automatic inflation capability. **[TSIB-RM-2023-01]**

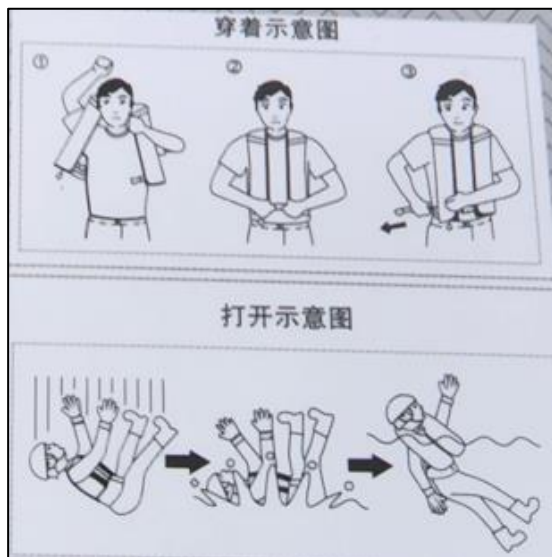
(iii) The label also had a pictorial depiction of the lifejacket's donning and operation once the user falls into the water (see **figure 19**).

Figure 19 – Pictorial depiction of lifejacket's donning and operation.

- TECH-2 was not familiar with the inflation method of the lifejacket.
- 2.2.4 The lifejacket worn by TECH-2 was a manual inflated lifejacket. However, the label on this lifejacket had instructions and a depiction which were common for both automatic and manual activated lifejacket, which can be misleading. It is unclear if TECH-2 had been influenced by the unclear depiction on the label of the lifejacket.

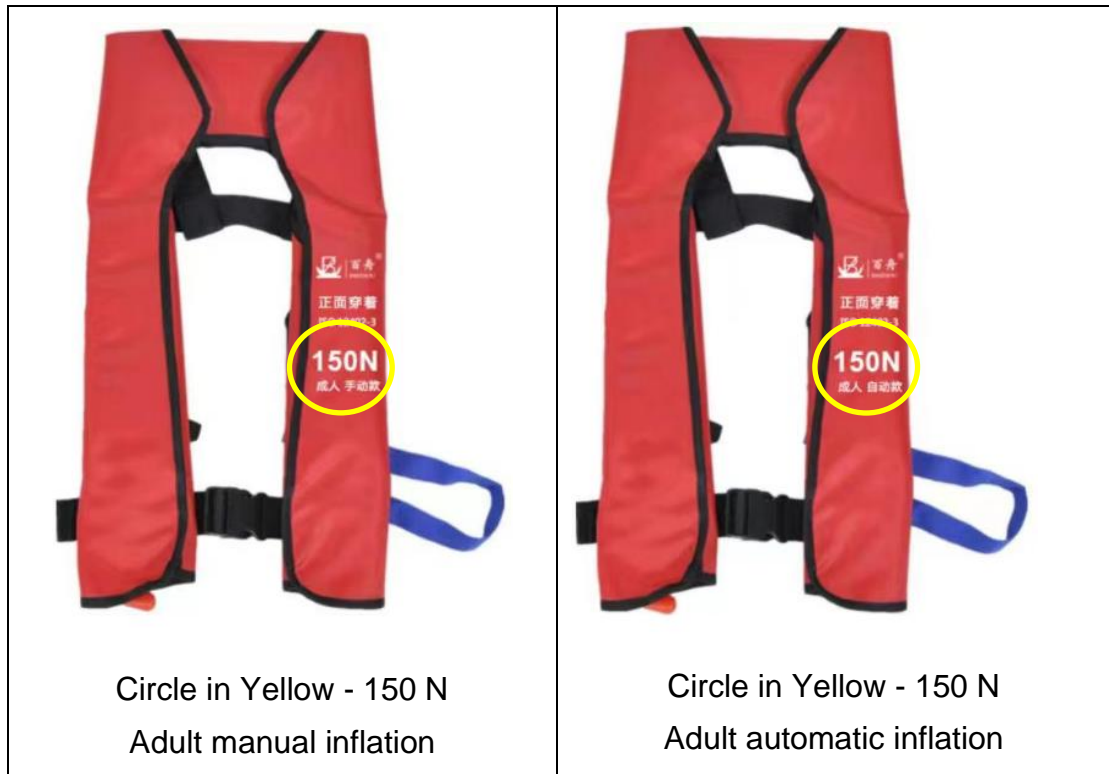
1.8.3.5 In its interaction with CCS, the investigation team noted that the Standards JT 346-2004⁴³ did not specify the lifejacket to be marked with the type of inflating mechanism. As a result of the investigation team’s discussion with CCS, a check carried out by CCS revealed that the “Instruction for use” labels for lifejackets manufactured after 2018 (meant for domestic use and recreational purpose) were also ambiguous. CCS further advised that the manufacturer had made improvements to the lifejackets as follows –

Figure 20 – Marking on the front of the lifejacket (translated by TSIB)
