## FINAL MARINE SAFETY INVESTIGATION REPORT ON A SERIOUS MARINE CASUALTY

VESSEL NAME / IMO NO : M/T TORC / 9544683  
FLAG OF THE VESSEL : Malta  
CALL SIGN : 9HA2351  
LOCATION OF CASUALTY : Port Of Bandırma Çelebi / Balıkesir  
DATE AND TIME OF MARINE : 28/08/2022 / 17:00 (LT) (GMT +3)  
CASUALTY  
DEAD / INJURED : - / 2  
DAMAGE DEGREE : The burner, which had become unusable,  
was replaced, and the thermal oil boiler was  
repaired and put into operation upon class  
approval.  
ENVIRONMENT POLLUTION : None

*Board Decision No: 15 / D-07 / 2023*

*Date: 17 / 07 / 2023*

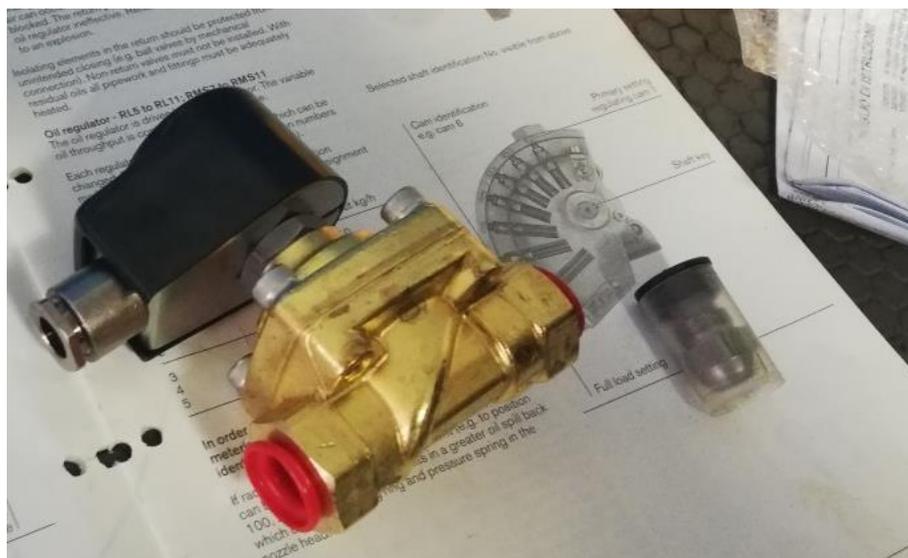
Image 6 Replacement Solenoid Valve and Nozzle

the nozzle with a capacity of 200 kg/h on the boiler burner was removed to increase the heating capacity of the boiler upon the request of the ship and replaced with a nozzle (Image 6) with a capacity of 250 kg/h, which was brought from the ship’s store but not proven to be an original spare part.

- 4.3** The solenoid valve of boiler No. 2 on board was replaced; it was operated after maintenance and adjustments and was observed to operate normally. Subsequently, a nozzle with 250 kg/h was fitted instead of a nozzle with 200 kg/h to increase the capacity.

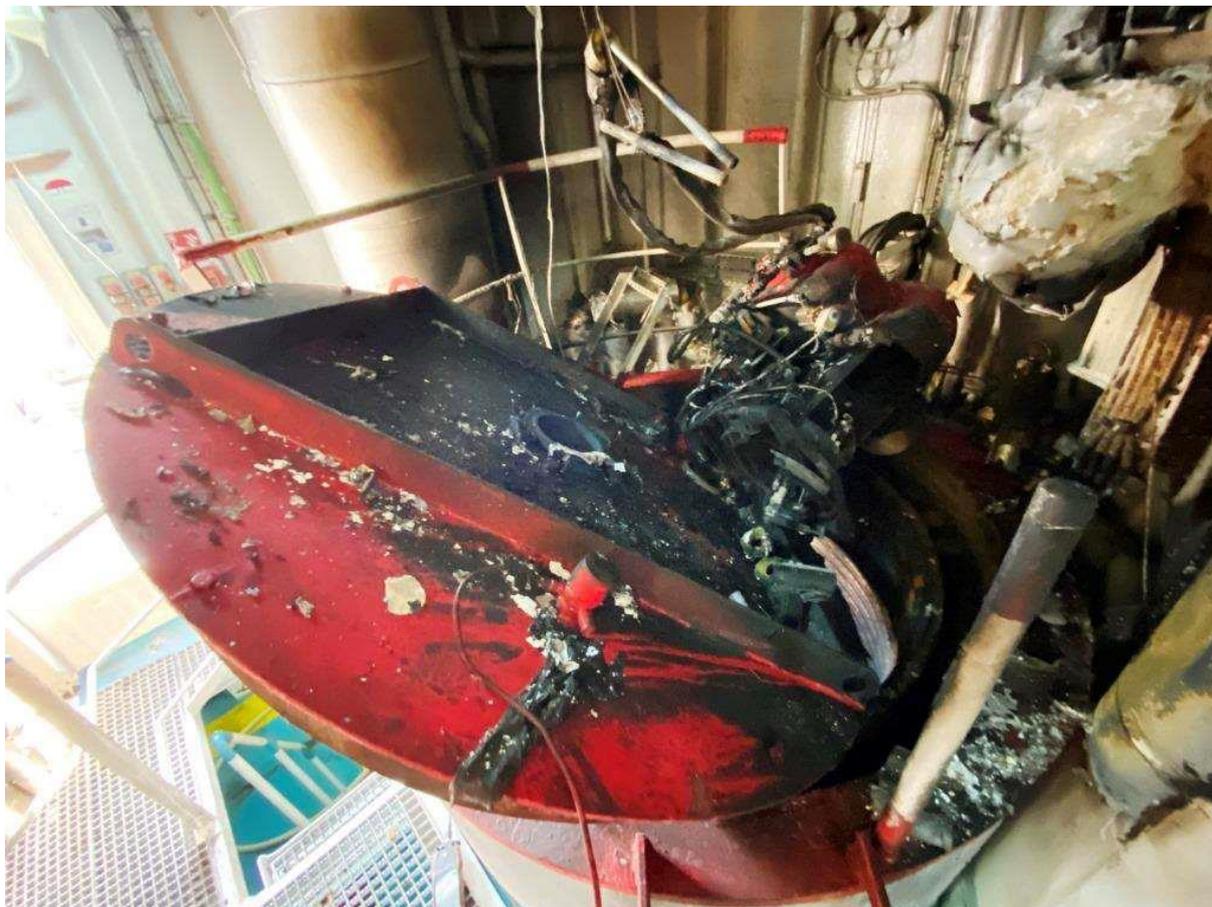
an explosion took place with ignition. The force of the explosion ejected the cover with a diameter of approximately 2 m and weighing 1500 kg, which was fixed to the body with 8 M16 bolts, and the burner of the boiler (Figure 3, Figure 4) from their places, and the Service Technician who was on top of the damaged (Image 7, Image 8, Image 9) was seriously injured, and the Second engineer who was nearby sustained minor injuries.

*Image 7 Damage to Boiler Cover After Explosion*

- 4.5** The force of the explosion ejected the boiler cover that was connected with 8 M16 bolts and nuts and the burner mounted on it.
- 4.6** The Boiler Technician who was standing on the boiler cover was seriously injured and the Second Engineer who was nearby sustained minor injuries.

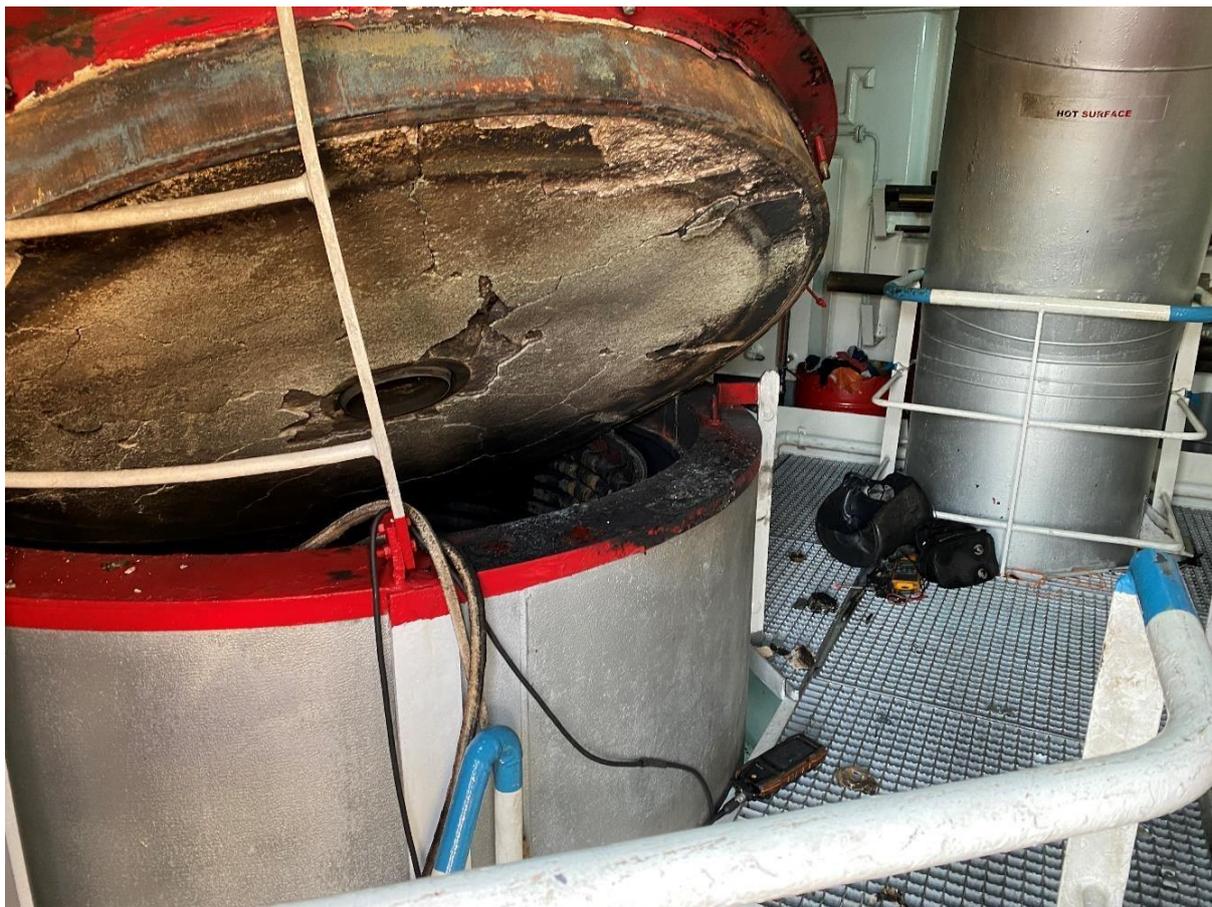
*Image 8 Boiler Cover After Explosion*

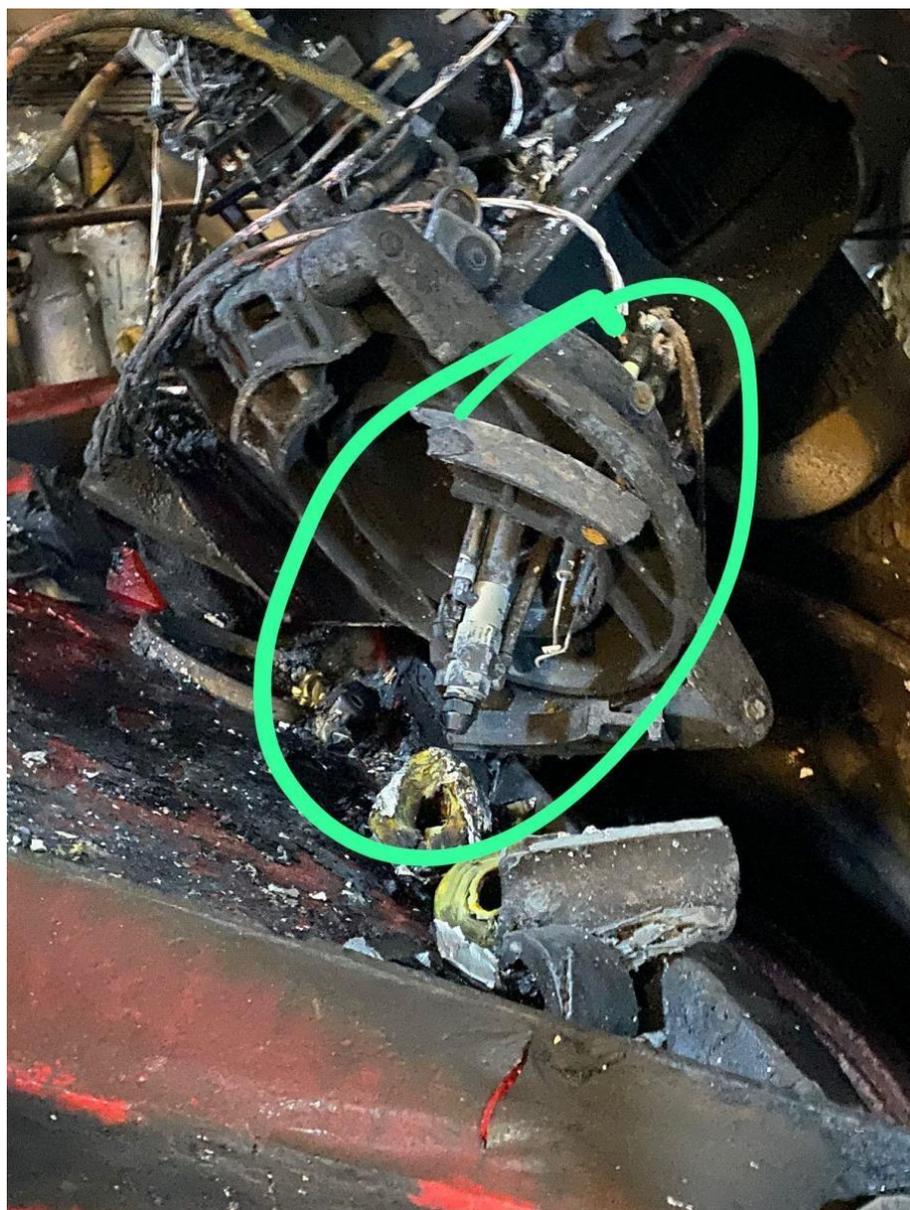
*Image 9 Nozzle and Electrodes as a Result of Explosion*

It is considered that the accumulation of fuel and vapor inside the boiler, which would have triggered a severe explosion, was due to the nozzle of 250 kg/h which was subsequently installed. Following the subsequent nozzle replacement, the fuel leakage/inflow into the combustion chamber must be checked with appropriate procedures, and ventilated sufficiently, and after making sure that the environment is safe, the repair and combustion process must be initiated.

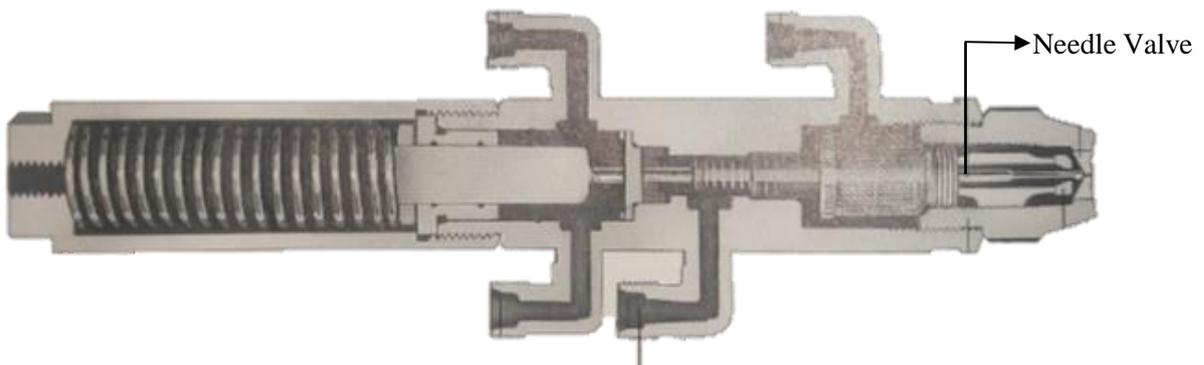
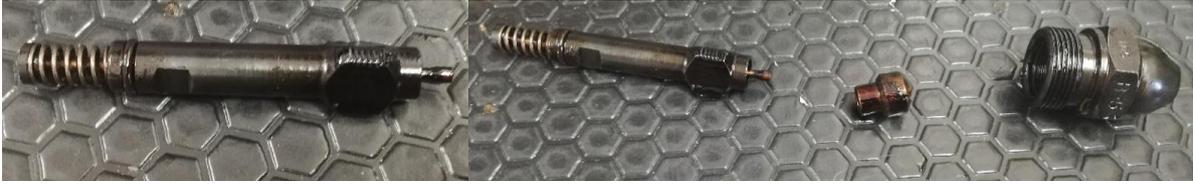
The shut-off apparatus at the nozzle head functions as a safety mechanism in the direction of flow and return line. Therefore, the system protection (Image 10 and Image 11) at the nozzle activates and prevents the fuel from leaking into the combustion chamber. The nozzle represents the final safety stop of the system. In case of leakage in the needle valve of the nozzle, it is considered that fuel and vapor accumulate in the combustion chamber.
