# NIGERIAN MARITIME ADMINISTRATION AND SAFETY AGENCY

## Marine Safety Investigation Report on The Collision of *MSC CORUNA* with *MFT OLOKUN XII* Along Lagos Channel on 07<sup>th</sup> November, 2022

NIMASA-MAI-SIR-23-04

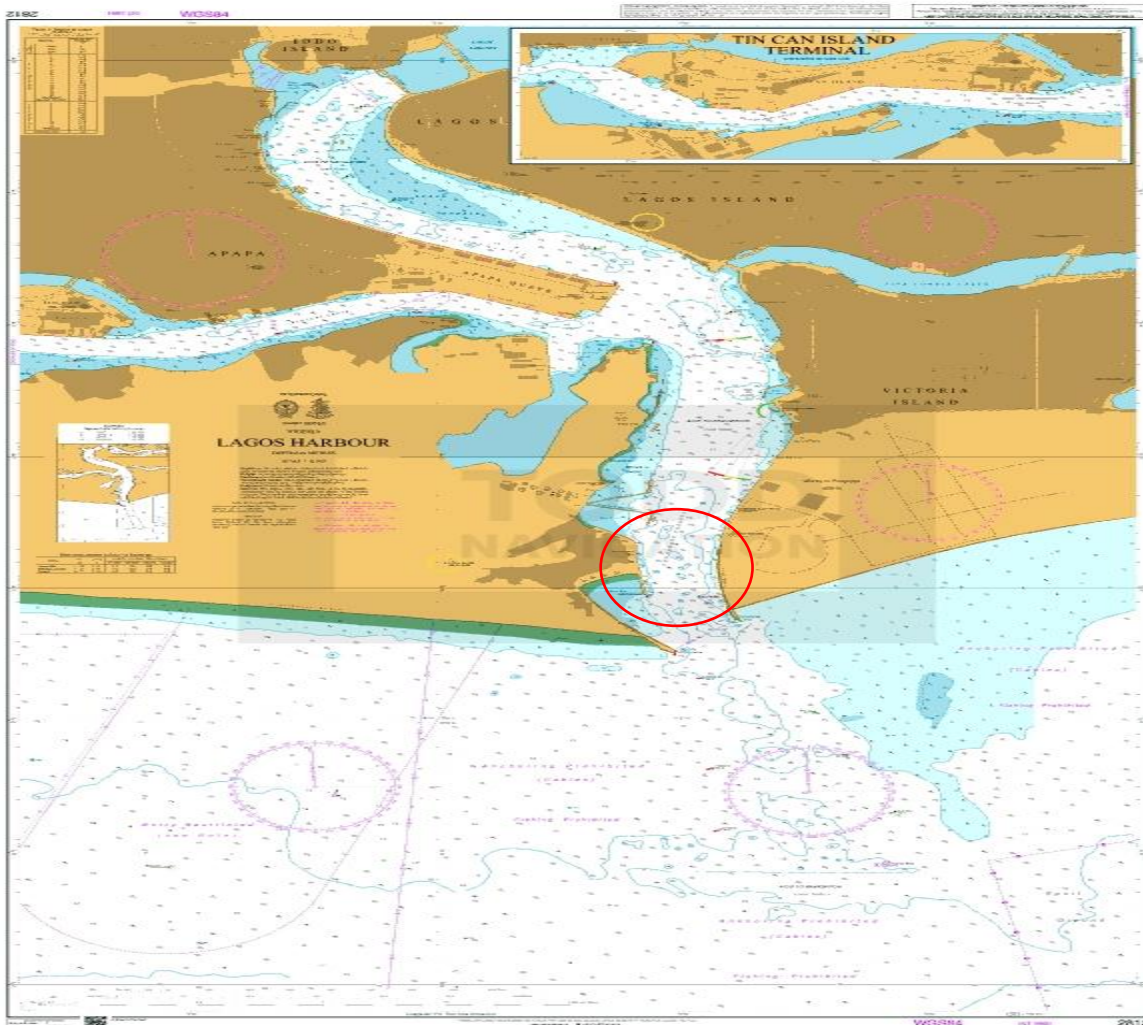
Picture 3: Chart showing location of incident

*MSC CORUNA* was still whistling to the trawlers and at this time oblivious of the ongoing towing operation and towing line in-between the two trawlers. Meanwhile, the alteration in *MFT OLOKUN IV*'s course created room in-between the two trawlers where *MSC CORUNA* thought she could quickly pass through along the deepest part of the Channel, to avoid grounding. In the process, *MSC CORUNA* made contact with towing line between the trawlers and dragged *MFT OLOKUN XII* resulting in capsizing and flipping over of the trawler at about 0721hrs as shown in picture 4 (Lat.06°24.5'N. Long.003° 24.0'E).

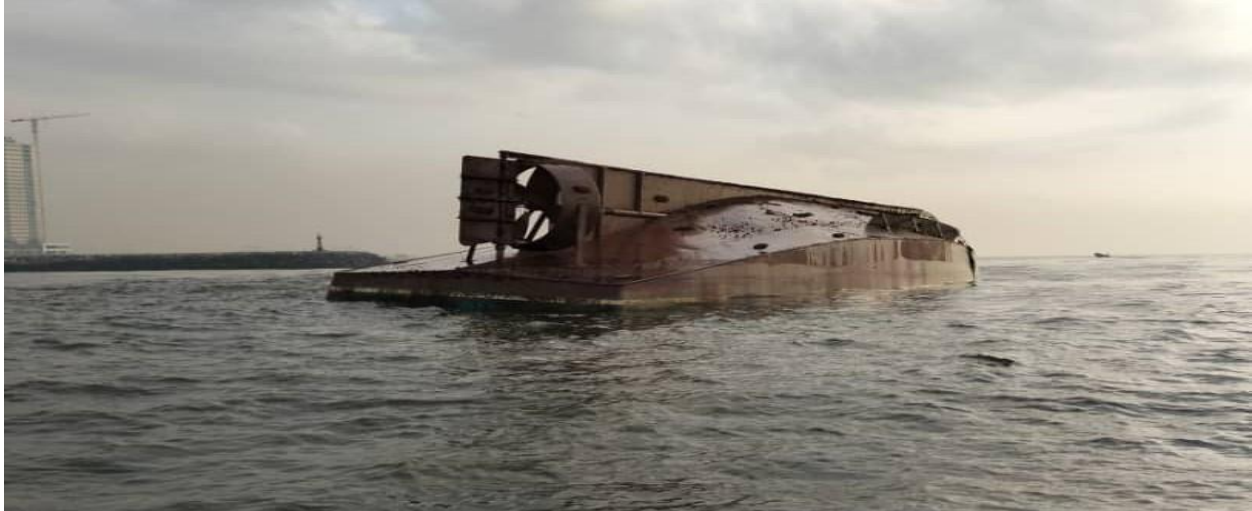
On 07<sup>th</sup> November, 2022 and at about 0721hrs, a Malta-flagged container vessel (IMO NO: 9480215) made contact with a Nigerian-flagged fishing trawler *MFT OLOKUN XII* (IMO No: 8778316) while under tow by a sister vessel *MFT OLOKUN IV* along the Lagos Channel, resulting in the capsizing and eventual sinking of the trawler (*MFT OLOKUN XII*).

**Picture 4: MFT OLOKUN XII capsized and flipped over after the impact**

The unfortunate incident resulted in the loss of two (2) crew members, one (1) Indian and one (1) Nigerian, whose bodies were later recovered by a search team.

1. The Nigerian Maritime Administration is Recommended to :
  - ii. Liaise with the owners of *MFT OLOKUN XII* to establish the current location and determine the danger posed by the wreck to the safety of navigation and the environment, and to also commence the process of removal of the wreck in line with the provisions of the Nigerian Merchant Shipping Act, 2007.

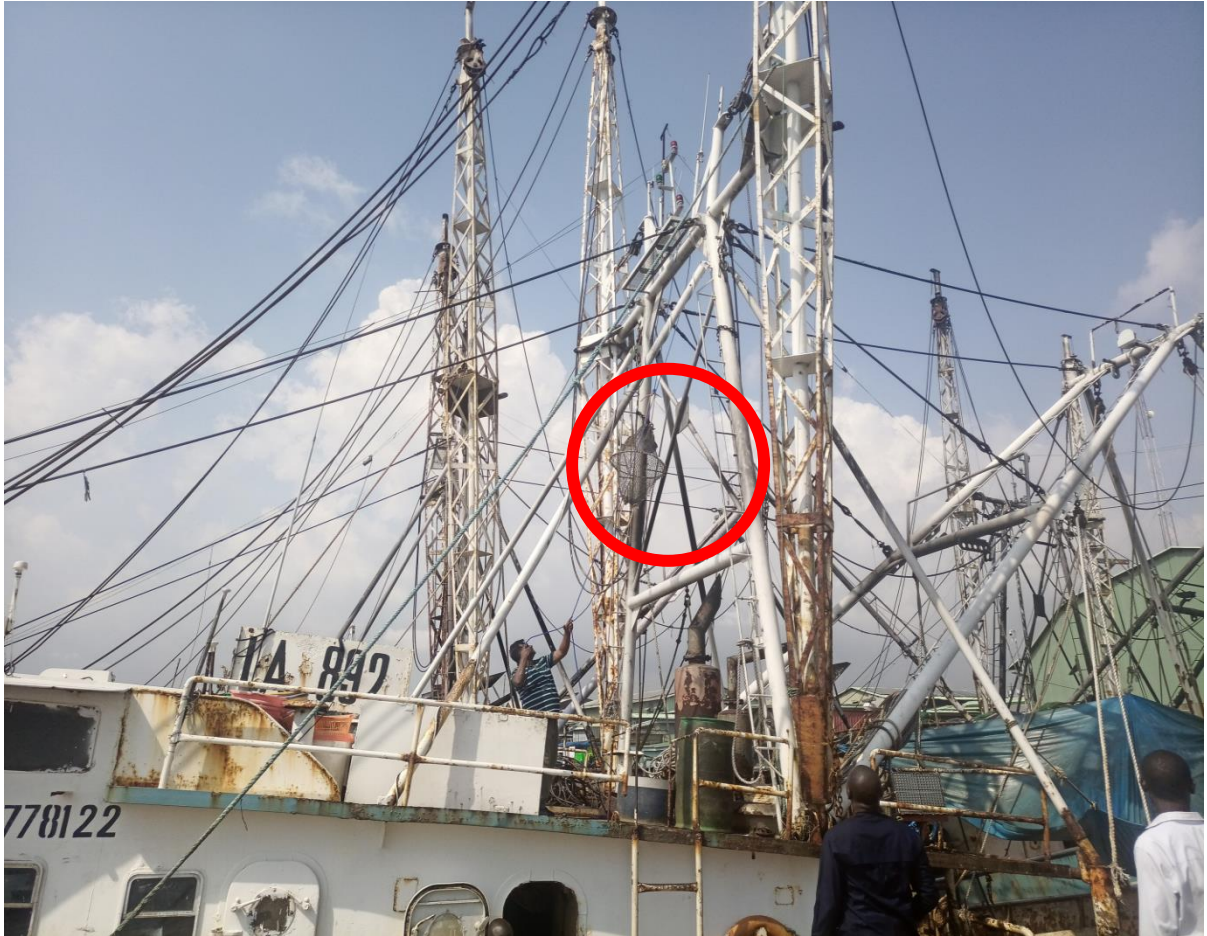
The Captain of the towing trawler insisted that the vessel had displayed a day light towing signal (Diamond shape). Investigators sighted a diamond shape displayed onboard during the investigation (see picture 5 below).

**Picture 5: Displayed towing signal on MFT OLOKUN IV**

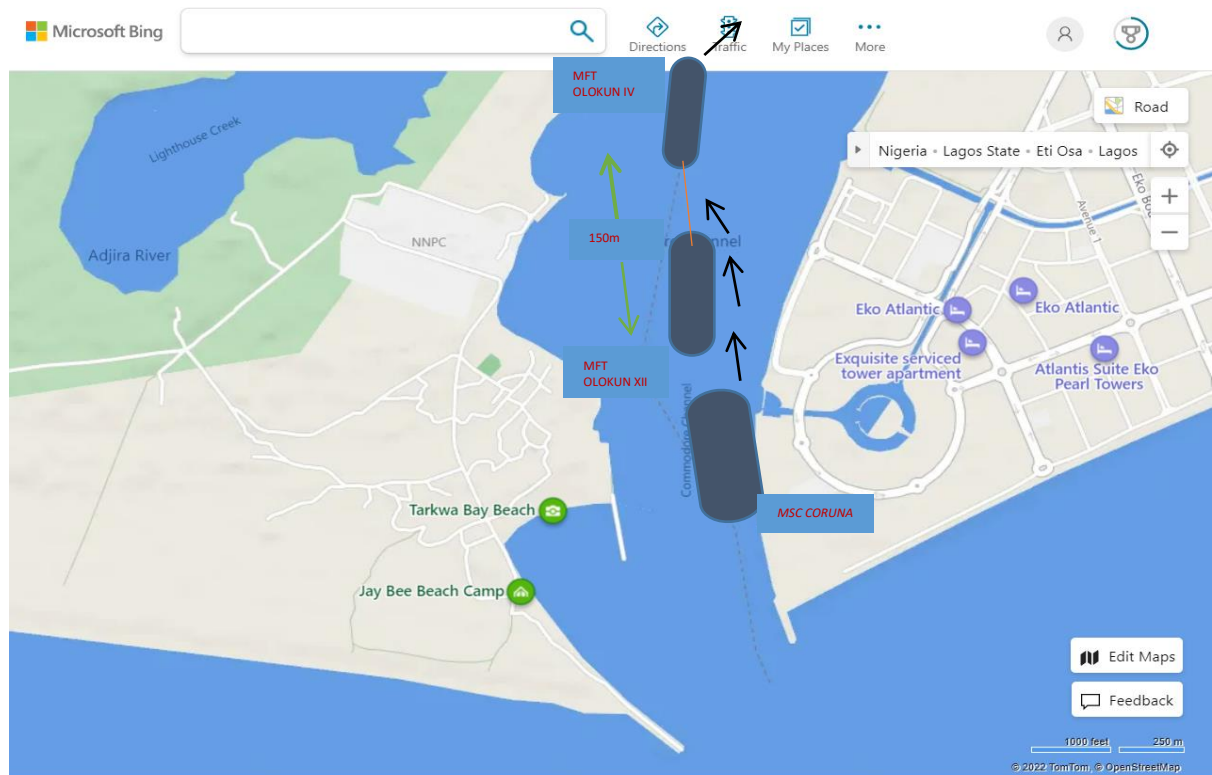
The Lagos pilotage district channel is an inland navigation channel. The entrance to the Channel has the 'great wall of Lagos (Eko Atlantic city) on the starboard side for inbound traffic, and the Takwa Bay beach on the port side. The incident occurred between Breakwater and Atlas Cove Jetty. The maximum breadth at the location of incident is about 440m while the deeper side of the Channel (being the middle of the Channel) is about 14.5 meters deep with a minimum permissible under keel clearance of 0.5 meters.

Picture 6: Description of the Lagos Channel

In view of the nature of the channel, and the effect of current, the Nigerian Ports Authority approved a speed limit of 7 – 8 knots for both in and outbound traffic in this location.
