SAFETY INVESTIGATION REPORT

REPORT NO.: 07/2025

MV *KAIRIT*

Near-grounding in Danish territorial waters,
in position 55° 22.3' N 012° 28.7' E
13 October 2024

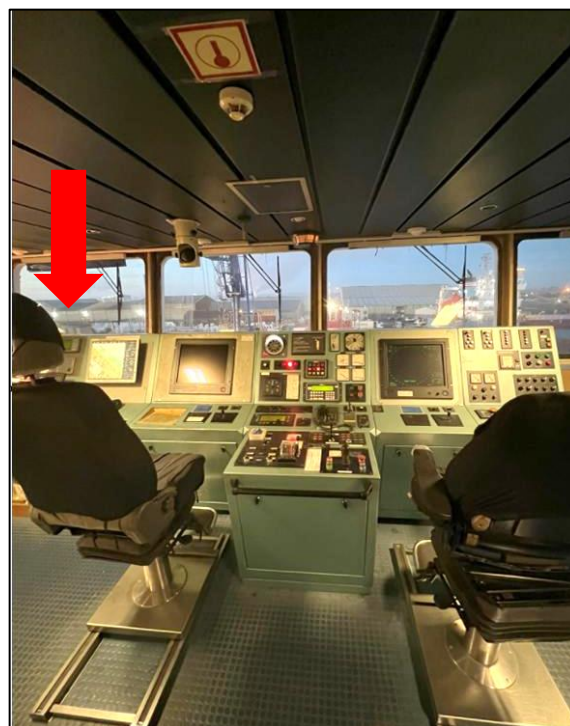
Figure 2: The bridge chair on which the chief officer fell asleep

was seated on a bridge chair (**Figure 2**), he fell asleep.

The chief officer recalled that after 0500, he started feeling tired, so he sat on the port side bridge chair. At some point, after the AB left the bridge for the safety rounds, he dozed off on the chair. The chief officer attributed this to high workload during the previous day, at the port of Mukran.
