SAFETY INVESTIGATION REPORT

REPORT NO.: 01/2026

MV OCEAN CENTURY **Fatal injury to a bunker / cargo surveyor,** **during the closing of a cargo hatch cover** **in the port of Gwangyang, Republic of Korea** **24 January 2025**

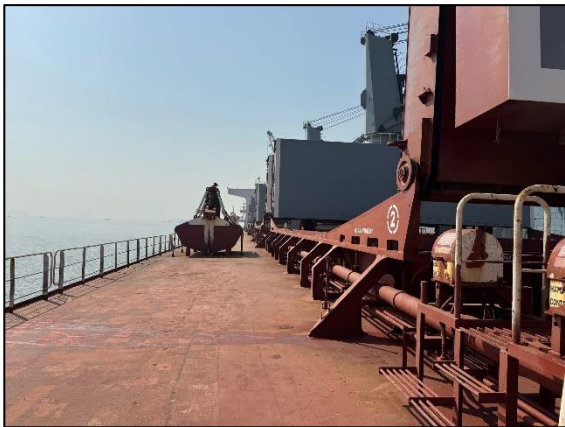
Figure 1: Starboard side main deck on MV *Ocean Century*

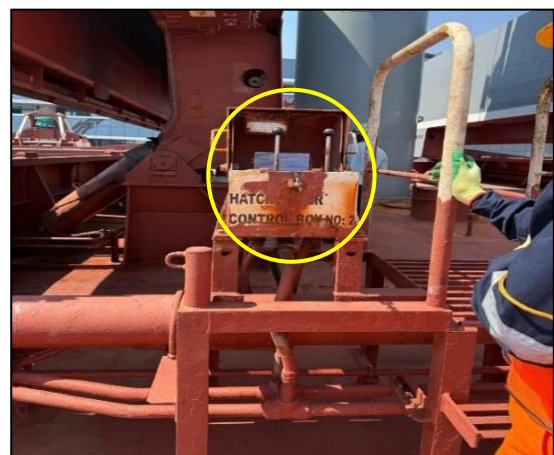
From the local control station, the aft part of the cargo hold would be out of sight. With the pumps of the hydraulic system running, the ordinary seafarer started closing the hatch cover, commencing with the forward section and continued to close the aft section.

Figure 2: Cargo hold no. 2 hatch covers control station

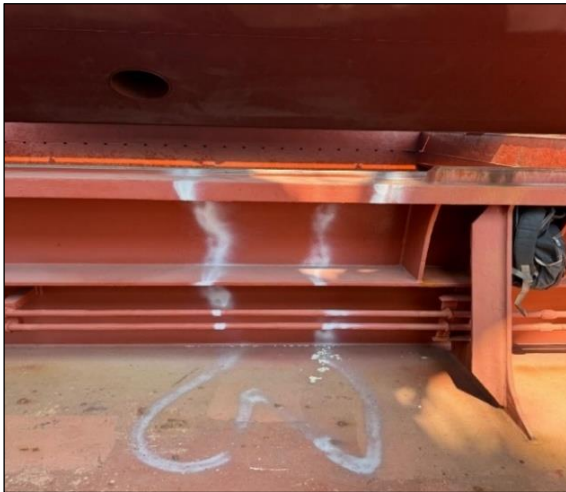
At approximately 0840, the electro-technical officer discovered the bunker / cargo surveyor trapped between the aft part of cargo hold hatch cover no. 2 and the cargo hold hatch coaming (**Figures 3a** and **3b**), with evident fatal injuries.

Figure 3a: The position where the bunker / cargo surveyor was found

The autopsy report confirmed that the bunker / cargo surveyor suffered from severe head injuries as a result of being trapped between the closing cargo hold no. 2 folding hatch cover and the cargo hold hatch coaming. In view of the absence of witnesses, the safety investigation could not determine why the bunker / cargo surveyor had positioned himself in the area.

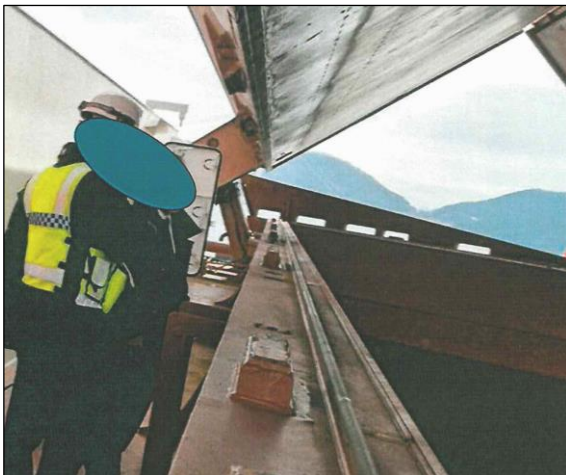
Figure 3b: Side view of the cargo hold hatch coaming where the bunker / cargo surveyor was found

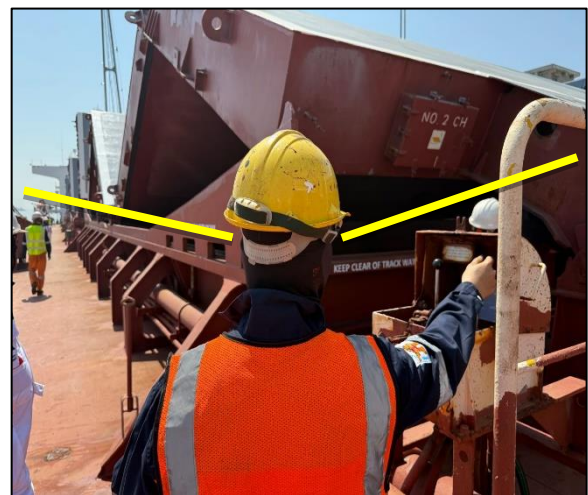
With the cargo hold hatch cover panels in the 'tent' position, the crew member at the control station had no direct line of sight to the aft section of the hatch cover (**Figures 4a and 4b**). Consequently, the crew member was unable to visually detect the presence of the bunker / cargo surveyor in the vicinity⁴.

Figure 4a: Cargo hold hatch cover in the 'tent' position (partially closed), obscuring the line of sight to the crew member

Given the operator's limited field of view (facing aft), the closing operation proceeded without awareness of any potential obstruction; an issue which remained even with the cargo hold hatch covers would have been completely closed.

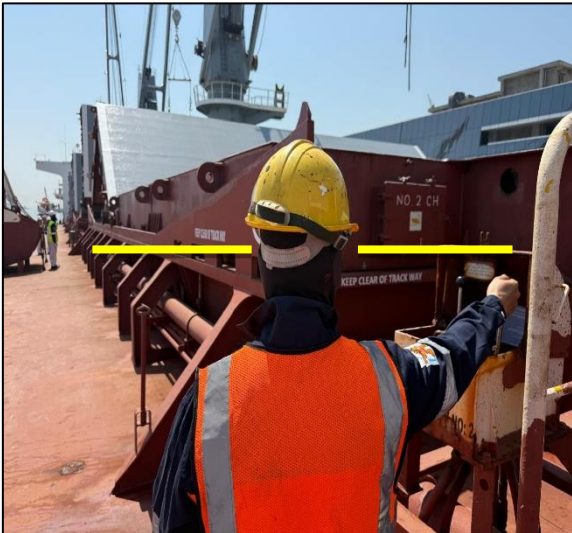
Figure 4b: Totally obscured line of sight of the aft cargo hold hatch coaming with the forward panels closed, and the aft panels in the ‘tent’ position

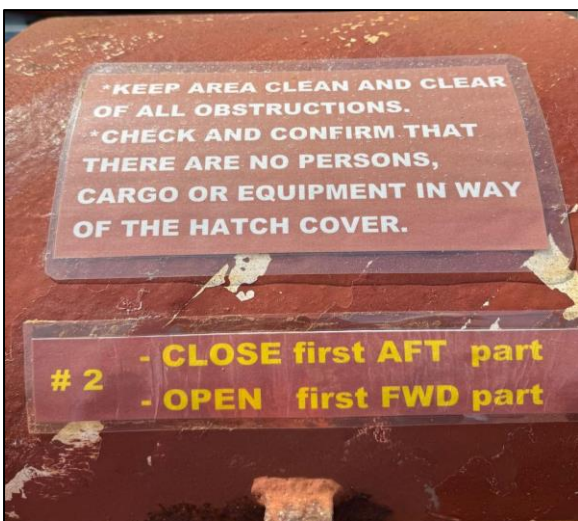
Symbolic barriers, such as warning signs, labels, and physical markings, serve as visual reminders of hazards. These barriers play a crucial role in alerting personnel to potential dangers. Warning signs had been posted in the area of the cargo holds (**Figures 5 and 6**). However, whilst noting that the fatality did

The safety investigation did not exclude the possibility that they may have been missed. It is not uncommon that warning signs are missed due to a combination of familiarity and cognitive overload. Studies indicate that (non-interactive) warning signs normally ‘blend’ into the background and tend to lose their impact over time.

Figure 5: The instruction posted on the hydraulic control station

- iii. fresh warning signs were displayed near the wheel tack of the cargo hold hatch cover tracks on port and starboard sides;
- iv. a warning sign has been posted on the operating lever to alert the operator to confirm hatch coaming is clear before closing / opening the hatch cover;

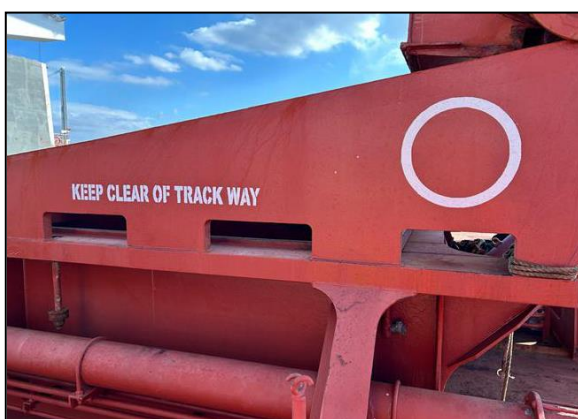
Figure 6: One of the warning signs at the cargo hold's hatch cover trackway
