# SAFETY INVESTIGATION REPORT

REPORT NO.: 03/2026

## MV ZEPHYR VENTURE

### Progressive flooding of the engine-room while at anchor, in position 02° 57.4' N 080° 31.8' E 27 February 2025

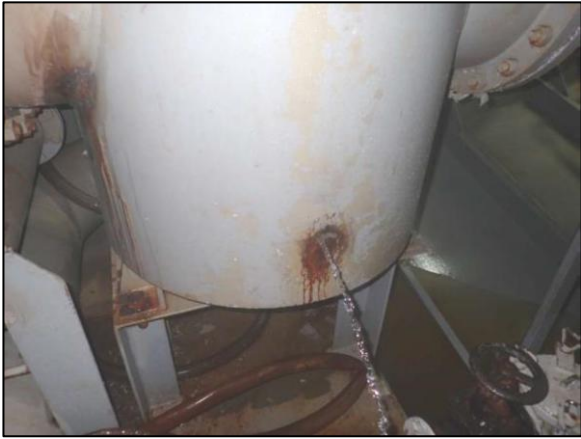
On 21 February 2025, whilst *Zephyr Venture* was *en route* from Rio Grande, Brazil, to Guayaquil, Ecuador, the engine-room crew members observed a leak in the port side sea chest strainer housing (**Figure 2**).

**Figure 2: The leaking strainer housing**

On further inspection, the crew members found that the leak was caused by corrosion in the strainer housing. Temporary repairs were carried out to arrest the leak after the necessary hot work permit and risk assessment were completed on 22 February 2025.

On 24 February 2025, the vessel arrived and anchored at Guayaquil outer anchorage, awaiting berthing instructions to unload its cargo. At anchor, the crew members proceeded with the maintenance works on the corroded areas of the strainer housing, following which, a coat of paint was applied to the internal area of the housing.

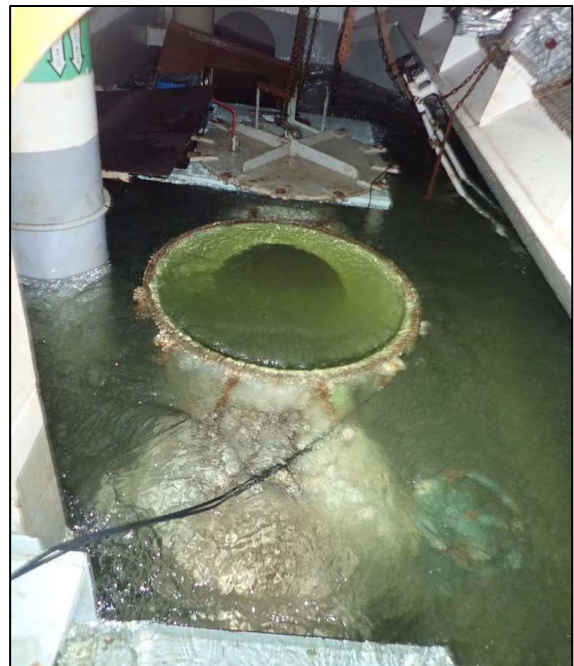
Shortly after, at about 1422, a series of high-level alarms for the engine-room bilges activated. The crew members proceeded down to the bottom platform to investigate and to their disbelief and shock, they found water gushing out of the open port side sea chest strainer housing (**Figure 3**).

**Figure 3: The open strainer housing** (photograph taken after the sea chest valve was shut)

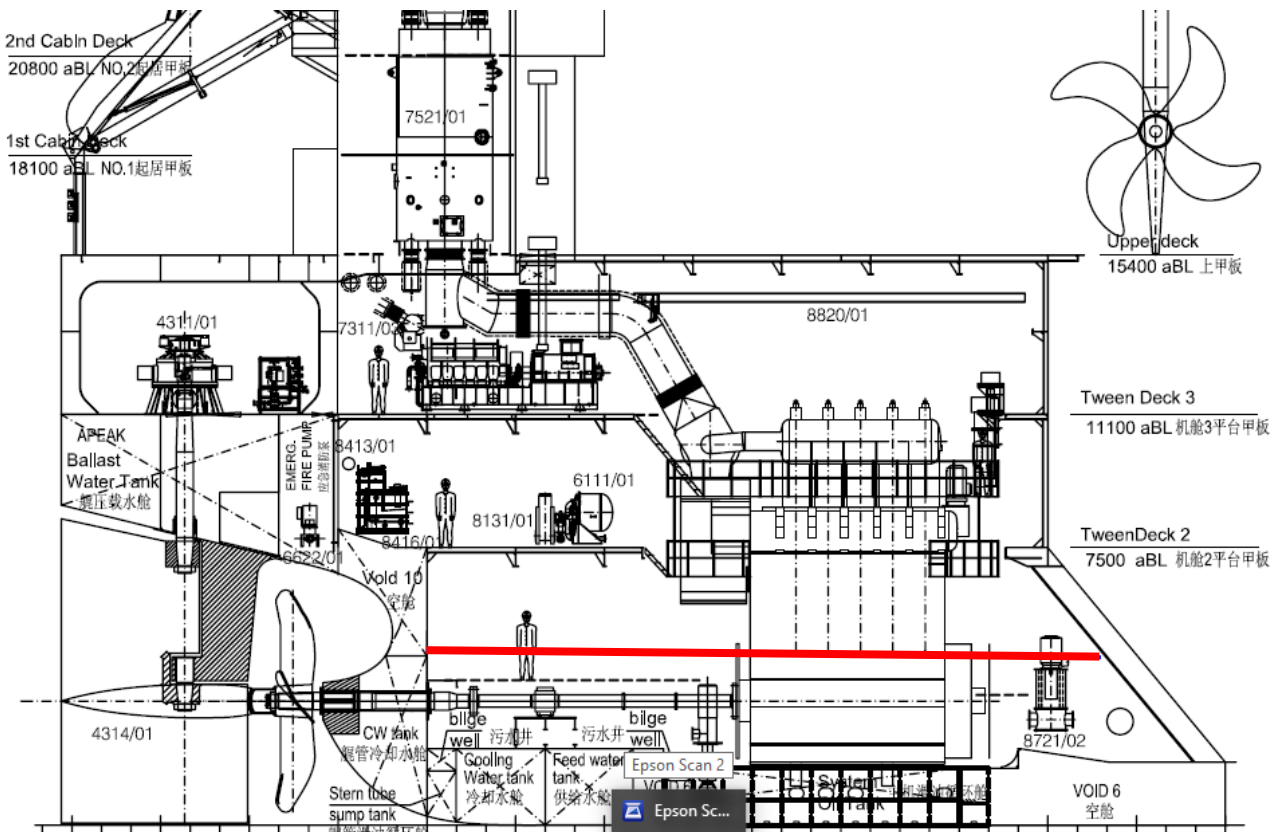
By this time, the engine-room was flooded with about 400 metric tonnes of water<sup>4</sup>.

The water level had reached a height of about 1.5 m above the bottom platform (**Figure 4**), i.e., about mid-height of the main engine crankcase doors.

Figure 4: The approximate height to which the engine-room had flooded (red line)

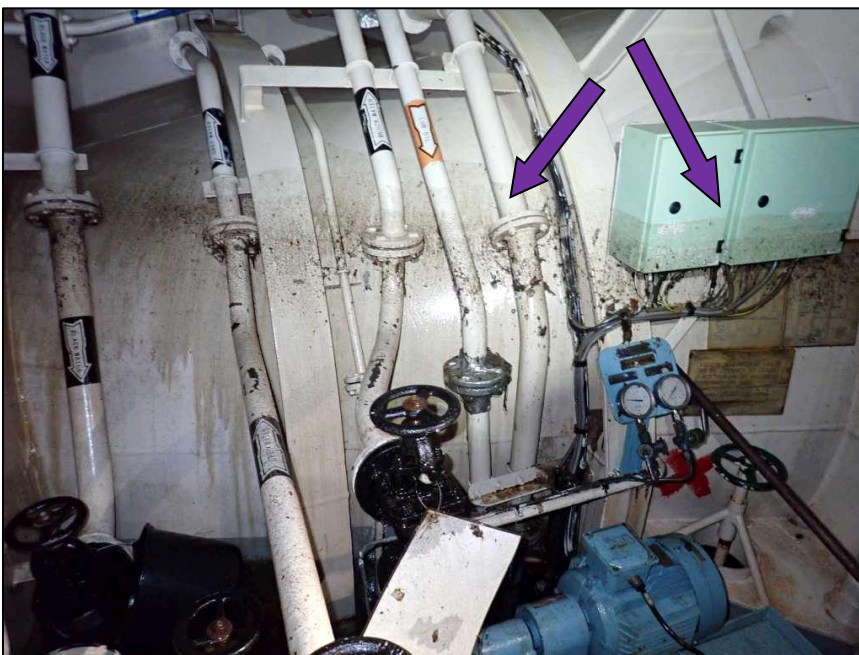
A damage survey was carried out by a DNV surveyor at Guayaquil on 13 March 2025, while the vessel was at anchor. The flooding (Figure 5) had caused severe corrosion of various components of the main engine (Figure 6), rendering it out of service until permanent repairs were carried out by shore service technicians. Additionally, several motors, electrical cables, and the insulation on the bulkheads and pipes in the flooded areas were damaged, while cracks were observed on the lower tube plates of the auxiliary boiler.

Figure 5: High water marks in the engine-room following completion of the pumping operation

The extensive and necessary repair and cleaning jobs in the engine-room were eventually completed by shore service technicians on 27 May 2025, following which, sea trials were carried out to confirm the satisfactory operation of the vessel.

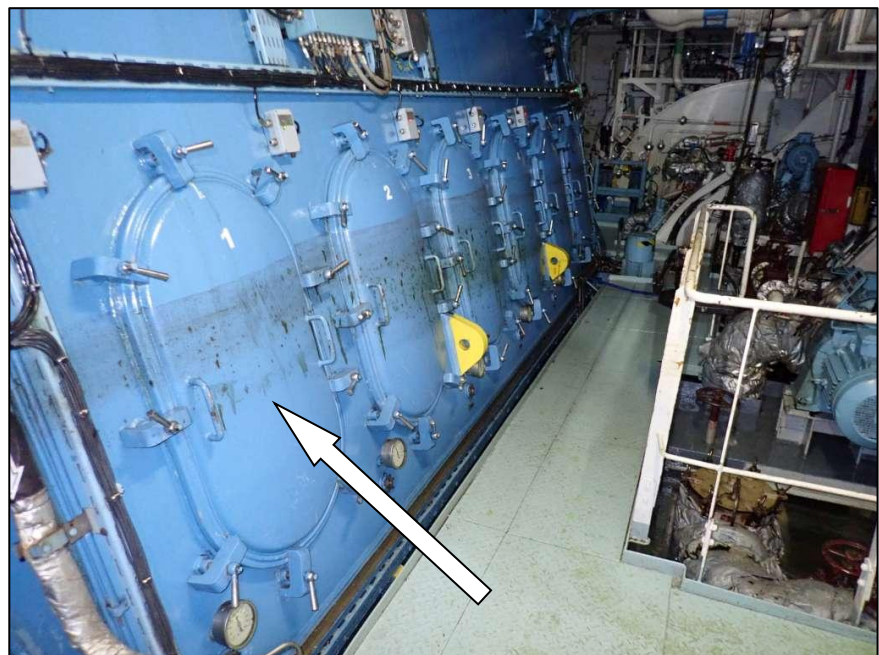
Figure 6: High water marks reaching the main engine crankcase doors

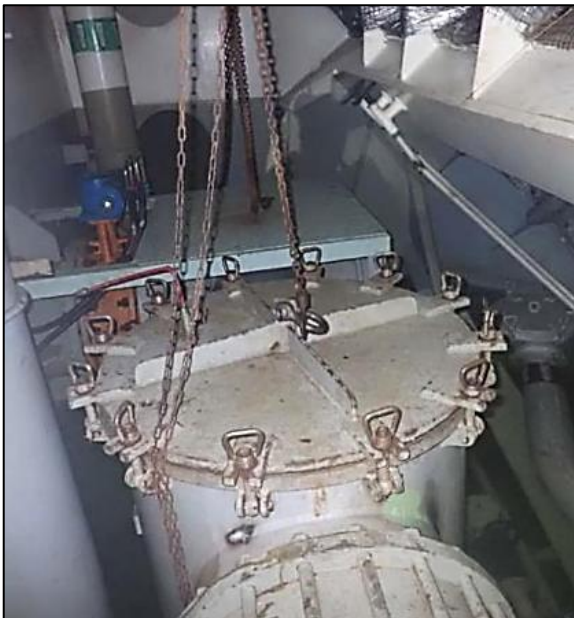
The safety investigation confirmed that the immediate cause of the flooding was the opening of the port side sea chest valve (**Figure 7**), whilst the strainer housing was also open.

**Figure 7:** Port side sea chest, showing the cover secured in place

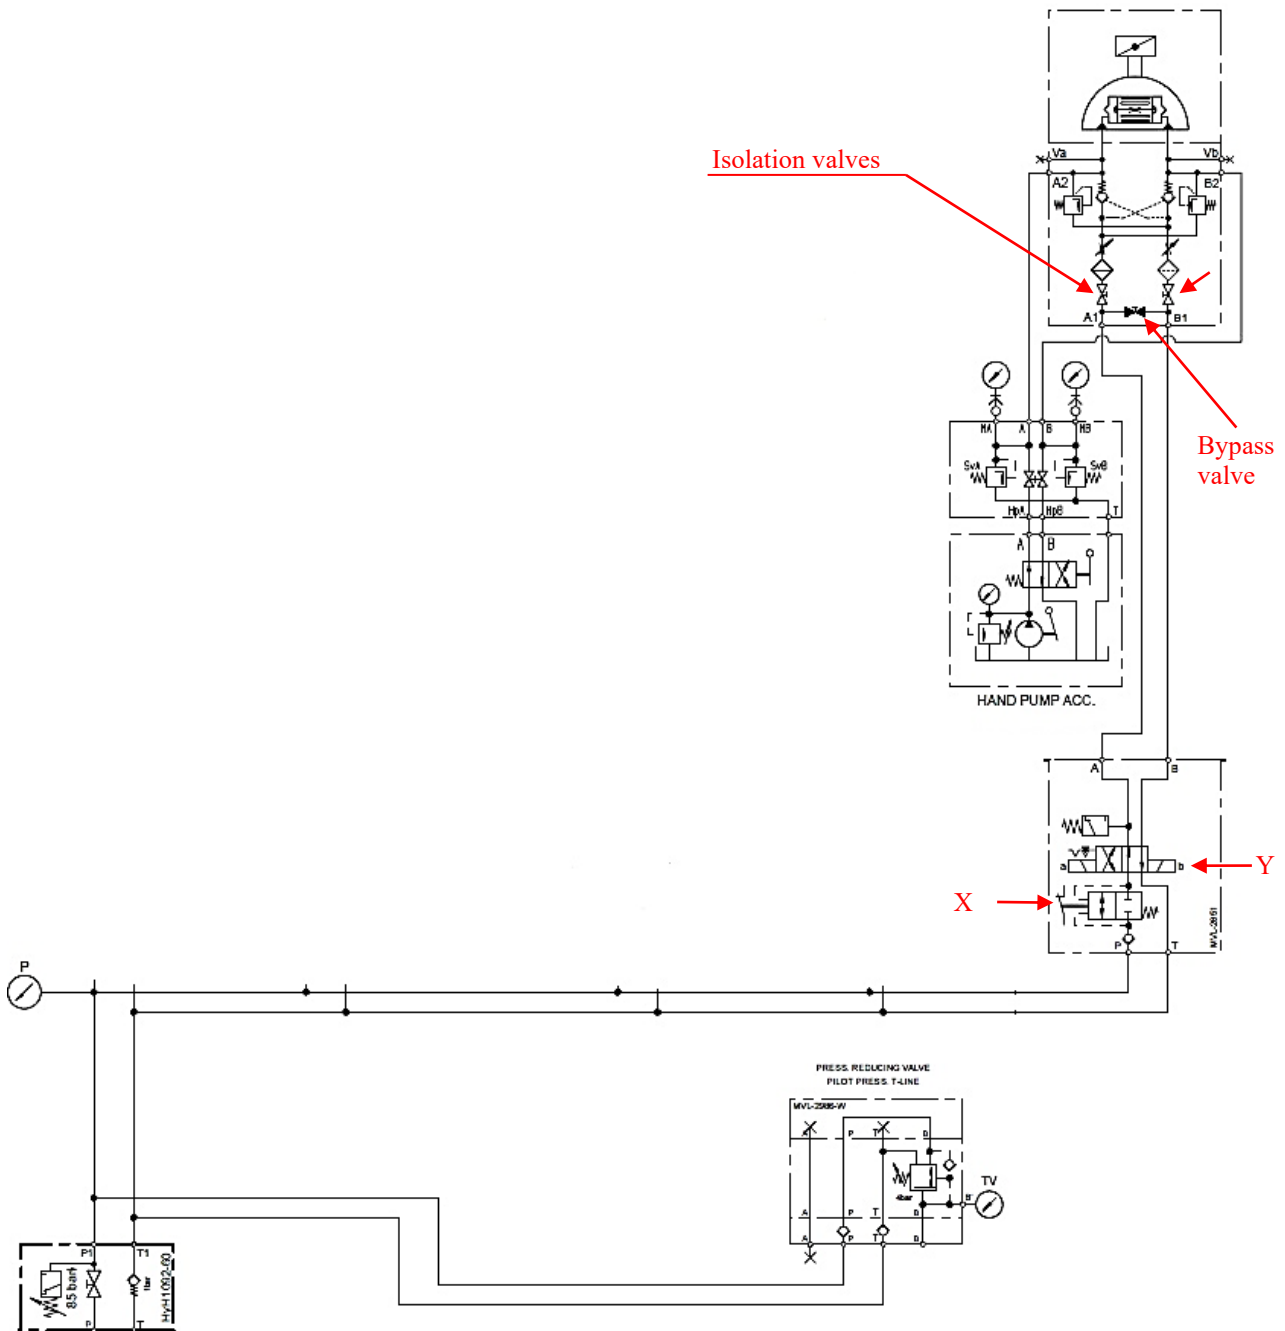
Figure 8: Diagram of the hydraulic, remote-controlled valves for the port and starboard side sea chests

Review of the hydraulic schematic for the remotely operated sea-chest valves (**Figure 8**) showed that solenoid-operated valve (**X**) was designed to activate automatically whenever hydraulic-oil pressure was detected. Solenoid-operated valve (**X**) had no manual-control capability and therefore, it relied entirely on system pressure for its operation.

The position of the solenoid-operated valve (**X**) in **Figure 8** corresponded to its normal state when the hydraulic pumps were shut down. Unless it had been intentionally isolated, solenoid-operated valve (**X**) would transition to the open position as soon as a pump was started, enabling remote control of the sea-chest valves. When the pumps were stopped, solenoid-operated valve (**X**) automatically returned to the closed position, interrupting the hydraulic enabling signal and preventing any further remote operation.

For the sea-chest valves to open, activation of solenoid-operated valve (**X**) was therefore a necessary precondition; without hydraulic flow and the consequent opening of solenoid-operated valve (**X**), the valves could not be driven from their closed position.

The directional control valve (**Y**) incorporated a mechanical latch that allowed it to retain its last selected position even after system depressurisation. The position of the directional control valve (**Y**) shown in **Figure 8** represented its normal state with the sea-chest valves shut. This latch provided operational stability.

When the strainer housing was opened for maintenance, the port-side sea-chest valve was known to be shut. Thus, for the valve to open and flooding to occur, both the activation of solenoid-operated valve (**X**) and a change of state in the directional control valve (**Y**) would have been required.

While the safety investigation considered the possibility of an intermittent electrical or hydraulic fault causing the directional control valve (**Y**) to operate, it also could not exclude inadvertent operation of the directional control valve (**Y**) during or following the accumulator maintenance.

If directional control valve (**Y**) had been unintentionally operated while solenoid-operated valve (**X**) was active, the resulting opening of the sea-chest valves would have allowed seawater to enter the engine-room

Opening the bypass valve and closing the isolation valves (**Figure 8**) would have enabled the operation of both the solenoid-operated valve (**X**) and directional control valve (**Y**) without altering the actual physical position of the sea-chest valve, regardless of whether the valve was open or closed. In this configuration, the bypass and isolation valves effectively served as a functional preventive barrier system, ensuring that hydraulic control signals could be managed without creating an unintended valve movement.

However, this procedure had neither been addressed in the risk assessment, nor were the bypass and isolation valves operated prior to the maintenance tasks. Therefore, the bypass valve remained closed and the isolation valves open. It was highly likely that the crew members did not recognise the need to operate the valves when preparing to open the port-side sea-chest strainer housing, or were unaware of the purpose and significance, particularly given the relatively short period they had been on board prior to this flooding incident.

The Company further enforced its ‘Lock out – Tag Out’ procedures and reminded crew members serving on board Company vessels to adhere to the Company’s procedures on job planning, risk assessments and permits to work.
