## SAFETY INVESTIGATION REPORT

REPORT NO.: 09/2026

September 2026

*Your Magic* (Figure 1) was a high-speed passenger catamaran of 397 gt. The vessel was built at PT. Cahaya Samudra Shipyard in Indonesia in 2023. At the time of the accident, the vessel's registered owner was Gozo Fast Ferry Ltd., and the vessel was managed by Newcastle Ship Management Ltd. of Malta. Bureau Veritas (BV) acted as the classification society.

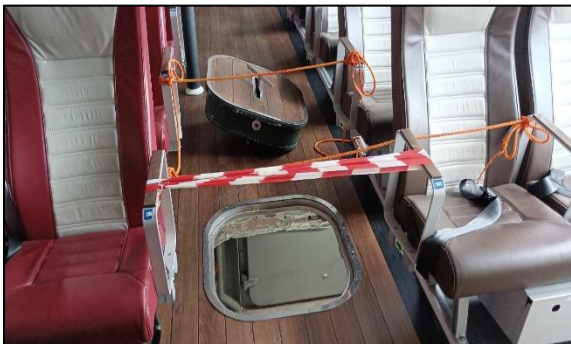
**Figure 2: Port side switchboard room emergency escape hatch opening on the port side passenger aisle**

The hatches opened flush with the passenger deck and were not fitted with coamings. The chief engineer stated that he opened the

emergency escape hatches on the master's instructions. No barriers, warning signs or other physical safeguards were placed around the openings.

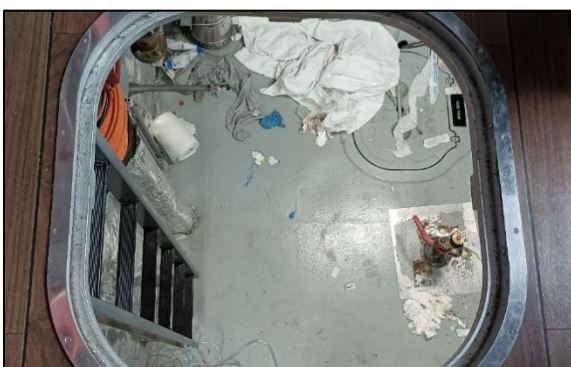
**Figure 3: Port side switchboard room from the passenger hall**

These hatches, which were opened by the chief engineer, led to the port and starboard switchboard rooms (**Figures 3 and 4**).

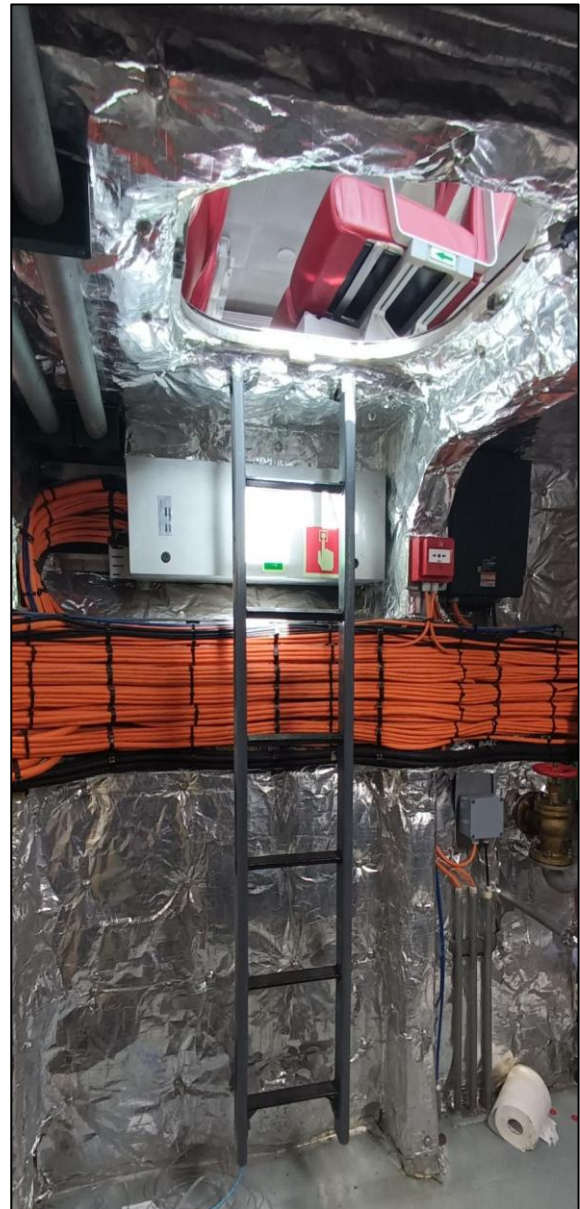
**Figure 4: Port switchboard escape ladder and open escape hatch cover**

In this case, the emergency escape hatch opened flush with the deck and did not provide an inherent barrier around the opening when raised<sup>5</sup>. In the absence of temporary guarding, control of the fall hazard depended on warning measures and individual awareness. As neither was provided, no independent layer of defence remained.

**09/2026\_R1** review its task-planning arrangements to ensure that, where non-routine work, departures from normal working arrangements or temporary conditions introduce a material additional hazard, the work and associated controls can be adapted proportionately to the changing conditions, with the active participation of the personnel involved.

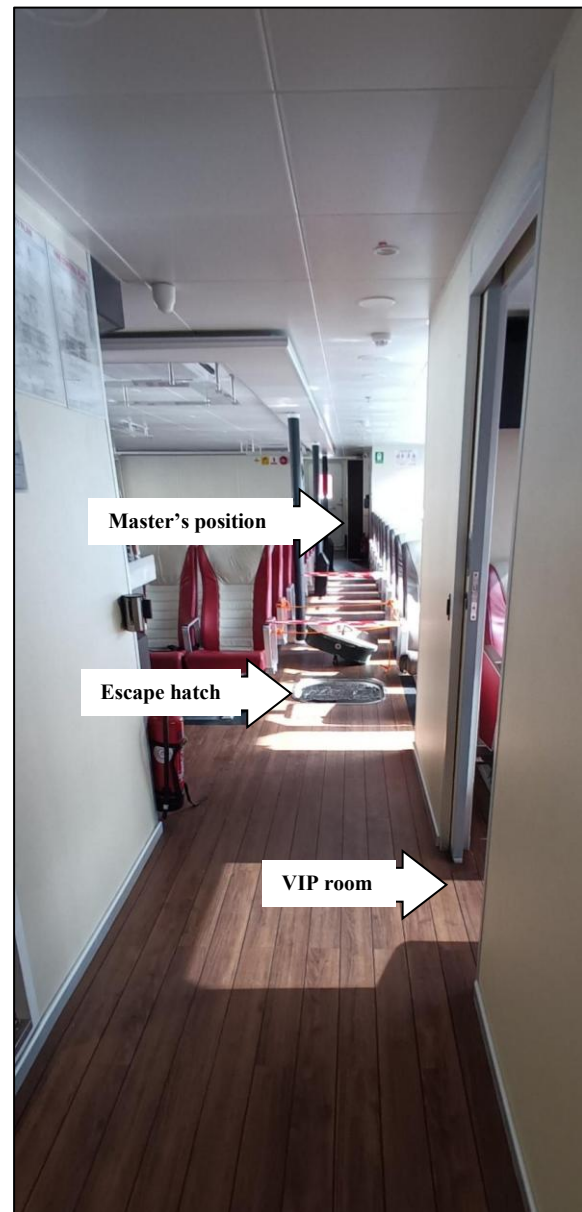
**Figure 5: VIP room and accident site**

On leaving the VIP room, he turned and proceeded briskly along the port-side passenger aisle towards the master at the aft end. During this movement, he appeared to be speaking and looking towards the master and did not seem to notice the open emergency escape hatch. Consequently, he fell through the opening into the port switchboard room, falling approximately 2.10 m onto the tank top.
