SAFETY INVESTIGATION REPORT

REPORT NO.: 21/2013

MV THEOFYLAKTOS Explosions in four cargo holds at Rio Grande Outer Anchorage 22 December 2012

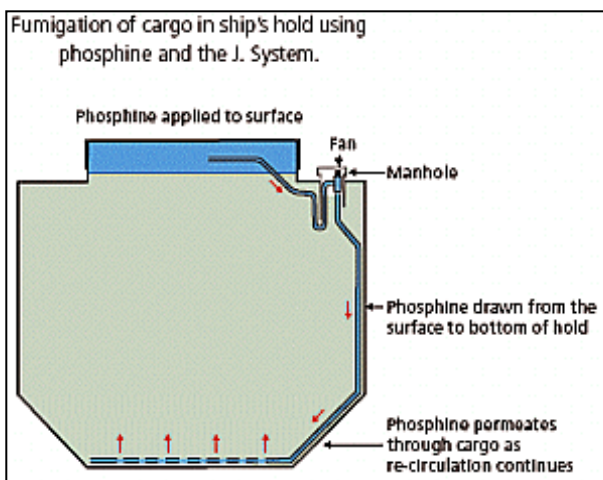
Figure 1: The ‘J System’

Where the cargo stow is deeper, *i.e.* in the region of 12 m to 20 m for Panamax-size vessels, the ‘J’ or ‘Recirculation System’ is utilised (Figure 1). In the Information Booklet provided to the vessel by the fumigation company, the ‘J System’ is described as a “patented... cargo hold fumigation system.”

In the ‘J System’, PH₃ gas is circulated through the cargo by means of perforated tubes and a special electrical fan. This results in a rapid, even and effective distribution of gas in the cargo hold.

At the same time, personnel from the fumigation company laid out plastic pipes on the tank tops of each cargo hold, as part of the ‘J System’ of fumigation. They also installed fan motor blowers inside the cargo holds’ access trunking. The suction inlet of the ‘J System’ was also located in way of the cargo hold access trunk (Figure 2) rather than in the cargo hold above the cargo top layer (Figure 1).

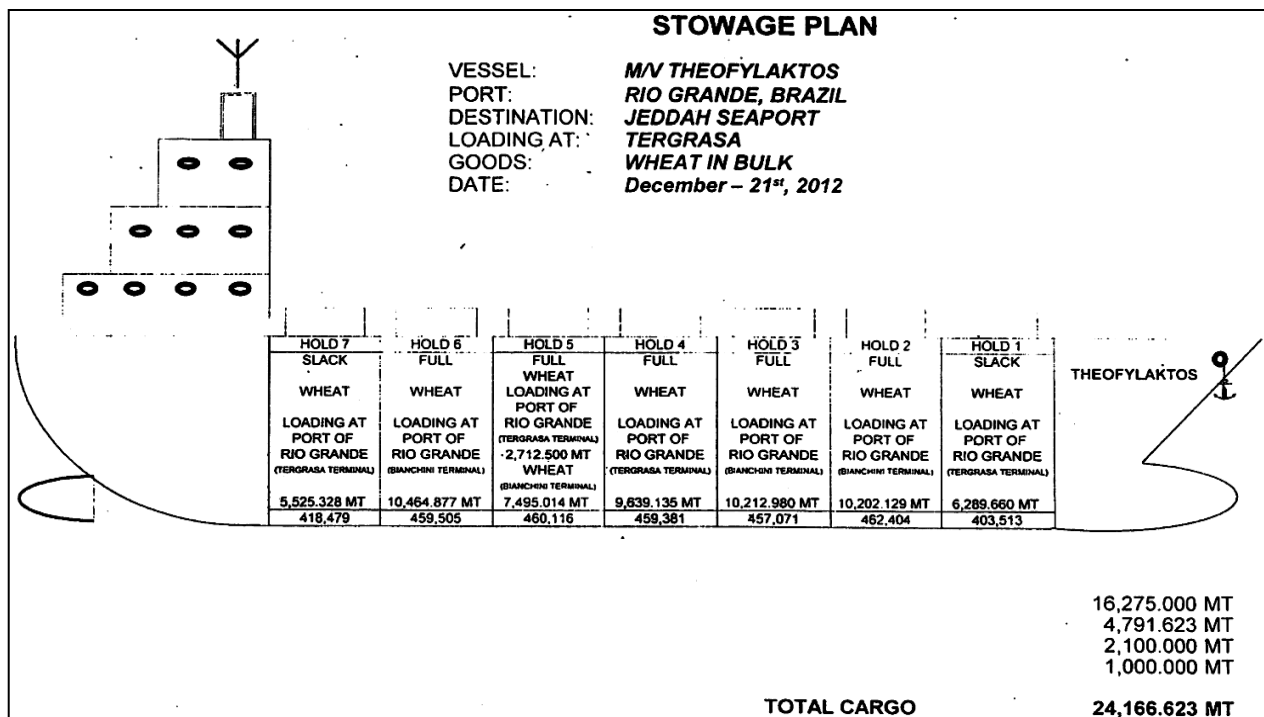
Figure 3: Cargo stowage plan

Theofylaktos was fast alongside at the second loading terminal (Tergrasa Grain Terminal) at 0054 on 20 December 2012. Loading of cargo holds nos. 1, 4, and 7 commenced at 0615 and was completed the next day at 2200 (Figure 3). Fumigation in the cargo holds was started shortly after at 2210.

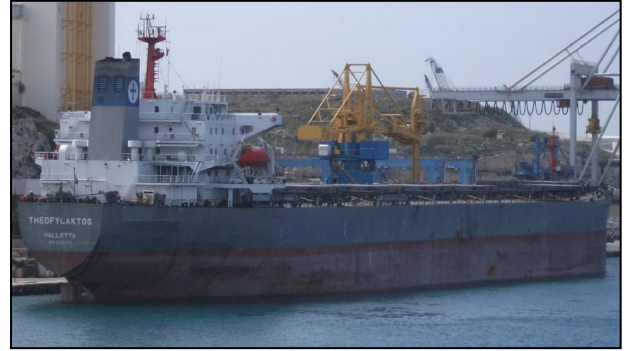
Figure 6: *Theofylaktos* at Valletta 28 March 2013

Further surveys and inspections were carried out after the vessel entered the port, where temporary repairs were carried out. On 09 January 2013, a short-term International Load Line Certificate was issued by the Classification Society on behalf of the flag State and the vessel sailed for Jeddah. Wheat in cargo hold no. 2 was eventually discharged for transshipment in Valletta, Malta on 28 March 2013 (Figure 6).
