Danish Maritime Accident
Investigation Board

MARINE ACCIDENT REPORT

AMBER II and SEA WORKER
Loss of tow on 27 January 2016

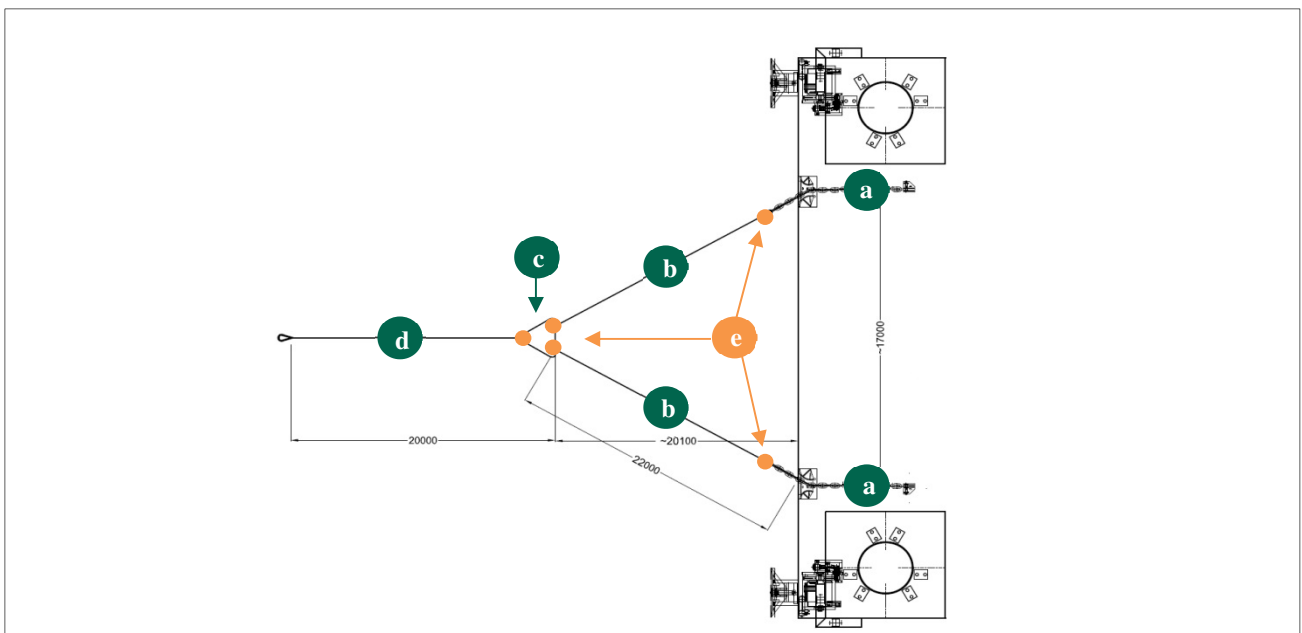
Figure 6: SEA WORKER's towing arrangement

The towing arrangement on SEA WORKER is depicted in figure 6 above and consisted of the following components:

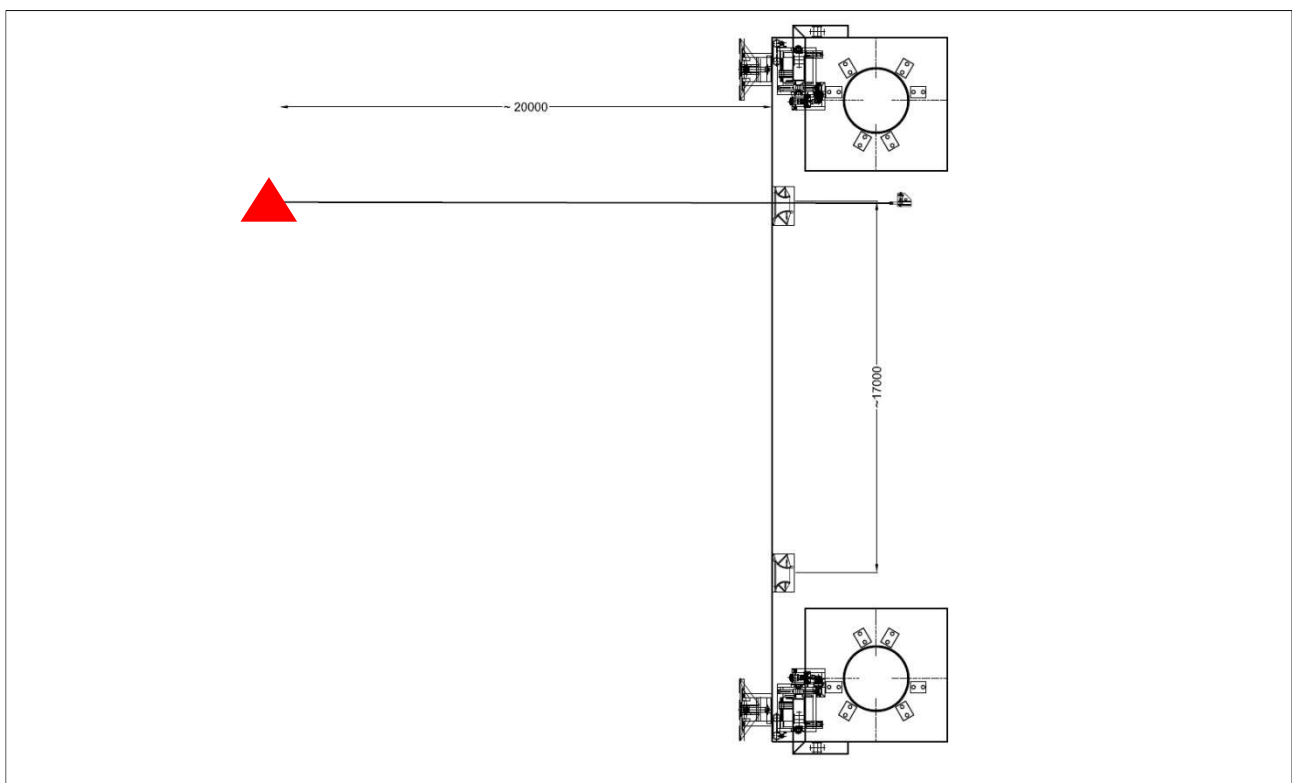
Figure 11: Excerpt of SEA WORKER's general arrangement
Source: DMAIB

SEA WORKER was equipped with an emergency towing wire fastened and stowed on deck at the bow. The emergency towing wire consisted of a single steel wire fastened on deck with a Smitt bracket and with a buoy mounted at the end of the towing wire (figure 11). The emergency towing wire was not fitted with a bridle, which meant that the ability for the tug to keep the platform within a desired angle was reduced. Therefore the emergency towing line was intended for the limited purpose of bringing the towage into sheltered water or a port of refuge, in case of emergency. The towing wire's safe working load was 20 t.

No procedure described how the emergency towing equipment was to be used, but the general principle of the emergency towing arrangement on SEA WORKER was that the equipment was to be deployed in case the main towing wire failed, and that the equipment then would drift alongside the platform and fall behind the platform, clear for the tug to pick up. During the release of the emergency towing line following the failed main towing connection on 27 January 2016, the buoy was caught alongside SEA WORKER making it impossible to pick up for AMBER II.

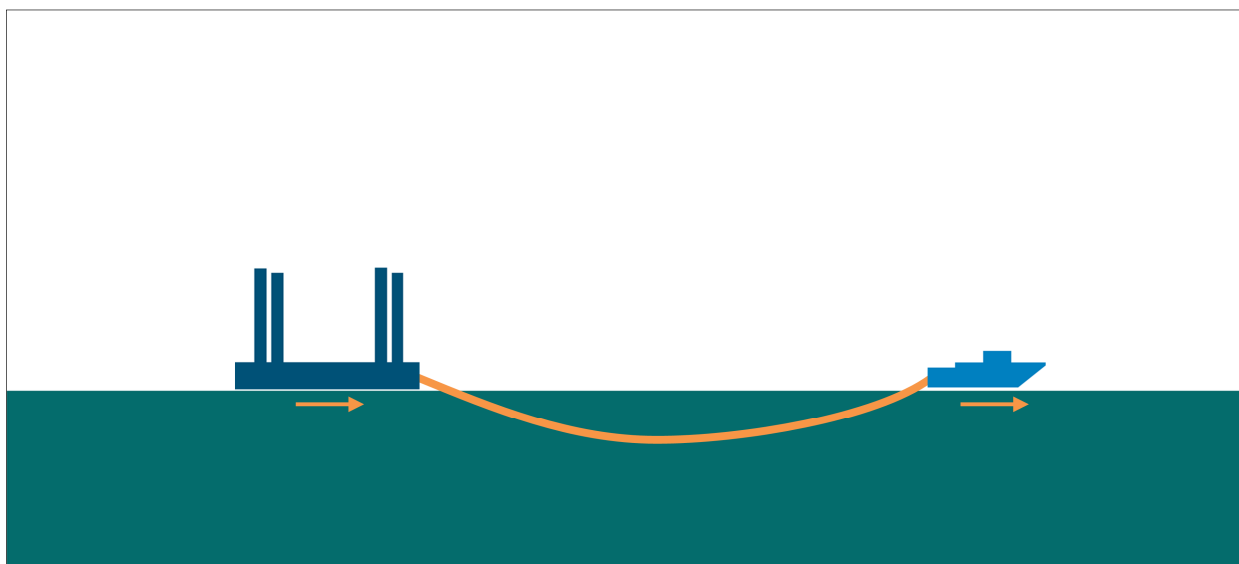
Figure 13: Towing situation with a great amount of catenary

Figures 13 and 14 below show two different towing situations⁷. The top figure pictures how the towing wire ideally should be hanging between the two vessels in a curve. The underwater curve adds flexibility to the tow, so that it is less likely to break.

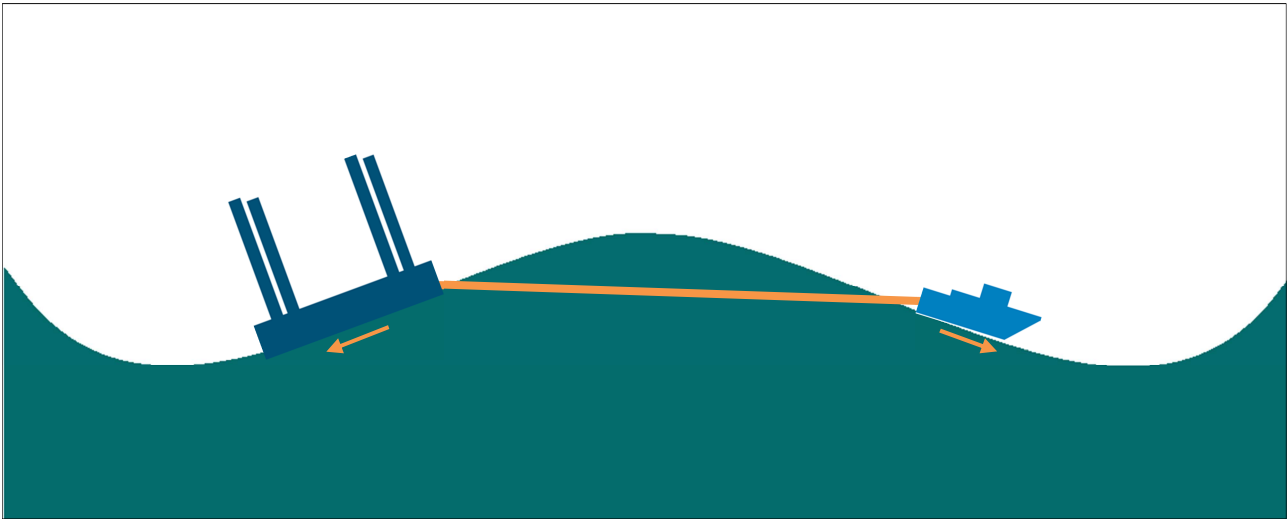
Figure 14: Towing situation with a tightening towing wire due to waves
Source: DMAIB

The bottom figure shows an undesirable situation where the towing vessel and the towed object are situated on each side of a wave. In this situation the towing vessel will pull forward, while the towed and often heavier object pulls in the opposite direction, causing substantial extra load on the towing line. Thereby, the towing wire is tightened, and the elasticity is lost. This can cause the wires or the joints of the tow to fail. When this situation occurs, the only way of reducing the strain on the towing wires is for the tug to idle or even reverse its engines, in order to let itself being pulled in the towed object's direction.

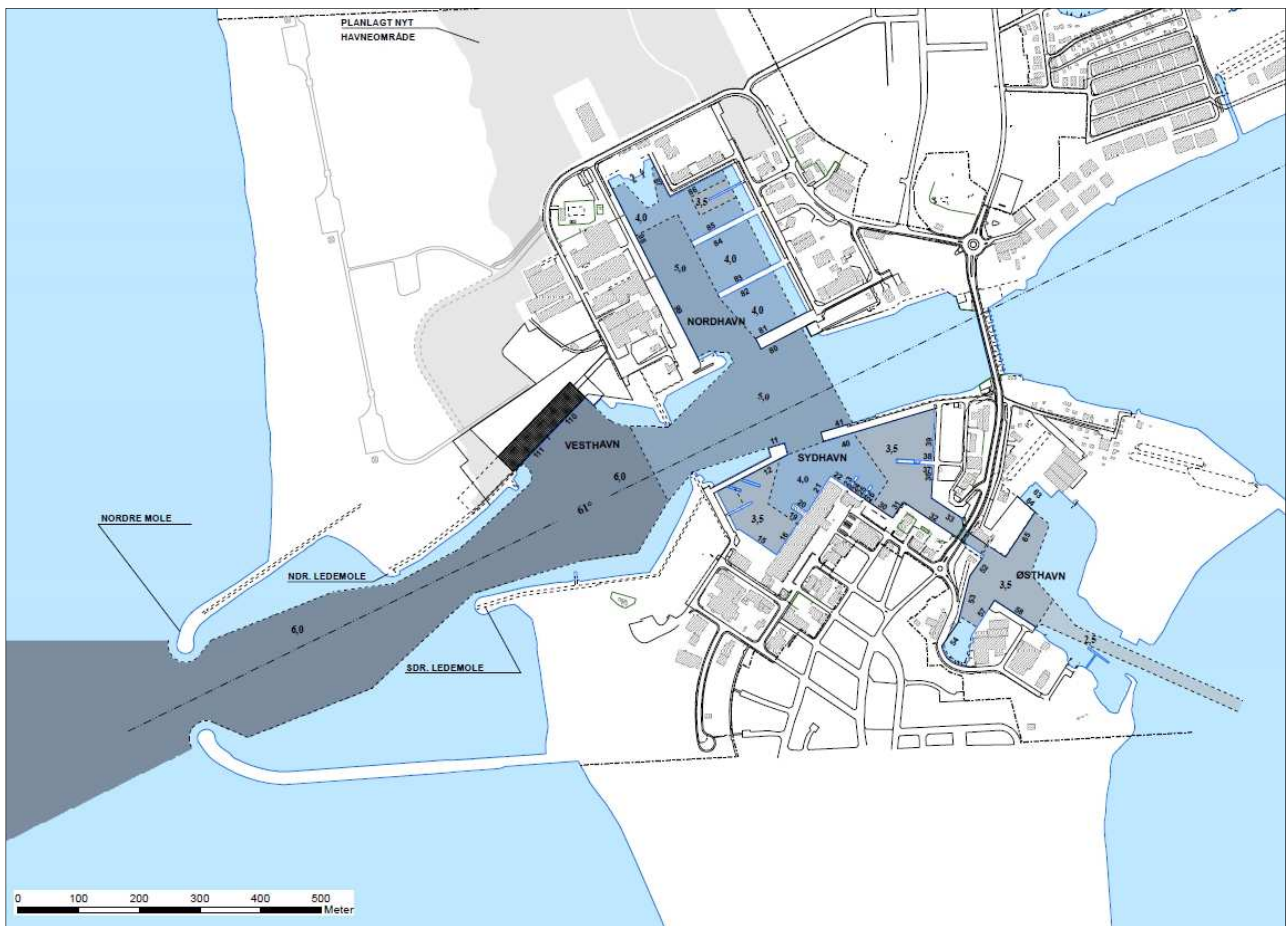
Figure 13: Map of port of Hvide Sande
 Source: Port of Hvide Sande

The width of the fairway between the outer pier heads is approx. 100 m and 75 m between the inner pier heads. The port can accommodate vessels with a length of 140 m, a breadth of 50 m and a draught of 5.5 m.

A work boat and a rescue boat were available to provide towage assistance during departure and arrival and each had a bollard pull of 7 t. Pilot service was ordered from the pilot station in Esbjerg.
