Unintentional release of the freefall lifeboat from *Aquarosa*

Indian Ocean | 1 March 2014

ATSB Transport Safety Report
Marine Occurrence Investigation
307-MO-2014-002
Final – 20 May 2015

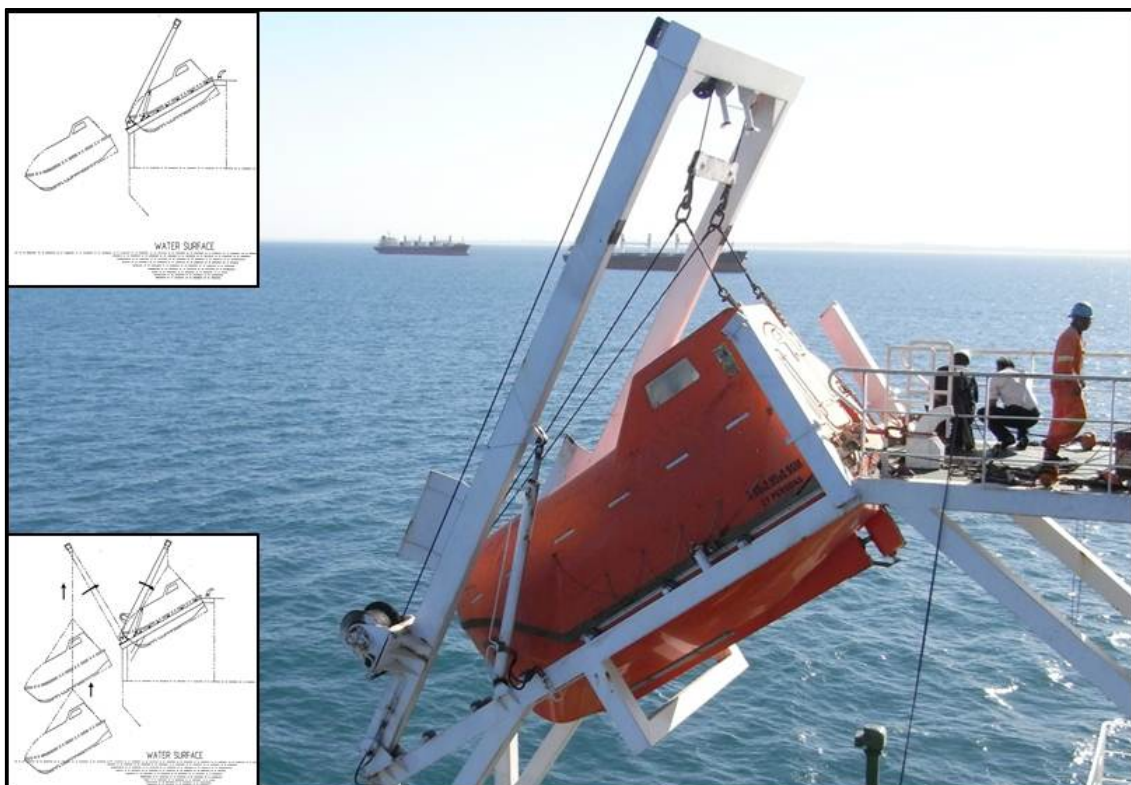
Figure 2: *Aquarosa*’s freefall lifeboat (insets show launch and recovery)

Aquarosa was fitted with a Jiangsu Jiaoyan Marine Equipment Company (JJMEC), model JY-FN-5.80, twenty-seven person fibre-reinforced plastic freefall lifeboat that was manufactured in November 2009. The lifeboat was 5.80 m long, had a beam of 2.55 m and weighed 5,460 kg⁵ with a full passenger and stores load (Figure 2).
