**The Report of the Investigation
Into the Allision incident involving the
Liberian Bulk Carrier NEW LEGACY (IMO No: 9804942) and the
Malta Registered Bulk Carrier DENSA TIGER (IMO No: 9432476)
Causing the foundering of a Bangladesh local cargo barge CHAR SHAMAIL,
And resulted in missing crew members of the barge
At Chittagong Anchorage, Bangladesh
On September 29, 2018.**

PUBLISHED BY THE LIBERIA MARITIME AUTHORITY

**December 20, 2019
Monrovia, Liberia**

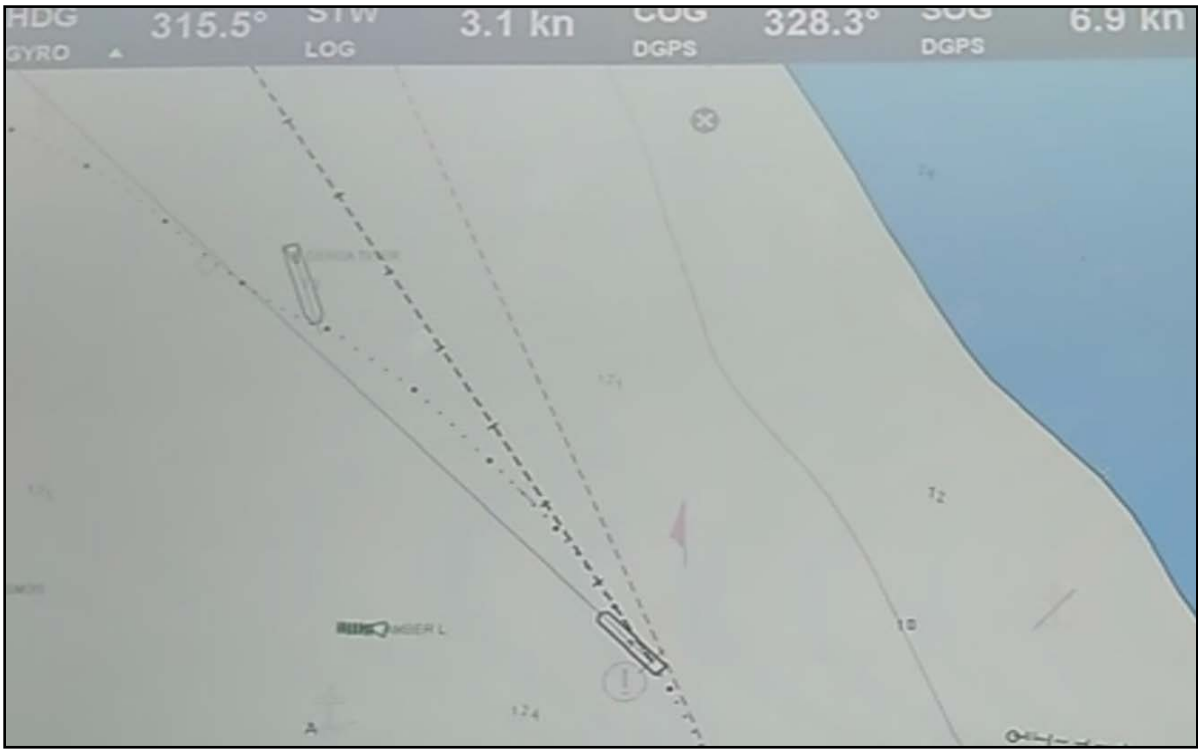
FIGURE 2 ECDIS Playback Position of the NEW LEGACY

At that same time, with the combination of strong tidal current, the slow speed the NEW LEGACY was making, and also the weight and forces of three (3) barges moored and made fast on both the port and starboard hull, the Master observed that his vessel was having difficulty to maneuver through density of vessels at anchor in the vicinity. During the maneuver, the Master of NEW LEGACY intended to cross the bow of the anchored vessel DENSA TIGER, but under the influence of tidal current, pushing the NEW LEGACY towards the DENSA TIGER, and despite the increase in propulsion RPM to half ahead, the full ahead, and hard port helm order, the distance from the bow of DENSA TIGER could not be maintained and the starboard side aft hull area of NEW LEGACY allided, and made contact with the bow of DENSA TIGER at about 1109 LT.

The sequence of the collision incident is shown in the following snapshots taken from the ECDIS play back of the vessel NEW LEGACY (*shown in Figure 2 to 6*).

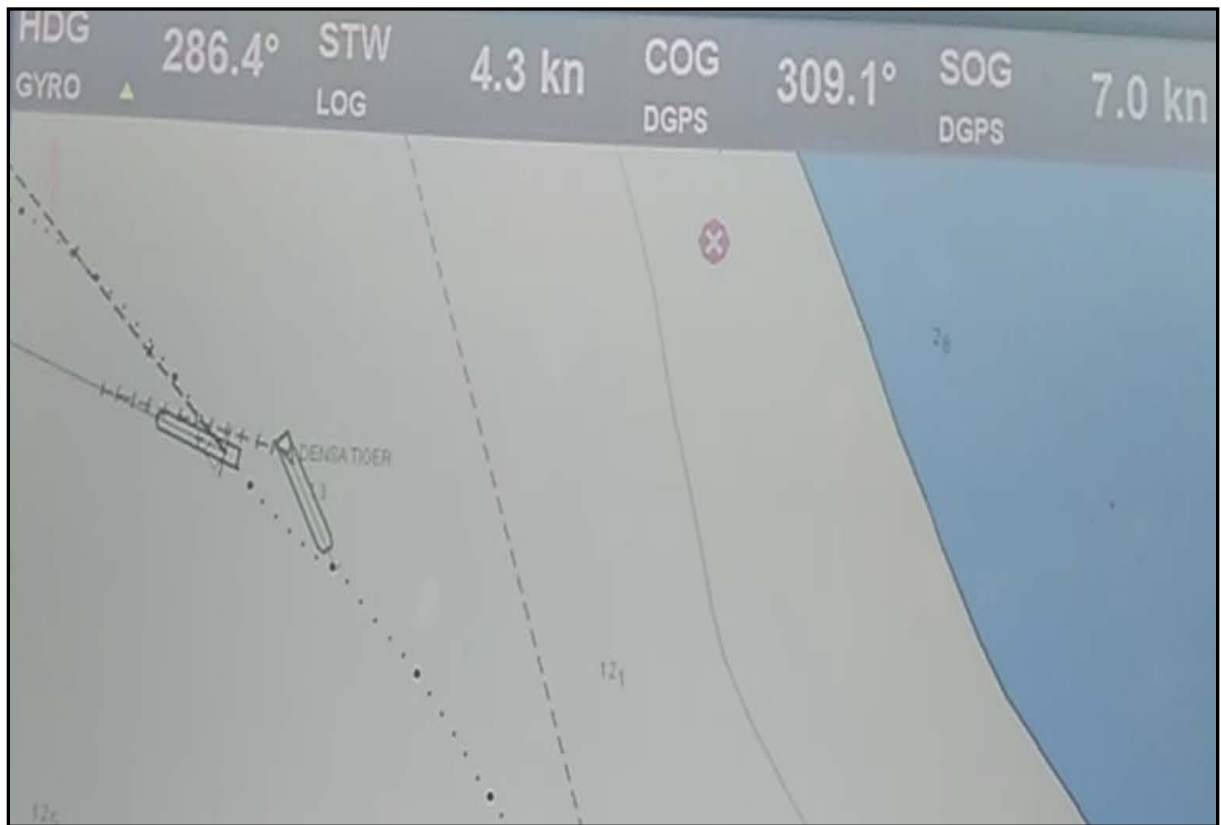
FIGURE 6 ECDIS Playback Position of the NEW LEGACY

The inland cargo barge CHAR SHAMAIL was at the starboard aft side of NEW LEGACY at the time of the contact, and she was crushed between the two vessels resulting in her severe breach to her hull, and causing in her foundering in less than five (5) minutes.
