Report on the Investigation of
The Collision Between
M/F ANKARA and M/V REINA 1

Adriatic Sea/Off Port Durrës
20th October 2011

Report No: 05/2012

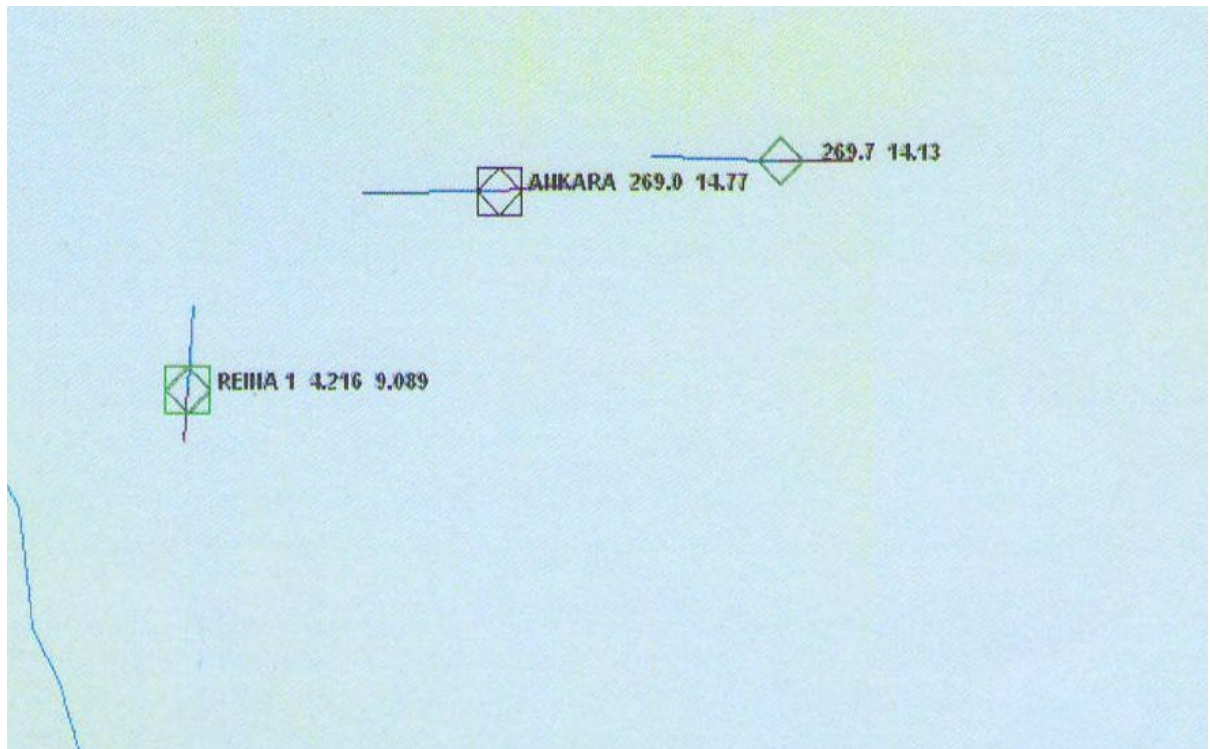
Figure 4: AIS screen display (1)

During his watch, the master of ANKARA had plotted a vessel on the radar, which was at a distance of 14 nm on the port bow. At the time, he was convinced that there wasn't a crossing situation. At approximately 00:20 hours, the look-out drew the master's attention and reported another vessel on the port bow. The vessel was later identified as REINA 1. The master started to monitor REINA 1 using the VRM (variable range marker) and EBL (electronic bearing line).

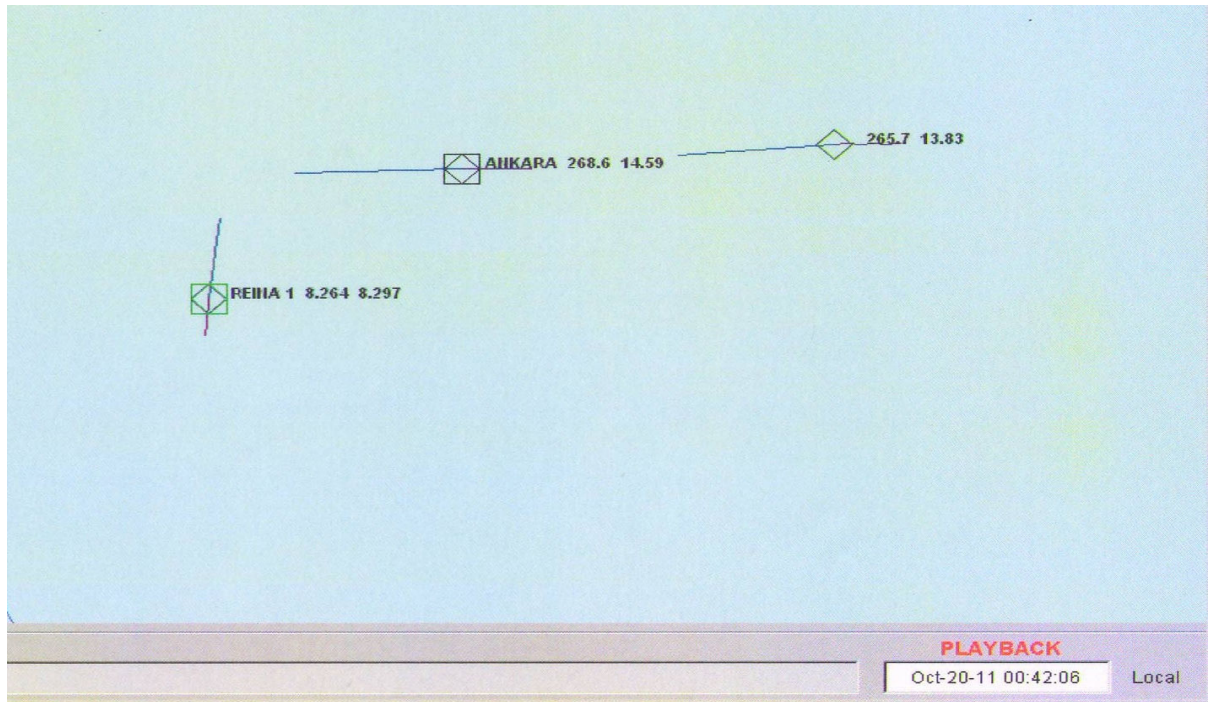
Figure 6: AIS screen shot (2)

Following the VHF communication, ANKARA maintained its course and speed. REINA 1, which initially intended to alter course to starboard side, changed its course to port after the VHF communication, by 8° to 9°.

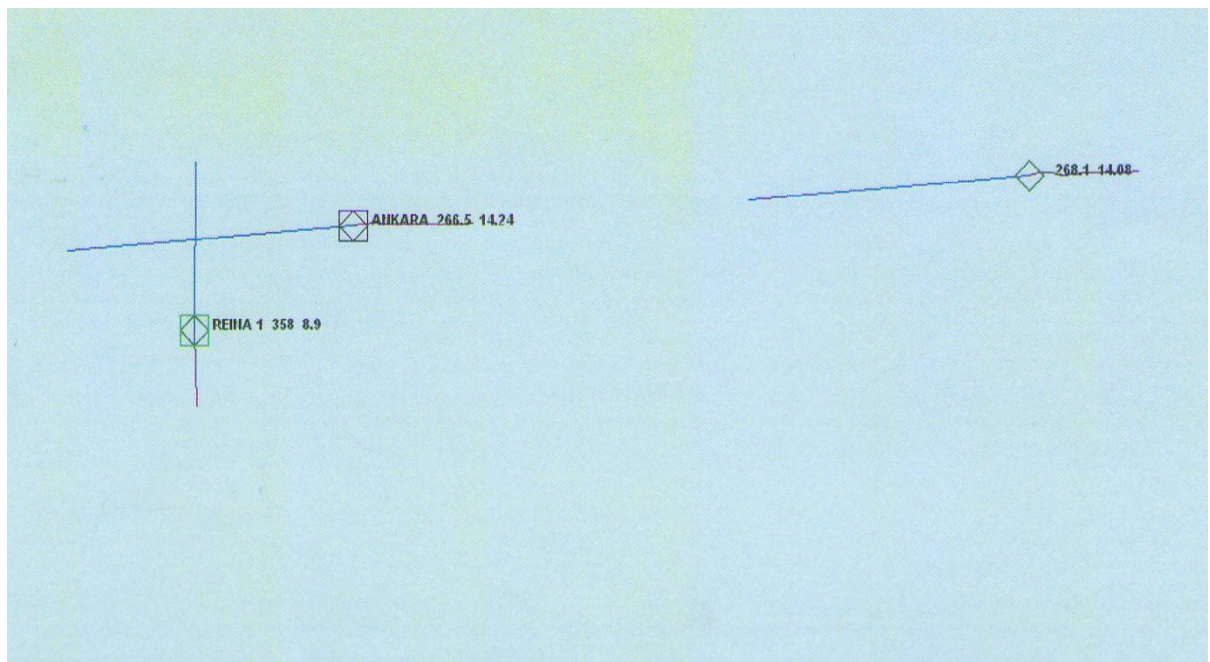
Figure 7: AIS screen shot (3)

At 00:49 hours, when the distance between the two vessels was just one to two cables, the OOW of REINA-1 called ANKARA and in an anxious tone repeated that ANKARA was passing too close. He asked again about the vessel's intentions. Similarly anxious, the master of ANKARA shouted on the VHF that REINA 1 should alter course hard to port. He also altered course to starboard by adjusting the auto pilot. However, distance between the two ships was too small and both vessels could not accomplish their respective manoeuvre. Consequently, ANKARA's bow collided with REINA 1 in way of its side shell plating, just aft of amidships. ANKARA hit REINA 1 at angle of 90°.
