## INTERIM SAFETY INVESTIGATION REPORT

REPORT NO.: 202006/006

### *MV Margarete Schulte* Fatal injury to stevedore in the port of Manzanillo, Panama 10 June 2020

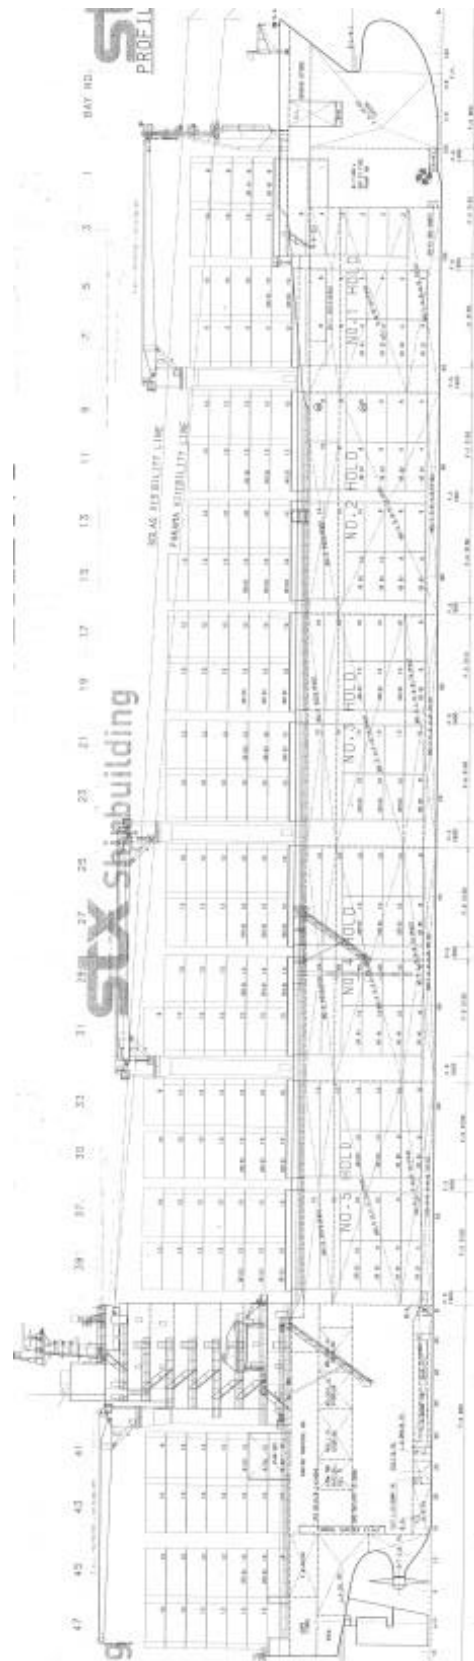
Figure 1: Extract of *Margarete Schulte*'s GA Plan

*Margarete Schulte* was designed to carry containers inside her five cargo holds, located forward of the accommodation, as well as on deck, in bays numbering from 01 to 47. Bay nos. 41 to 47 were located aft of the accommodation. In the lowermost tier (tier 82) of bay 45, only 20-foot containers
