Panama Maritime Authority
Directorate General of Merchant Marine
Maritime Affairs Investigation Department

M/V “BLUE STAR I”
IMO No. 9375159
R-002-2020-DIAM
CASUALTY DATE: 05th October 2019

REPORT ON THE INVESTIGATION OF COLLISION BETWEEN

At Danube River near Tulcea, Romania

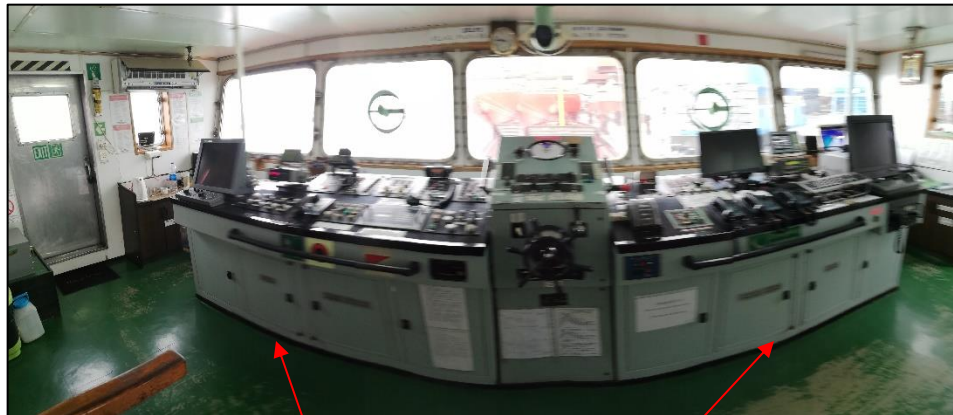
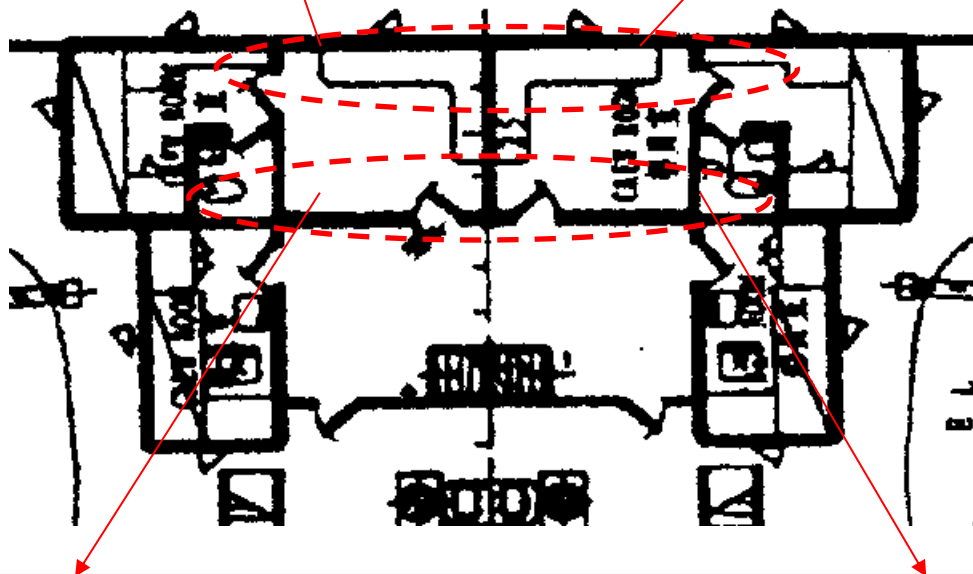
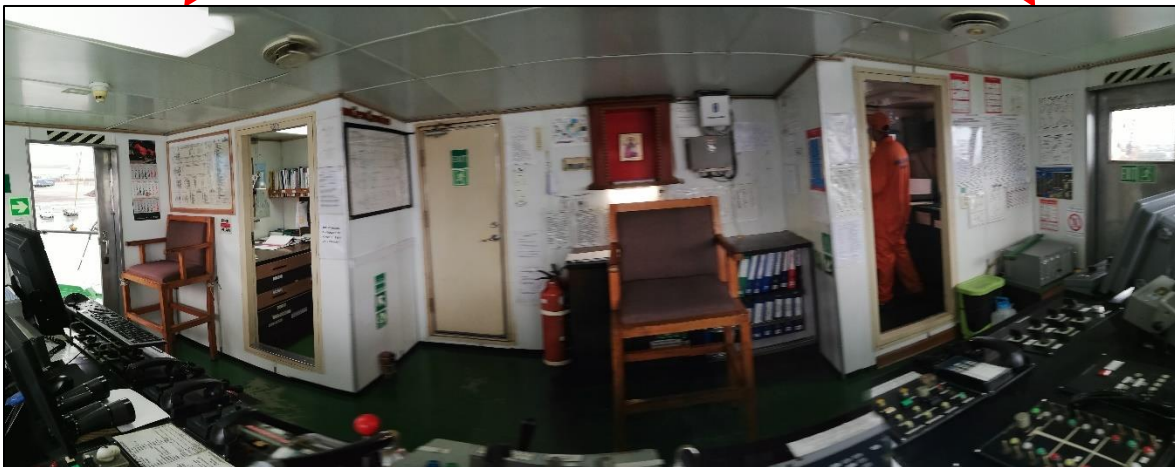
Figure 2.4 – BLUE STAR I Navigational bridge arrangement

- 2.14 On the starboard side, the second radar is fitted as well as the VHF, engine telegraph below the forward windows there is a large radar which partly occupies the visibility outside if looking forward.
