# National Transportation Safety Board

## Marine Accident Brief

### Breakaway of Bulk Carrier *Privocean* and Subsequent Collision with Tanker *Bravo* and Tugboat *Texas*

<b>Accident no.</b>	DCA15LM019
<b>Vessel names</b>	<i>Privocean</i> , <i>Bravo</i> , and <i>Texas</i>
<b>Accident type</b>	Breakaway and collision
<b>Location</b>	Mile* marker 161, Lower Mississippi River, Convent, Louisiana; 30°02.5' N, 90°50.4' W
<b>Date</b>	April 6, 2015
<b>Time</b>	1553 central daylight time (coordinated universal time – 5 hours)
<b>Injuries</b>	Four minor injuries
<b>Damage</b>	Estimated \$11 million
<b>Environmental damage</b>	About 10 barrels of oil
<b>Weather</b>	Clear visibility; southeast winds at 6–7 knots; air temperature 73°F
<b>Waterway information</b>	Lower Mississippi River; high water conditions; current about 5 mph

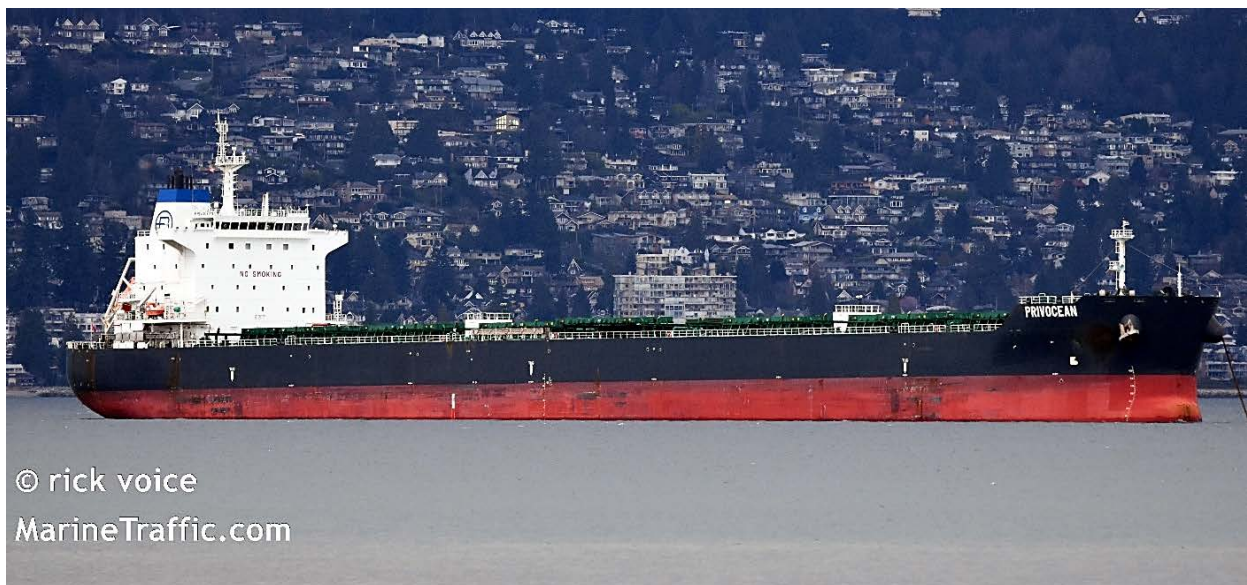
Photo of bulk carrier *Privocean* at anchor. (Photo courtesy of Rick Voice)

Damage to the *Privocean* was estimated at \$250,000 and included inset and scuffed shell plating, internal structural distortions, a fractured and distorted accommodation ladder, and 14 parted mooring lines. Damage to the *Bravo* was estimated at \$1.5 million and included fractured shell plating on three ballast tanks with internal structural damage; inset and buckled shell plating on four other ballast tanks; distorted and broken railings; and damaged cargo, fuel, and drain lines. Additionally, three of the 17 parted stern lines fouled the propeller and had to be

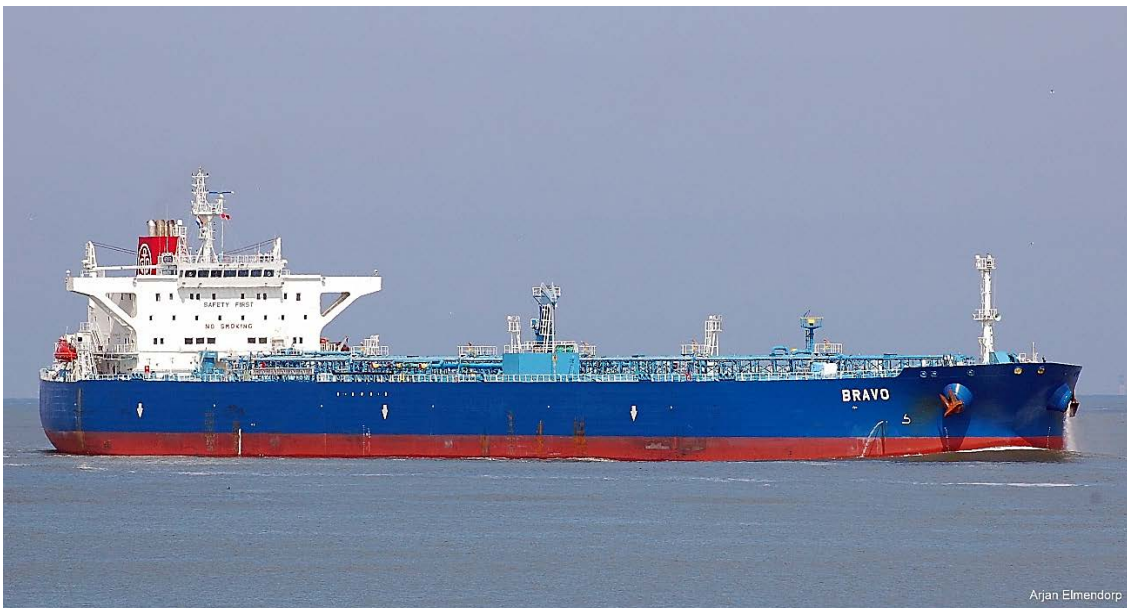
Photo of tanker *Bravo*. (Photo courtesy of Arjan Elmendorp)

cleared by a diver, and the gangway ladder broke and fell into the river. No cargo tanks were damaged in the accident.
