Bundesstelle für Seeunfalluntersuchung
Federal Bureau of Maritime Casualty Investigation
Federal Higher Authority subordinated to the Federal Ministry
of Transport and Digital Infrastructure

Investigation Report 405/20

**Allision with a quay wall by
the tanker NORTHSEA RATIONAL
in Hamburg
on 25 November 2020**

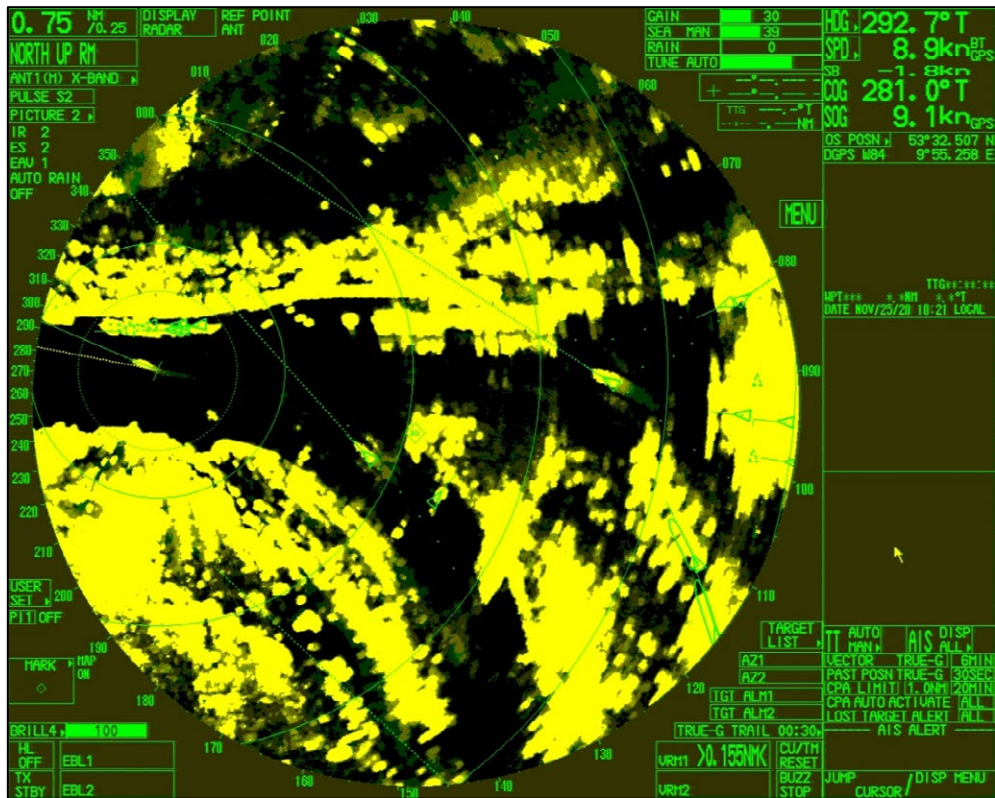
Figure 9: Radar image at 1021, first image

102039	The port pilot apparently notices the starboard tack and recommends "Port ten."	278	9.7
102044	Port pilot: "No autopilot. We keep on hand steering!"		10.3
102046	Port pilot (directed at the second officer): "What are you doing?"	280	9.8
102048	Port pilot: "Port ten!" [The rudder is almost amidships.]	281	9.9
102102	The second officer indicates that the rudder is not responding.	287	10.4
102105	Port pilot: "Long horn! Long blast!"		
102107	Port pilot: "Port 20 the wheel!"	289	10.4
102117	Port pilot: "Long horn, long horn!"	294	10.3
102122	Long signals from the tyfon can be heard.		
102131	Master: "Let go anchor?" Port pilot: "Let go."	302	10.2
102135	Port pilot: "Full astern!"	305	10.3
102142	Port pilot: "Long horn, long horn!"	311	9.6
102150	Port pilot: "Long horn again!"	320	7.4
102210	Allision with quay wall.	330	7.0

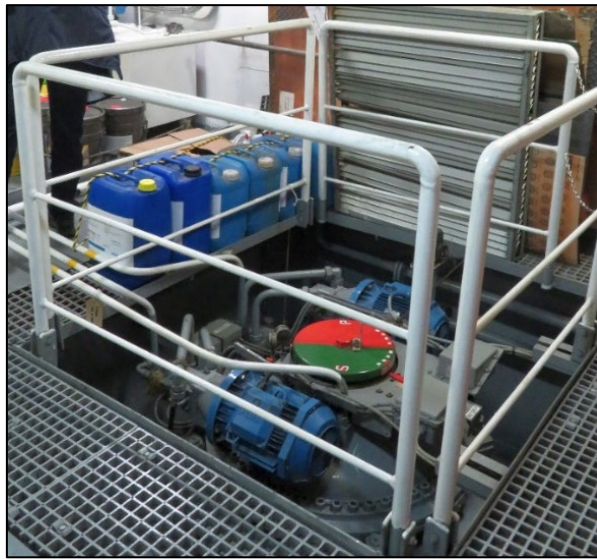
Figure 12: NORTHSEA RATIONAL's steering gear¹⁶

"In the present case, the hydraulic pump units are mounted in a compact manner on the steering gear's housing (see Figures 12 and 13). In accordance with class design regulations, two identical pump units, hydraulically connected in parallel, are provided for reasons of redundancy. The hydraulic system is a closed, controlled circuit, i.e., the

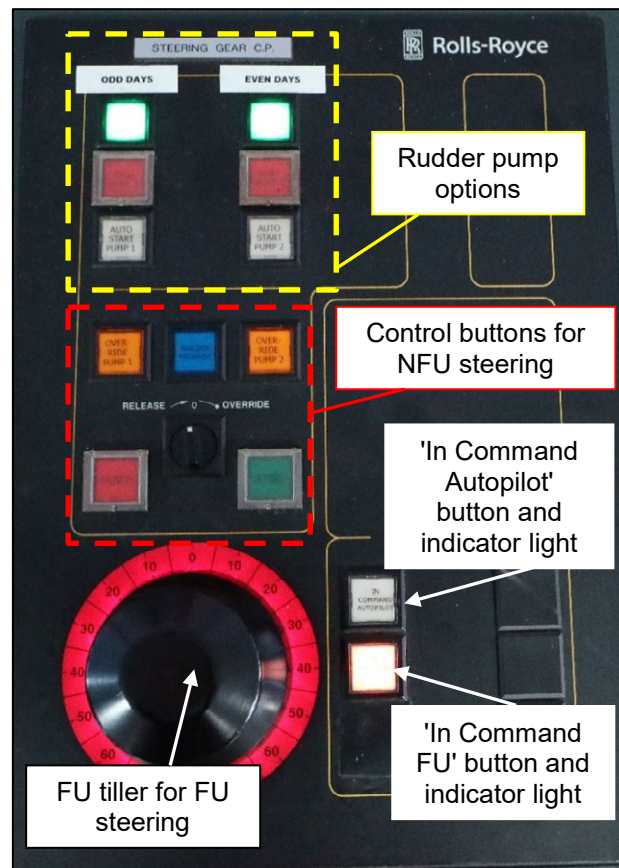
Figure 16: Steering gear control system panel

It was only possible to switch from FU to NFU steering and back on the rudder position control panel in the central console (marked with a red dashed line (---) in Figure 16). FU steering constitutes normal operation. NFU steering is the emergency steering. When NFU steering is switched to, the normal signal path is bypassed. For example, this means that pressing the push-button for starboard directly activates the hydraulic circuit for moving the rudder to starboard. This is also known as the override function.
