Saga Sapphire

SYNOPSIS

At 1020 on 29 March 2012, two crewmen fell 22m into the water from *Saga Sapphire's* No 5 lifeboat while the ship was secured port side alongside in Southampton. They sustained minor injuries.

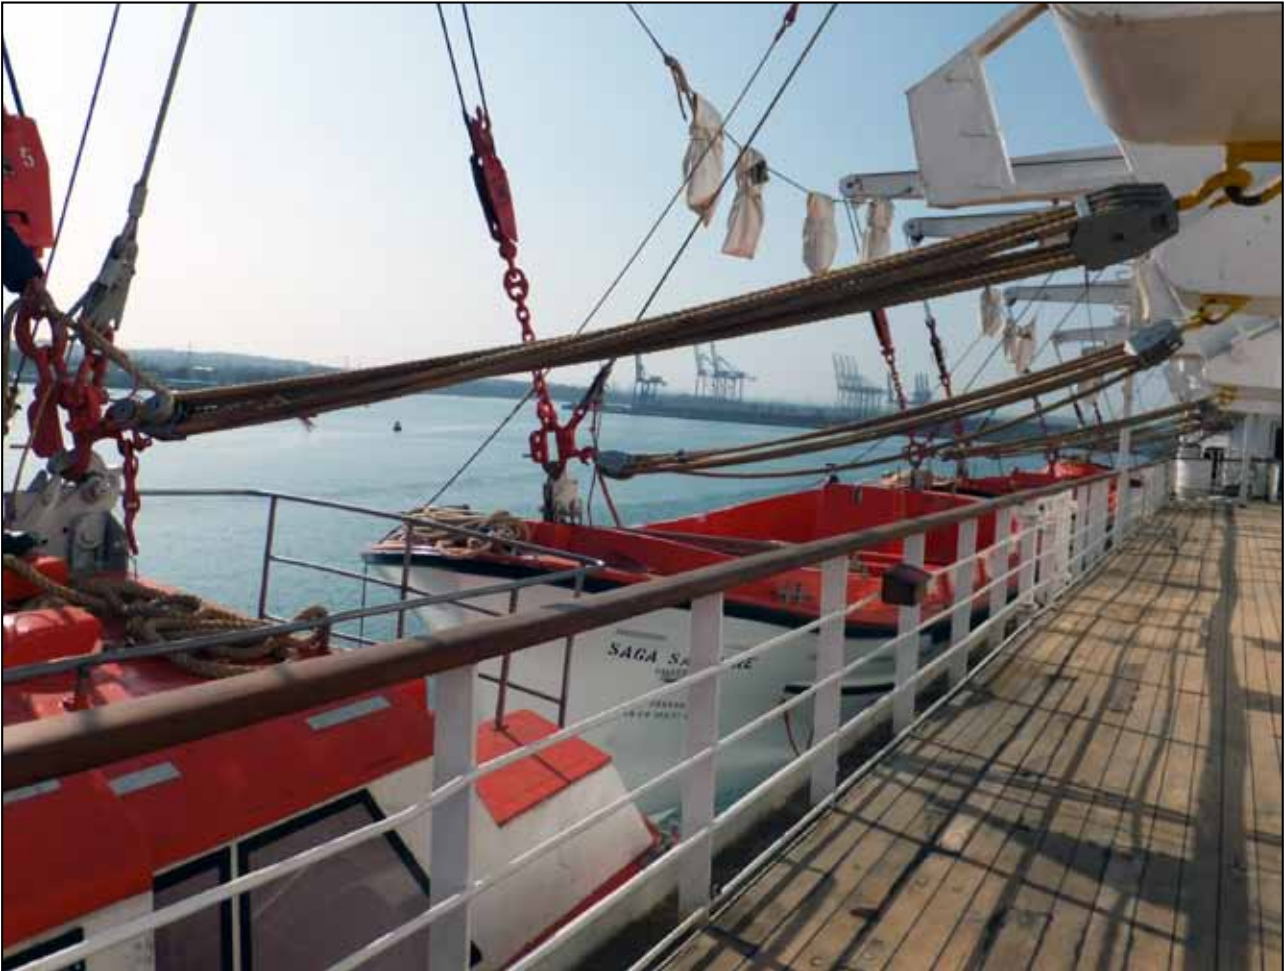
Figure 1: Starboard boat deck

In the meantime, the crew were sent to crew alert stations and the master instructed the fourth officer to proceed to the starboard side of deck 9 (**Figure 1**) to oversee the lifeboat preparations. As the lifeboat preparation teams and "soul counters" arrived, the bosun lowered the two tenders and three lifeboats, which were automatically held at deck level by their respective tricing pennants (**Figure 2**). The two-man lifeboat and tender preparation crews then started to rig their respective fore and aft bousing tackles. This was done under the instructions of the bosun and fourth officer, in readiness to release the tricing pennants, embark the simulated passengers, lower the boats to the water, and release the "on-load" hook to enable the boats to proceed away from the ship under their own power.

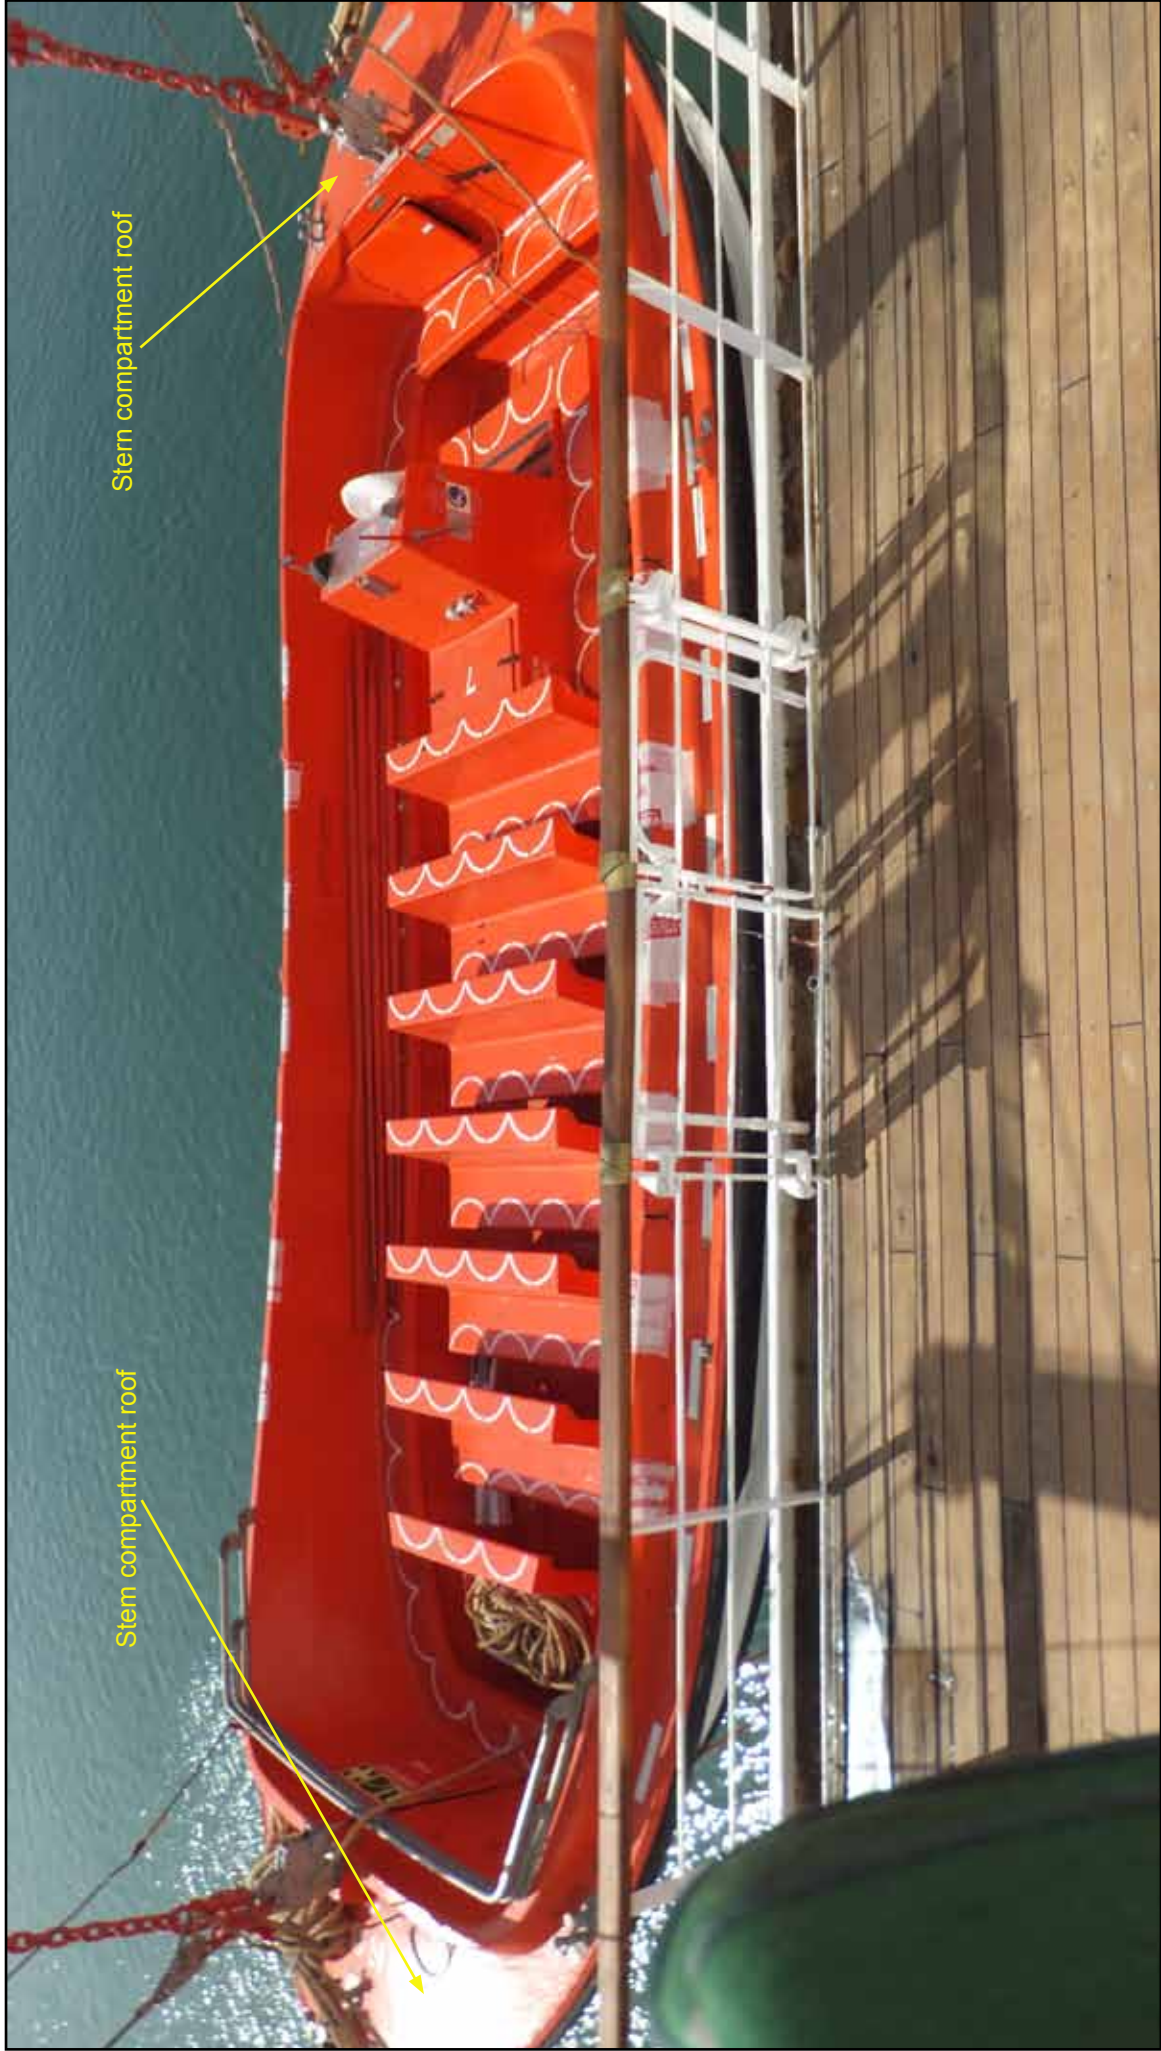
Figure 4: Open lifeboat - access to bowing tackles

To access the bowsing tackle connection points, the lifeboat preparation crews had to stand on top of the tenders' coach roofs (**Figure 3**) and on the top of the open lifeboats' stem and stern compartments (**Figure 4**). While the crews wore safety helmets, safety shoes and solid lifejackets, none of them wore a safety harness and tether.

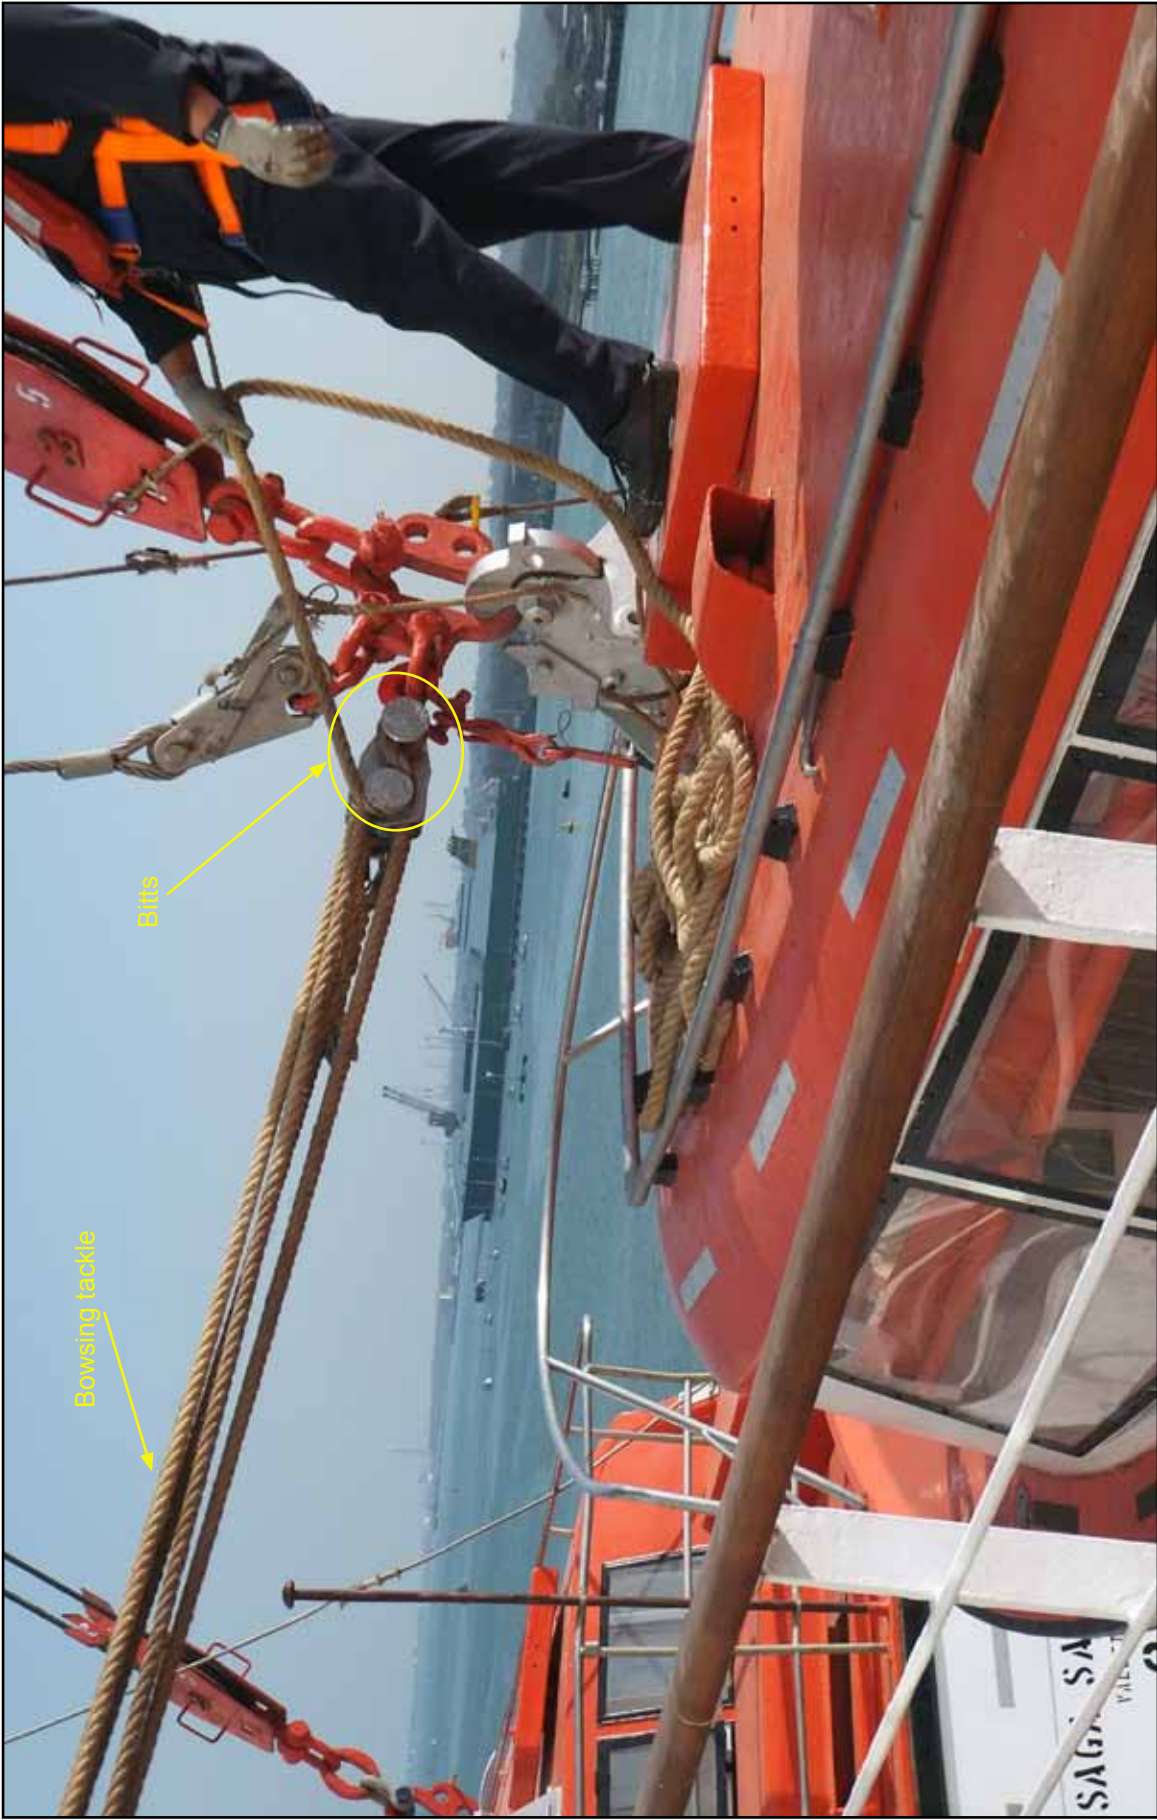
Figure 5: Bowsing tackles secured to bitts

By about 1017, the fourth officer had satisfied himself that all the bowsing tackles had been rigged, tensioned and the ropes secured on the bitts (**Figure 5**). Shortly afterwards, he instructed the lifeboat crews to release their tricing pennants.

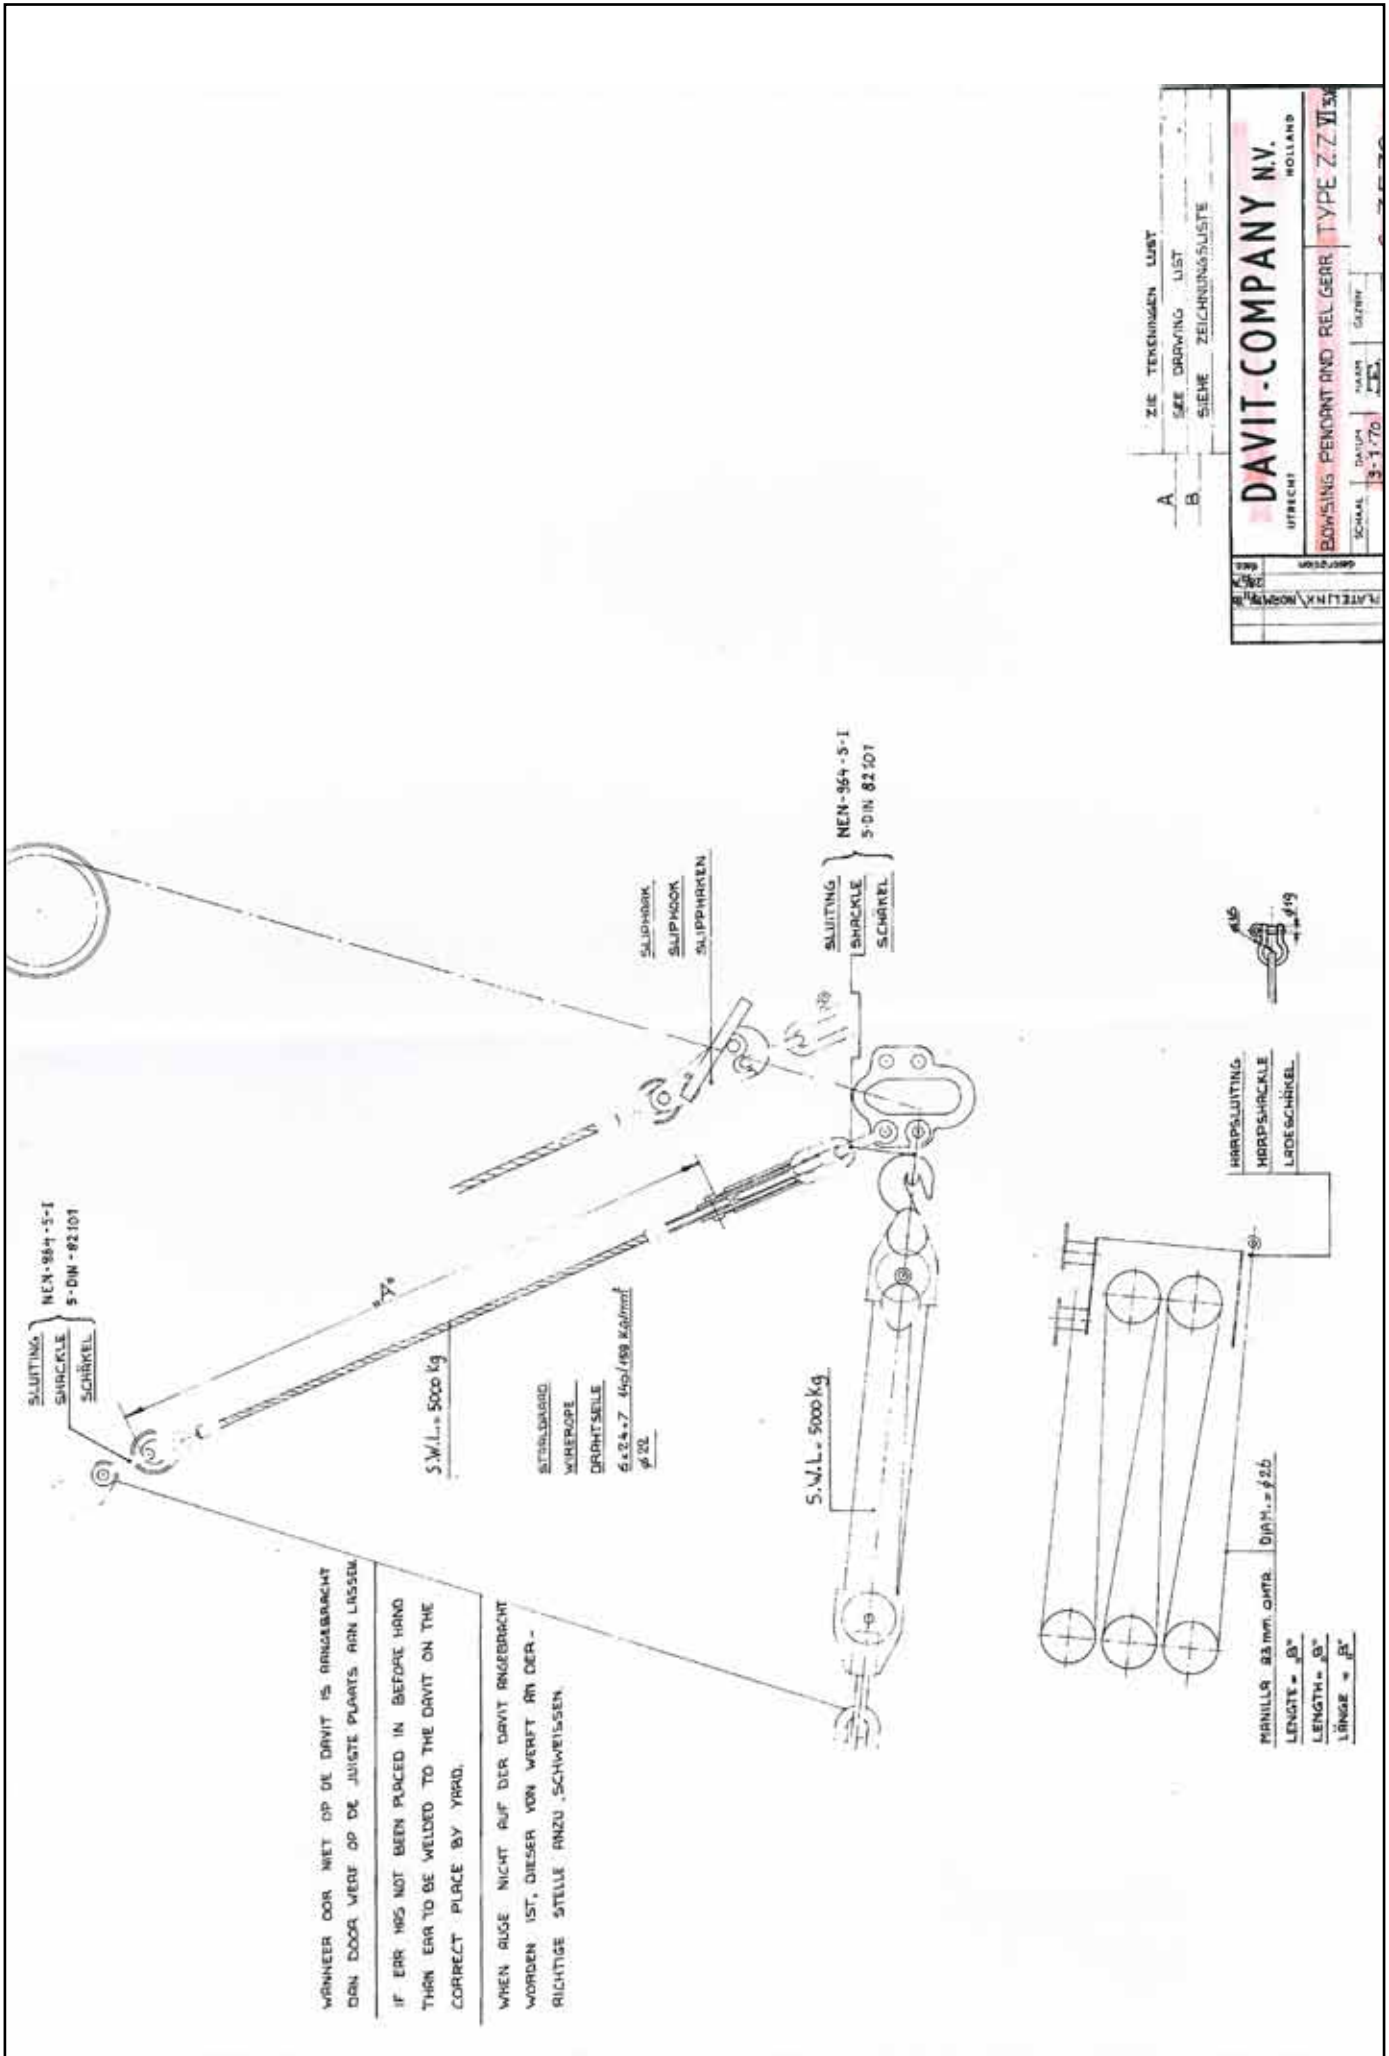
Figure 15: Davit - Company N.V. design drawing C.3570 dated 9 January 1970 - Type Z.Z.V1 Bowsing tackle and tricing pennant arrangement

The original design drawing for the bowsing gyn-tackle arrangement, which includes the tricing pennant, is shown at **Figure 15**. It was designed for a SWL of 5000kg (49kN) and a mechanical advantage of five. During the investigation it was found that the forward bowsing tackle used on No 5 tender was fitted with a 34mm diameter manila rope instead of the designed 26mm diameter manila rope. Only 4 of the 20 bowsing tackle ropes complied with the design dimensional criteria; all of the others exceeded 26mm to varying degrees.

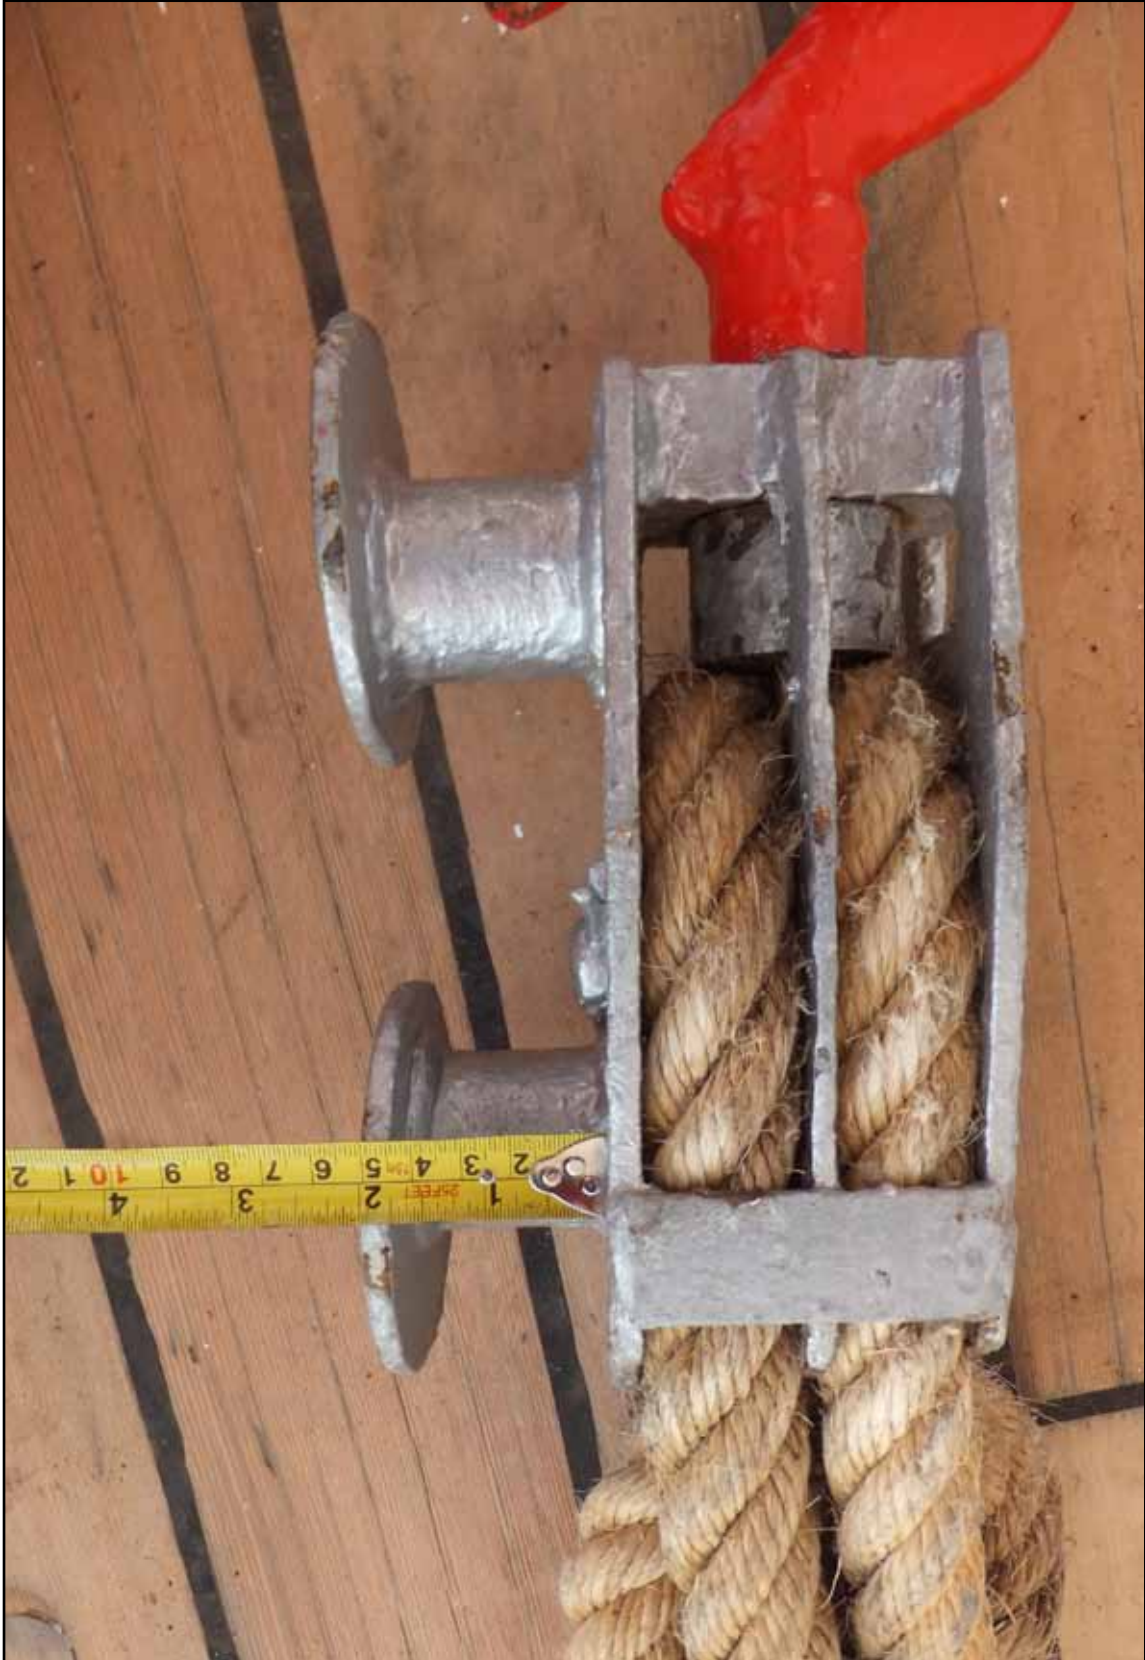
Figure 16: Height of bitts

Securing and control of the bowsing tackle ropes was managed by the lifeboat crew and preparation teams from on board the lifeboats. Once sufficient tension was applied to hold the lifeboat alongside deck 9, the rope was secured in figure-of-eight turns around the bitts welded to the block hooked to the boat's lifting plate link. The bitts were 50mm high from their base to the underside of the cap, and the distance between the inner faces was 80mm. The bitts' dimensions are shown in **Figures 16 and 17**.

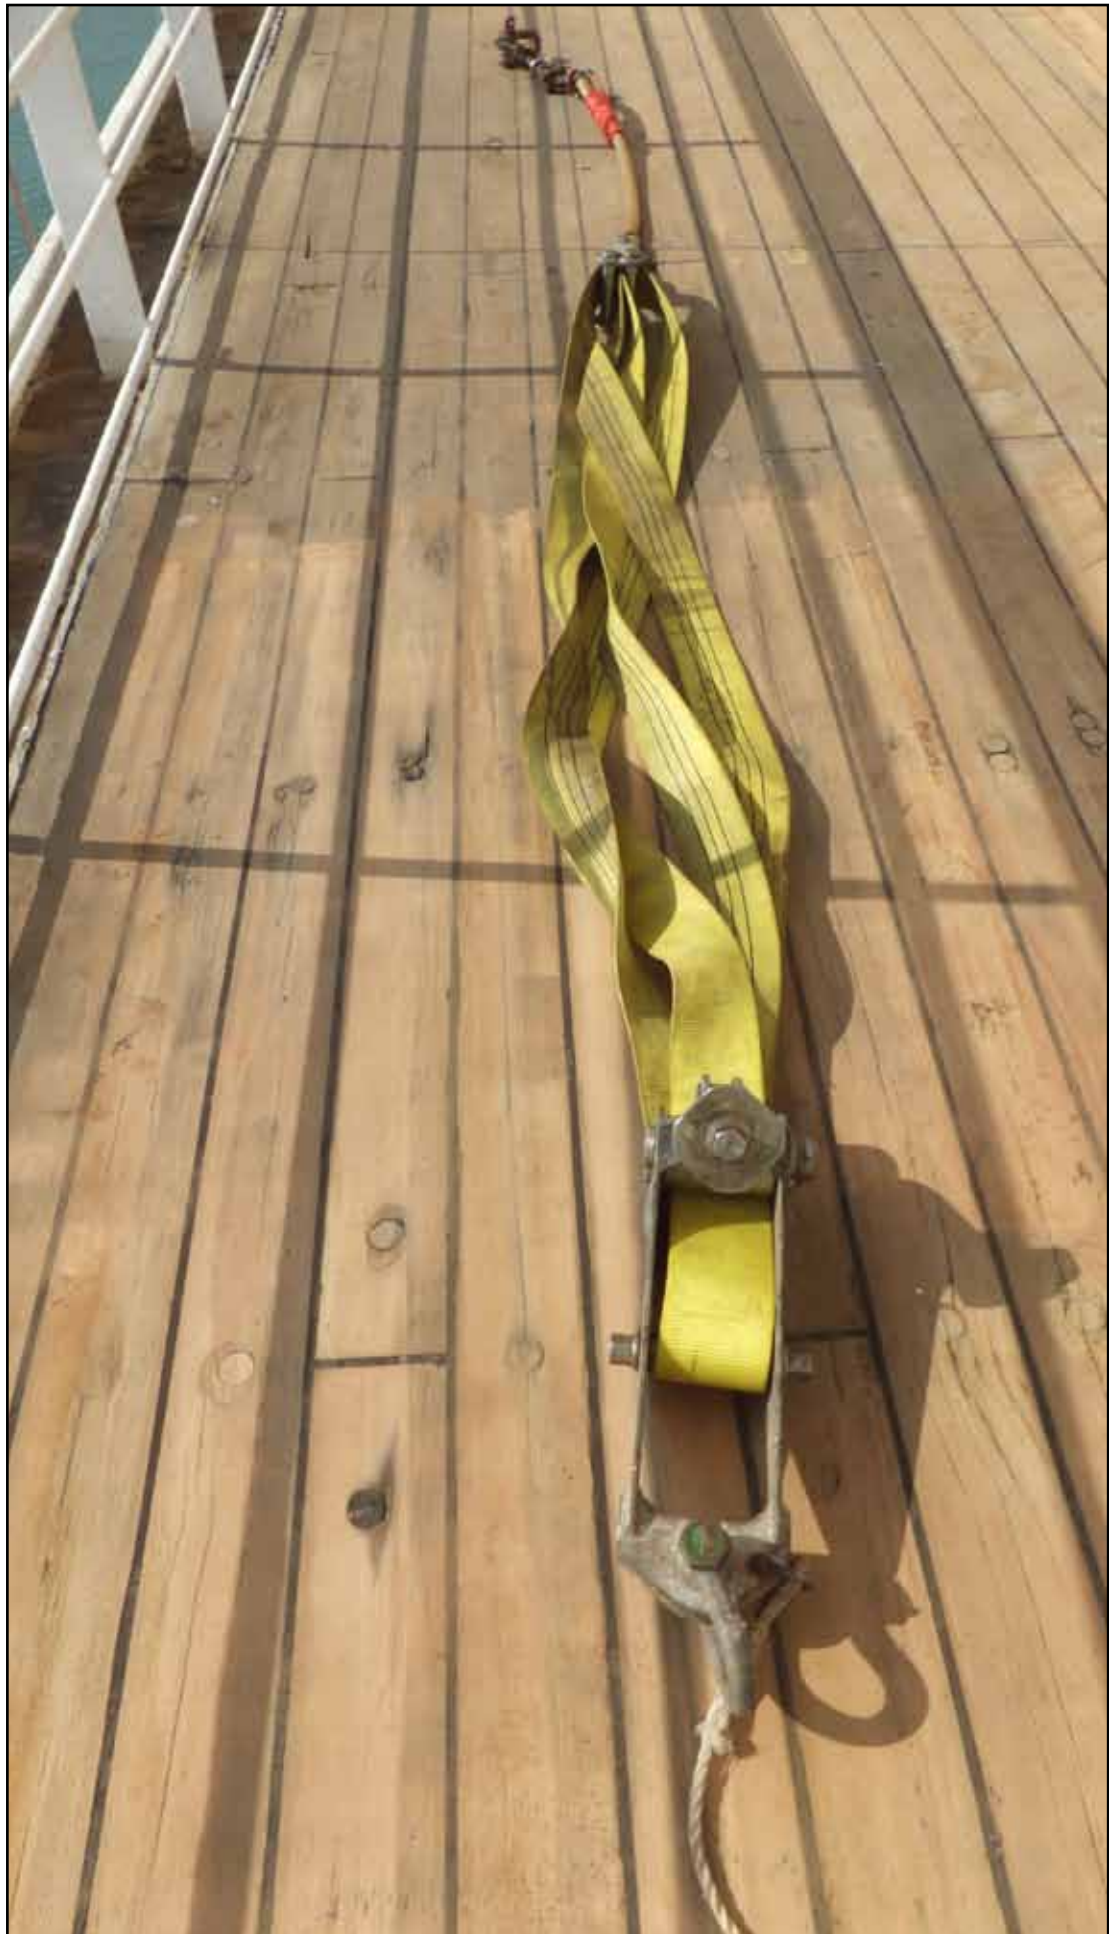
Figure 18: Wire, strap and ratchet bowsing tackle

Pullmantur Ship Management Ltd first managed the ship in May 2004 when she was known as *Holiday Dream*. At that time, until the ship entered refit as the *Bleu de France* on 2 November 2011, a wire, strap and ratchet bowsing tackle arrangement was used on the tender/lifeboat (**Figure 18**). The equipment was still on board when the vessel emerged from refit. Immediately after the lifeboats were brought back on board, the tackles were rigged to the boat. However, the ratchet handles were missing and there were no test certificates or other documentation approving their use or documenting their history. Consequently, it was decided to revert to the original equipment, which was in use at the time of the accident.

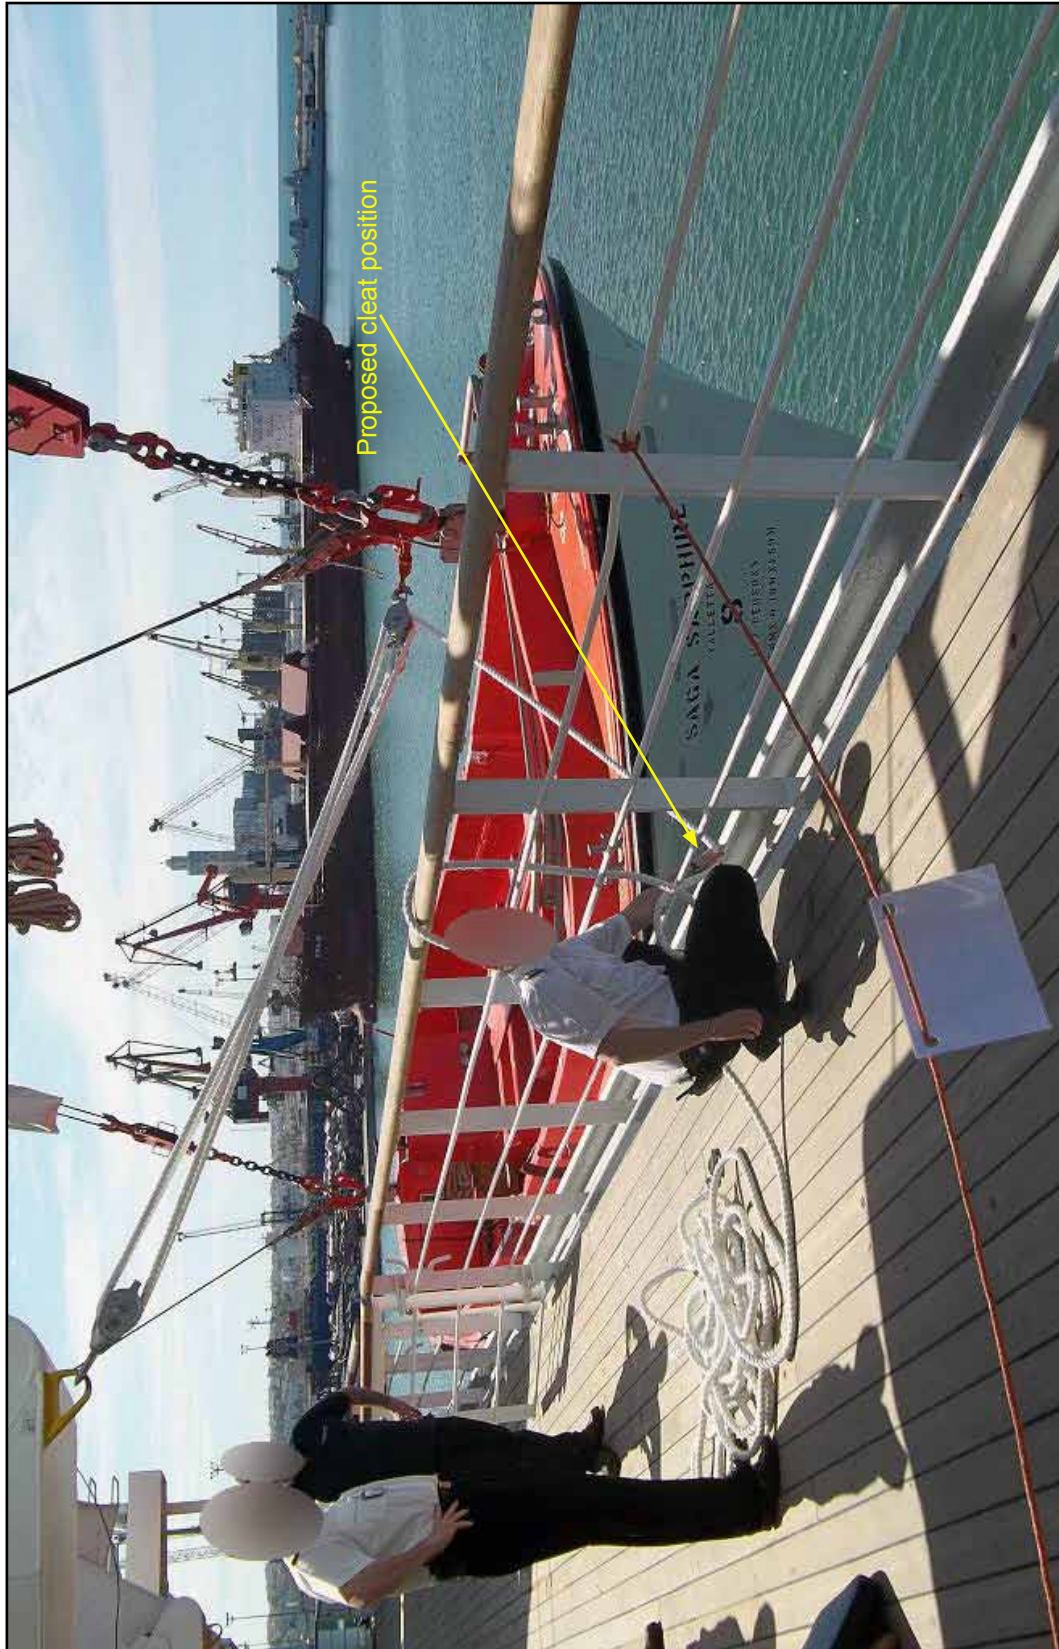
Figure 20: Proposal to use two-fold bowing tackles secured to shear strake cleats

After sailing from Southampton on 3 April, it was decided to use the newly acquired two-fold tackles. The rope securing problem was temporarily overcome by securing the tail around the 10mm bar (known on board as the “yellow bar”), which was welded to the boats’ lifting plate link (**Figure 14**). This method provided a mechanical advantage of four. Acromas subsequently informally suggested to GL that sheer strake cleats be fitted to overcome the tail rope securing issues and to improve the efficiency of the arrangement to a mechanical advantage of five. This would enable the bowsing tackles to be controlled from on board the ship rather than on board the lifeboat. A simulation of the proposal is shown at **Figure 20**.

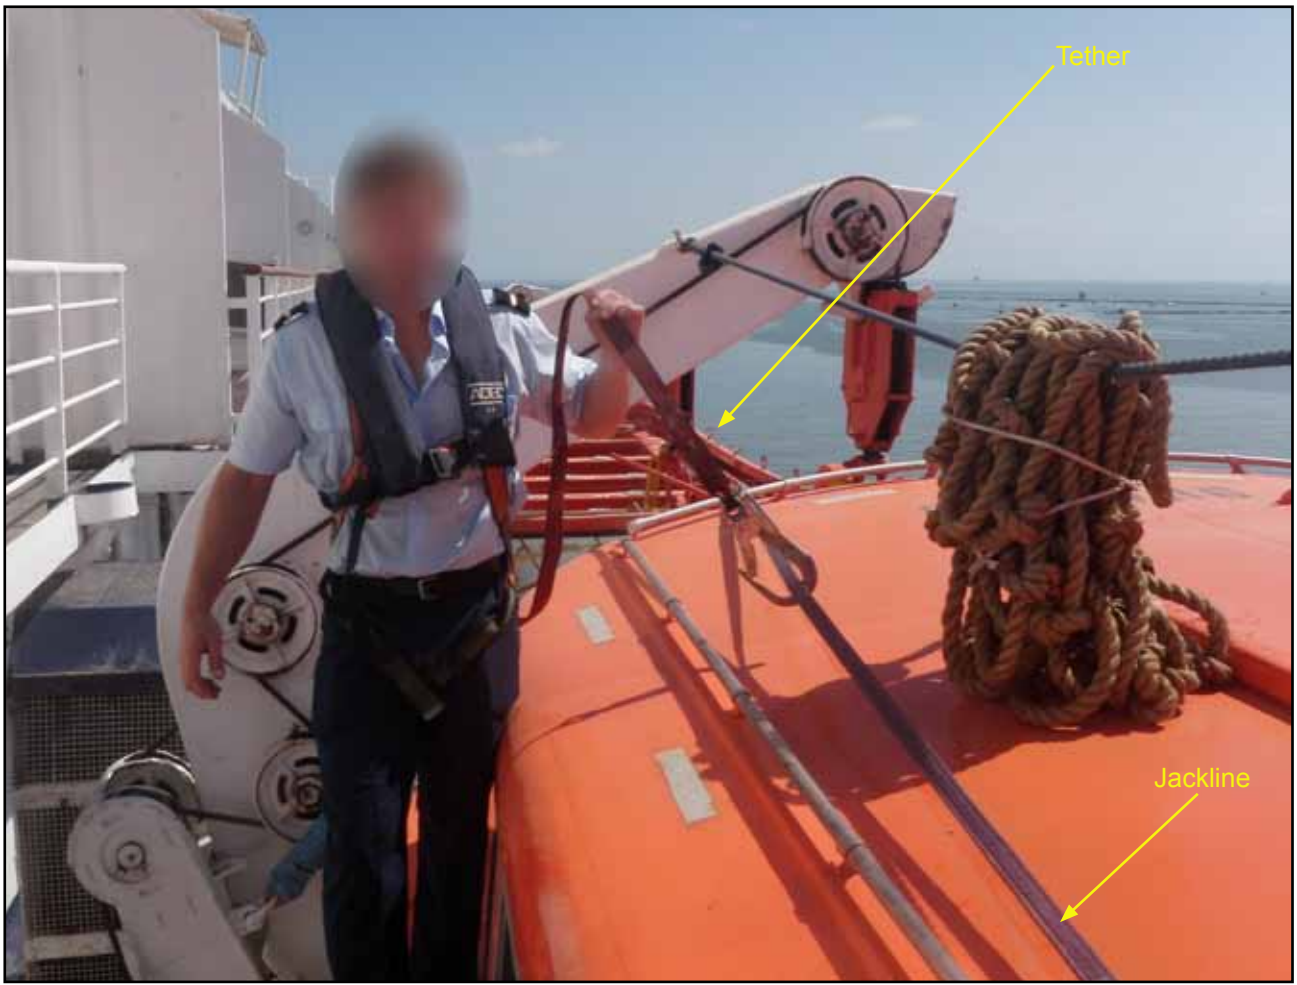
Figure 21: *Saga Ruby's* tender jackline and tether arrangement

Access to the bowsing tackle arrangements fitted to the tenders/lifeboats on board *Saga Ruby* required the lifeboat preparation/ lifeboat crews to climb onto the coach roof. There were no readily accessible strong points on the lifeboats/tenders to which to attach a safety harness tether. To overcome this, webbing jacklines, running fore to aft, were fitted to the glass reinforced plastic (GRP) coach roof to which a safety tether was attached (**Figure 21**). The jacklines were secured to shackles fitted to eyebolts which passed through the roof. The shackles were fitted to the eyebolts with, what appeared to be, a standard nut and bolt arrangement which had been prevented from slackening by a split pin (**Figure 22**). The issues relating to this arrangement are discussed at Section 2.10.
