# **STATE COMMISSION ON MARITIME ACCIDENT INVESTIGATION**

## **FINAL REPORT 54/14**

**M/V MARICHRISTINA**

Grounding of the vessel while approaching the Świnoujście anchorage  
on the day of 11 December 2014

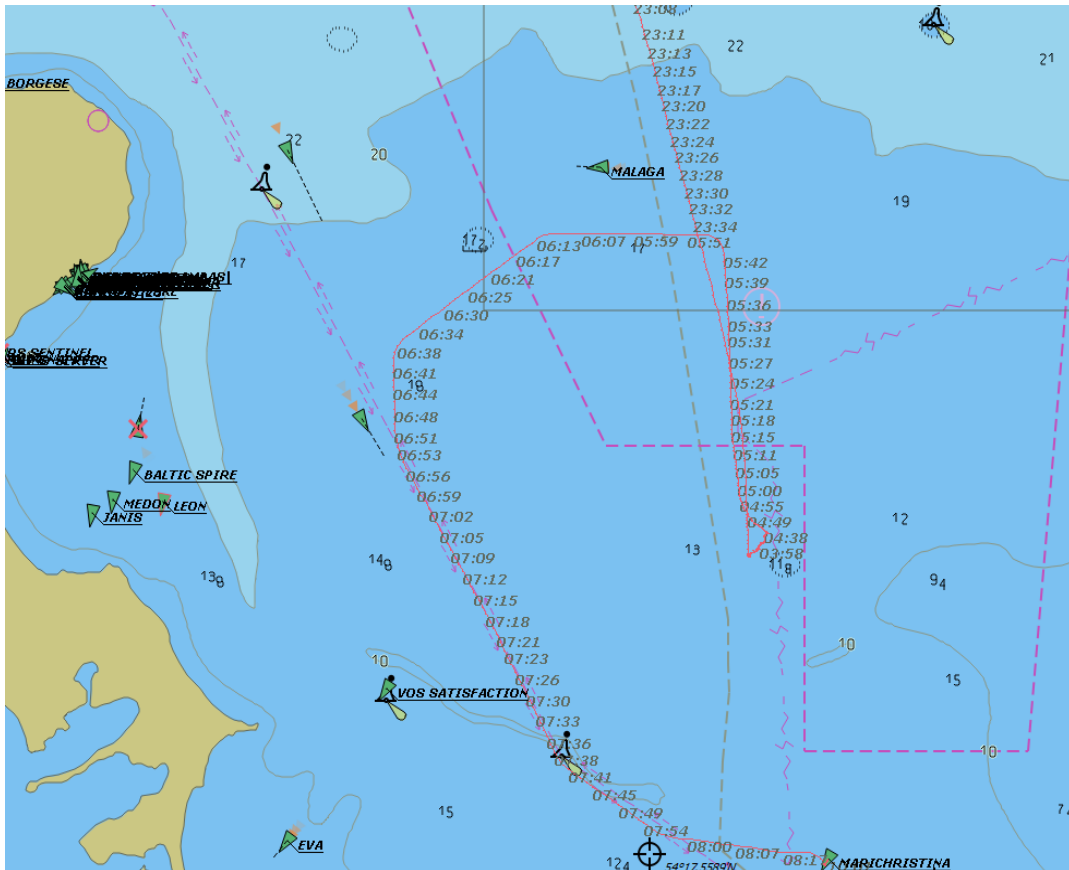
Annex 3: Recording of Marichristina movement registered by SWIBŻ

At 0:15 the speed of the vessel dropped to 3.5 knot. At approximately 00:27:22 the vessel stopped. The crew did not feel that the vessel ran aground. Nothing but the lack of speed on the indicators was observed.

At approximately 02:30 the soundings were completed. On the basis of a sketch of soundings made by the crew it was found that the hull of the vessel was leaning on the ground at the level of the Hold no 2, on the port side (at that point the sounding showed 12.75 m). To make sure that there was no damage to the double bottom tanks on the port side, they were opened and checked for tightness and possible deformations.

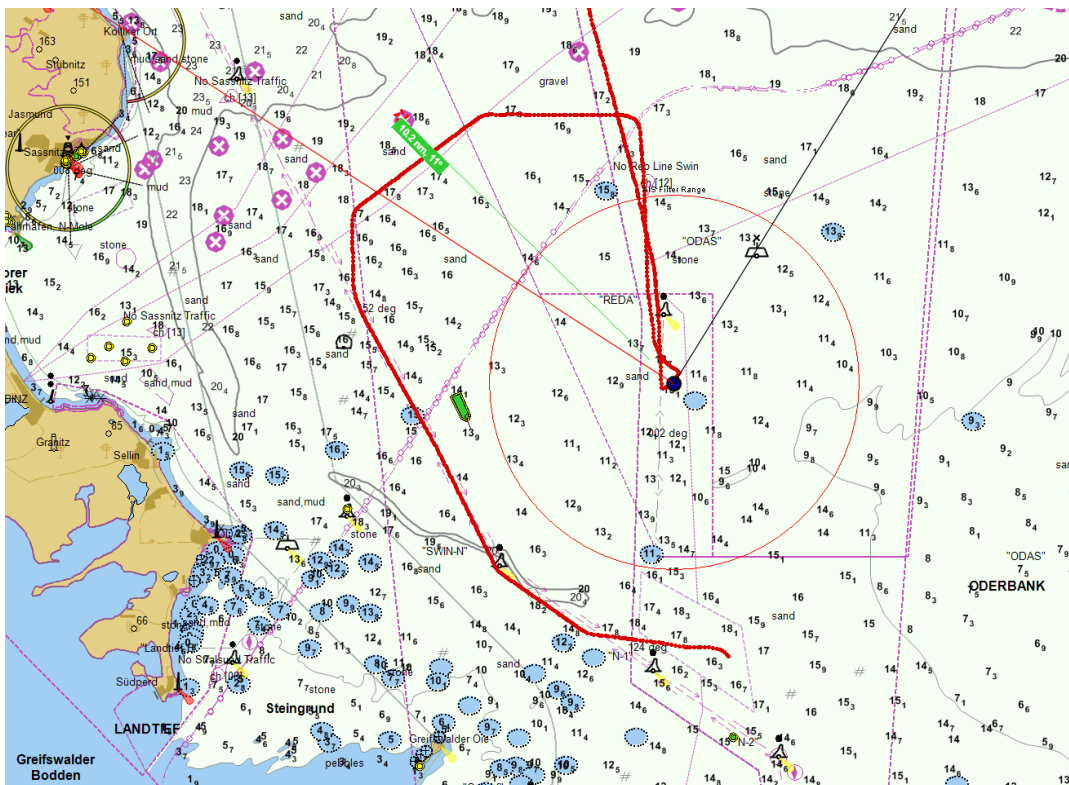
Annex 4: Recording of the vessel's movement from the ship's VDR using the NavCruiser Pro application (electronic chart Waters East of Ruegen DE316004.000)

When the VTS operator saw on the radar screen that the vessel was sailing on the fairway leading directly from the Reda Buoy to the anchorage No. 3, he warned the vessel at 23:49 that it was going into area of shallow water and advised the crew to check the depth on navigational charts they were using; also he recommended that the vessel should approach Świnoujście by a deep water route and then drop anchor at the anchorage No. 3. The watch officer confirmed that he would check the charts and that the vessel should go by a deep water route.

At 00:36 the watch officer at the command of the master called out the VTS Świnoujście and reiterated that the vessel *“stopped because of the shallow water”*. He informed that the crew would conduct surveys of depth around the hull. The VTS operator accepted the information and asked for confirmation that he had previously warned of the shallow water in front of the vessel on its course and recommended that the vessel should have kept the deep water route. The watch officer confirmed and repeated after the master that it was so and that *“the vessel was approaching by a deep water route”*.
