REPORT: M/V “CARNIVAL GLORY”

R-022-2020-DIAM

Casualty Date: DECEMBER 20th, 2019

**MARINE INVESTIGATION
REPORT
COLLISION BETWEEN
MV “CARNIVAL GLORY”
&
MV “CARNIVAL LEGEND”
At COZUMEL, MEXICO**

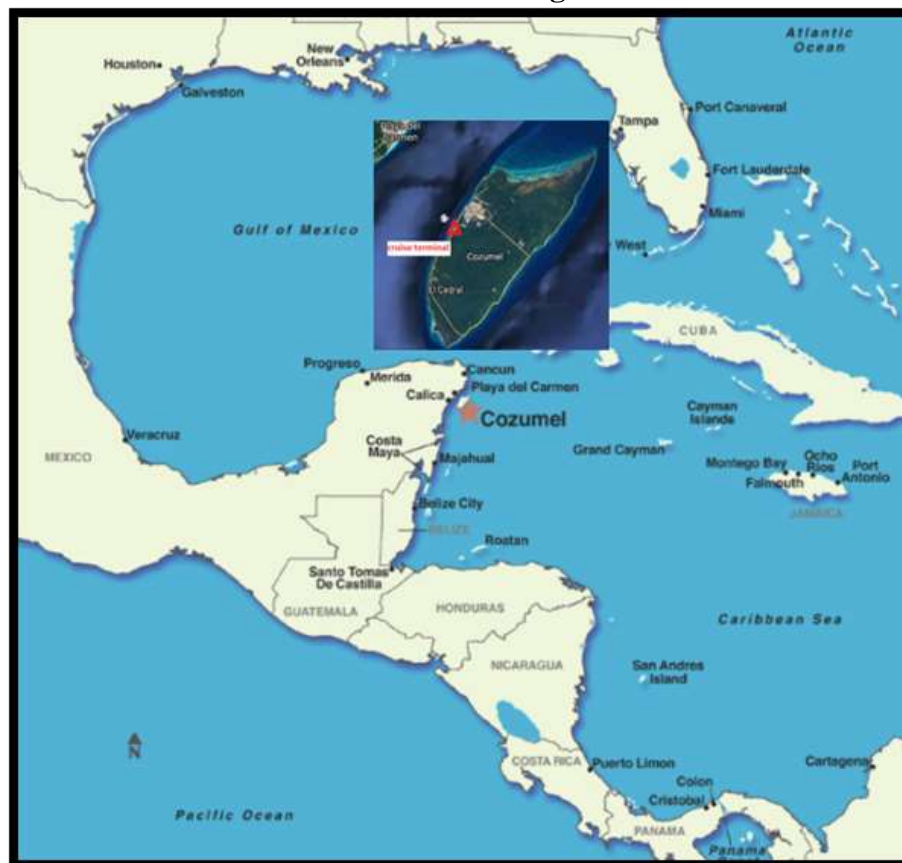
Figure 5: Accident location. (Background source: Google Maps)

**During the berthing maneuvering operation on December 20th 2019
At Puerto maya, Cozumel Mexico (figure 5 , 5.1, 5.2 and 5.3)**

Wind 340°/20 kts gusting to 25 kts. & current NNE with a speed between 0.5 to 2 knots and increasing.

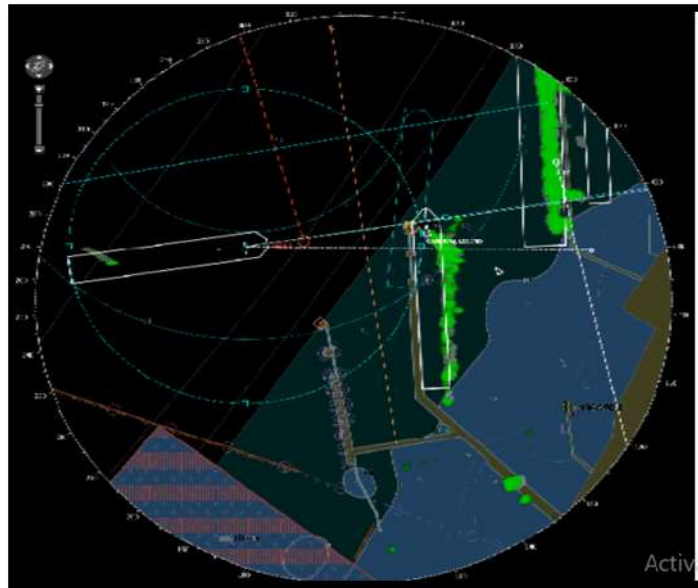
Figure during sequence - Figure 9.

At 07:42:05, The captain said, “The current is pushing to north. The navigator replied, “We should increase it (ROT) to port.” The navigator set the bow thrusters full to port.

At 07:42:10, The OD stated the vessel’s position prediction set at 4 minutes did not look good. No one in the bridge team acknowledged.

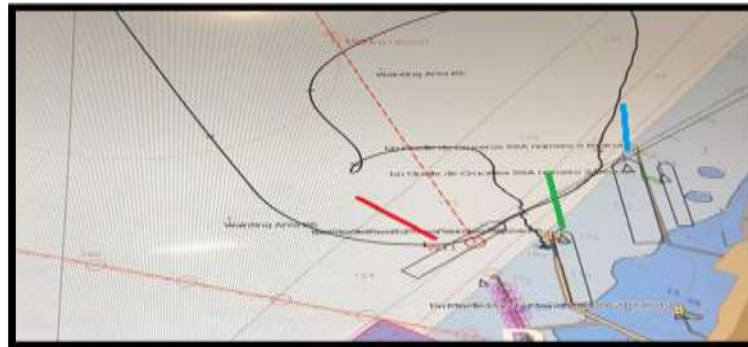
Figure during sequence - Figure 11.

At 07:44:00 Captain asked the Mooring aft if we are clear. The Navigator answered: we are not clear.

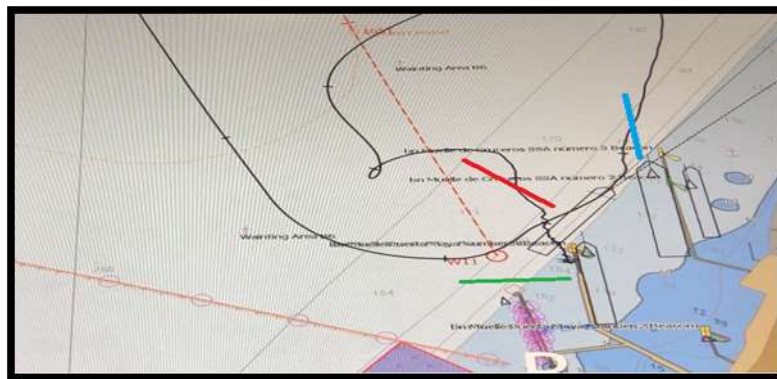
Figure during sequence - Figure 15

At 07:45:25, The navigator stated, “We are not clearing station 2”. The bridge team did not acknowledge.

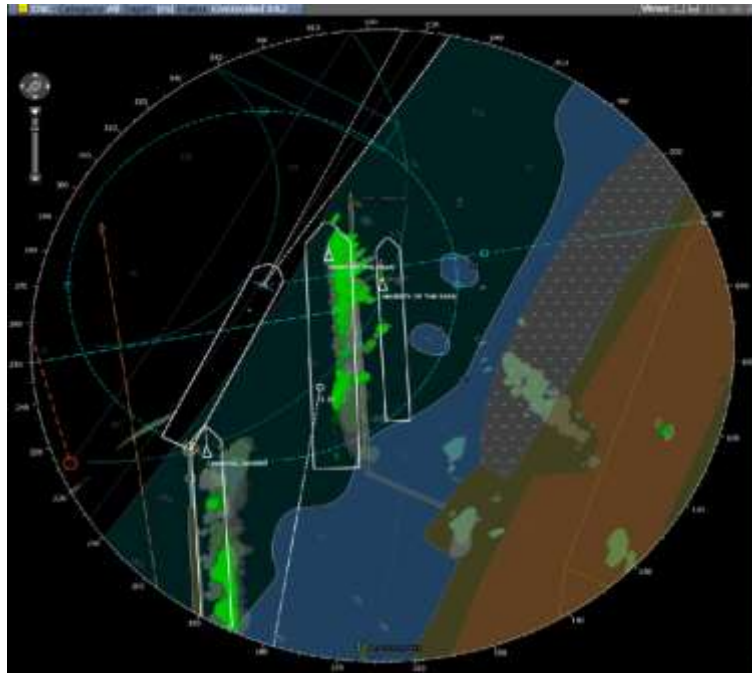
Figure during sequence - Figure 19

At 07:45:50 The navigator called station 2 and station 2 reported the stern was getting closer to the Carnival Legend. The bridge team did not acknowledge.

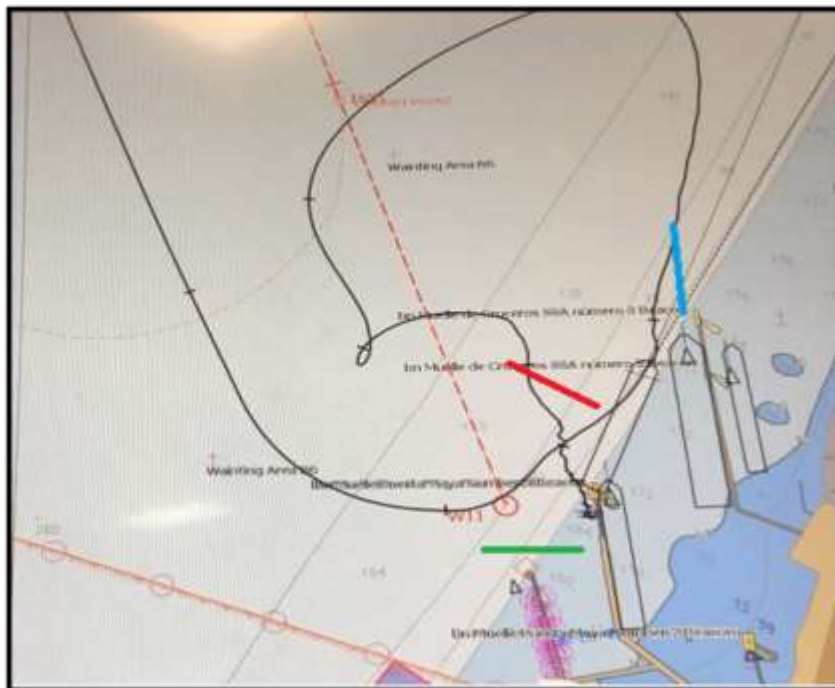
Figure during sequence - Figure 20.

07:46:00 STBD quarter collided with the Carnival Legend Bow. The Bridge Team, at this point, did not realize of the impact with the Carnival Legend.
