Final Report

Man Overboard

Supply Vessel LEO 38

And Tanker AGIOS NIKOLAS

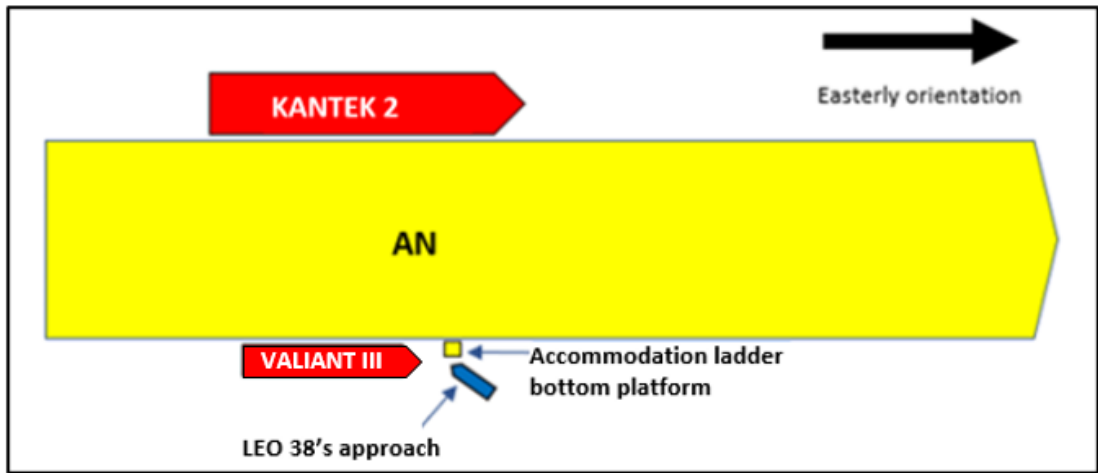
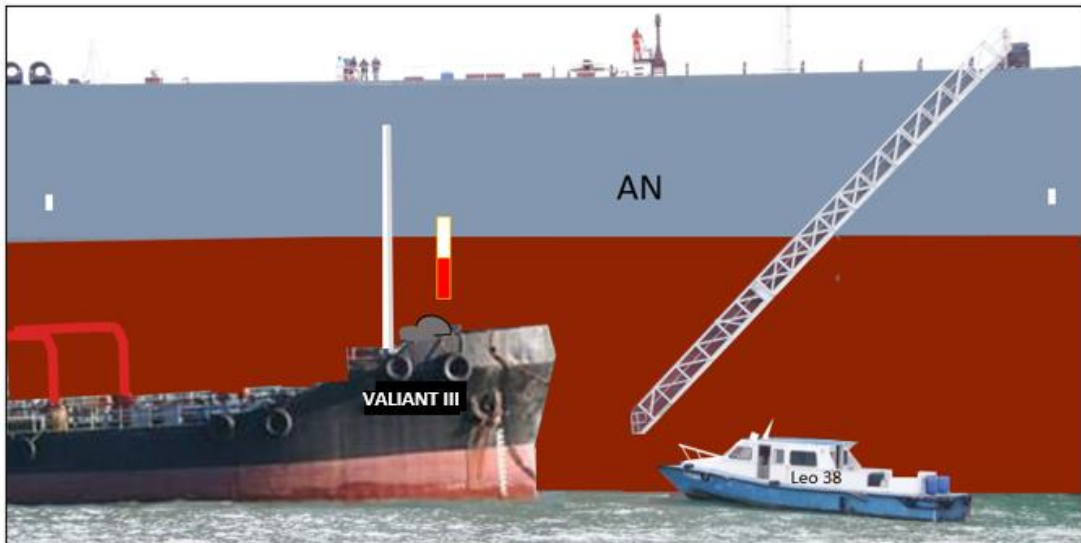
Figure 3 – Plan view of graphical representation of vessels involved and LEO 38's approach (Not to scale).

1.1.4 After rounding off the bow, the Skipper noted that AN's starboard side had another bunker barge, the VALIANT III secured alongside, with its bow about

2-3m aft of the bottom platform of the accommodation ladder. See **figures 3 and 4**. The accommodation ladder was used instead of a combination ladder.

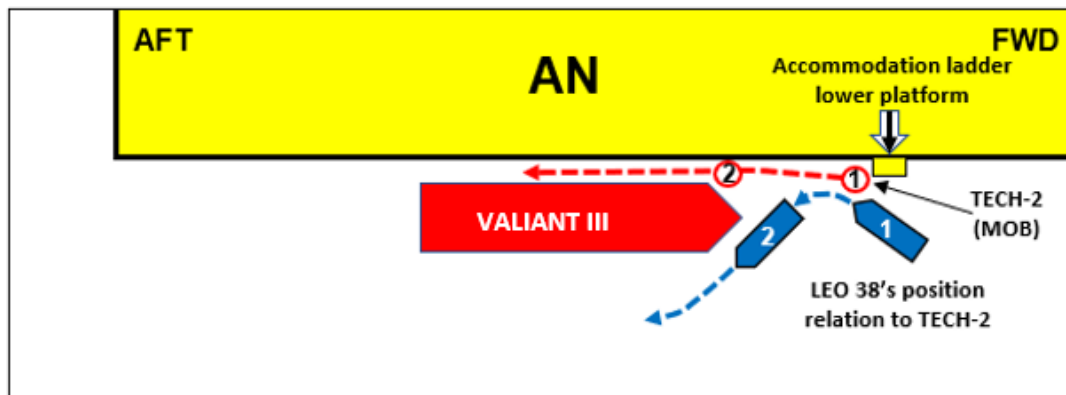
Figure 7 - Depicting LEO 38's positions in relation to TECH-2's drifting (Not to scale)

- 1.1.15 Meanwhile, TECH-3 seeing the occurrence during his descent, also shouted MOB. TECH-3 then ran up the accommodation ladder and requested the crew of AN for assistance. During this time, TECH-3 saw TECH-2 was drifting between AN and Valiant III.
- 1.1.16 The Skipper instructed TECH-1 to grab a lifebuoy from the aft part of the boat and throw it to TECH-2, as he manoeuvred LEO 38 towards TECH-2 while keeping clear of the accommodation ladder and the bow of VALIANT III. TECH-1 threw the lifebuoy to TECH-2, who was conscious, but TECH-2 did not grab it (See **figure 7**).

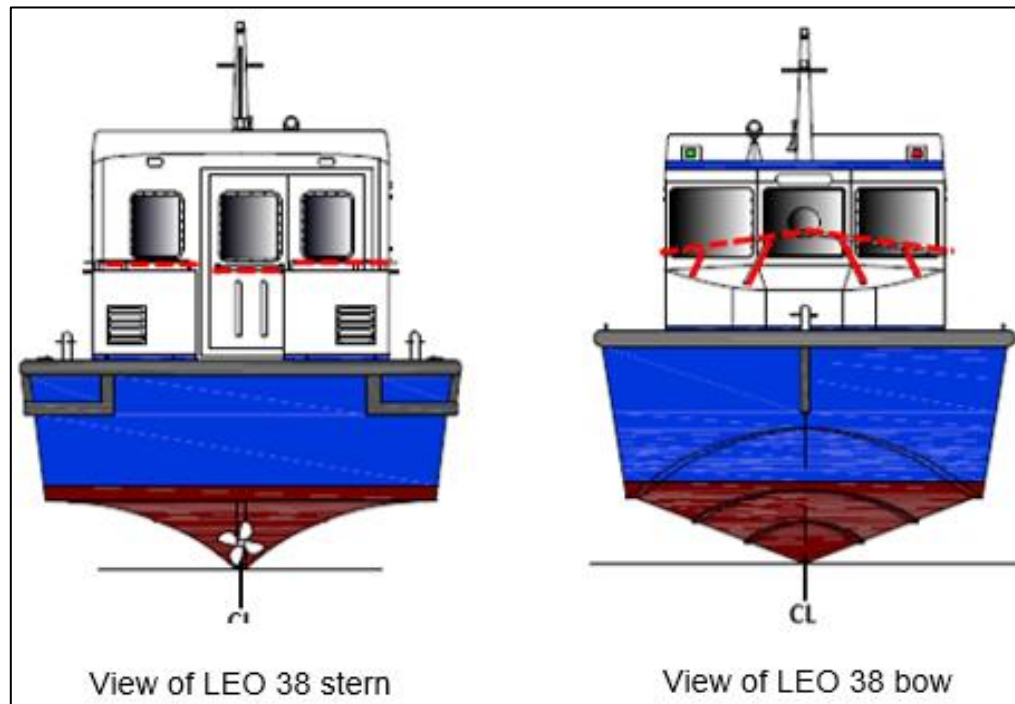
Figure 9 – Bow and stern view. (Source: Owner of LEO 38 — annotation by TSIB)

1.3.1.2 The investigation team boarded LEO 38 at Marina South Pier and noted that, for access and to move around the boat, continuous handrails are provided in most areas, see **figures 9, 10 and 11** – depicting the location of two lifebuoys²¹, red dashed line indicating handrails and highlighted yellow indicating the main deck of the boat being coated with anti-slip paint.

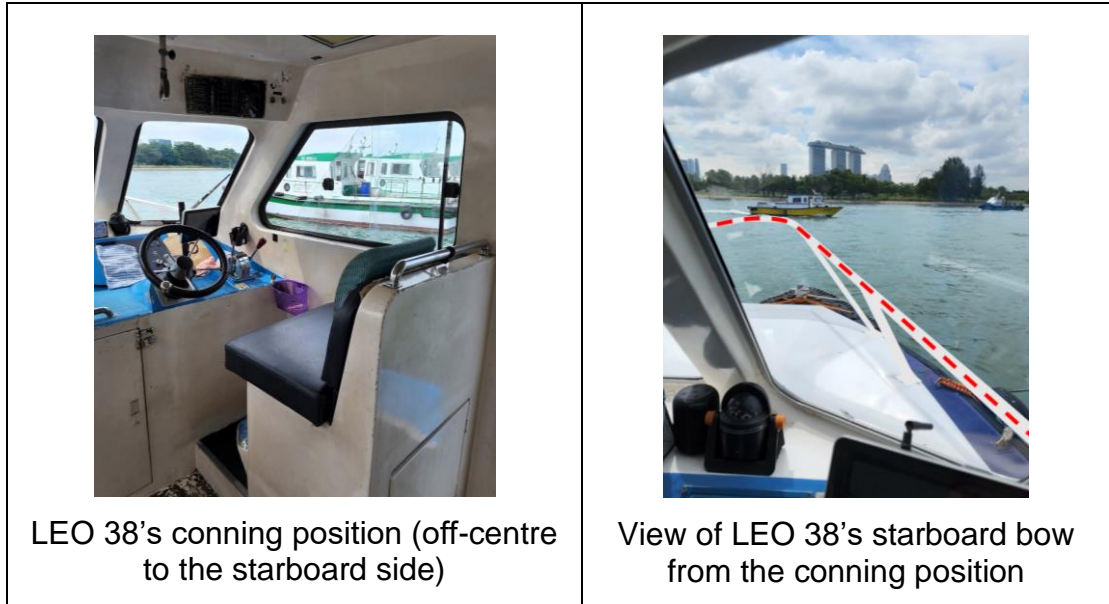
Figure 12 - Showing view of and from the conning position. (Source: Owner of LEO 38 - annotation by TSIB)

1.3.1.3 According to the Skipper, the conning position of the boat (located closer to the boat's starboard side) has an unobstructed view of the starboard bow (the location from where TECH-2 fell overboard). From the conning position, the Skipper could see the accommodation ladder's bottom platform clearly. At the time of the occurrence, LEO 38 was operated by the Skipper alone²².

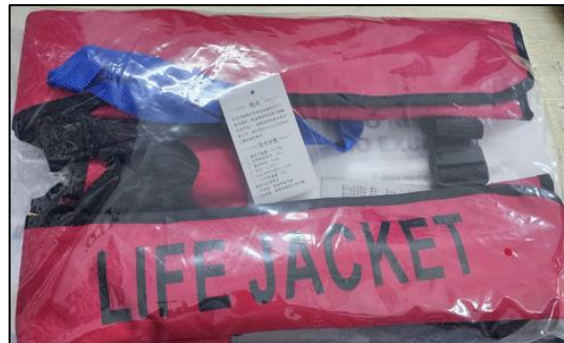
Figure 17 – Lifejacket⁴⁰ sold by the local vendor (current stock)

- (i) The local seller kept only manual lifejackets (see **figure 17**), and the method of inflation would be made known to the buyer at the point of sale.
