## FINAL MARINE SAFETY INVESTIGATION REPORT ON A SERIOUS MARINE CASUALTY

VESSEL NAME / IMO NO : M/T TORC / 9544683  
FLAG OF THE VESSEL : Malta  
CALL SIGN : 9HA2351  
LOCATION OF CASUALTY : Port Of Bandırma Çelebi / Balıkesir  
DATE AND TIME OF MARINE : 28/08/2022 / 17:00 (LT) (GMT +3)  
CASUALTY  
DEAD / INJURED : - / 2  
DAMAGE DEGREE : The burner, which had become unusable,  
was replaced, and the thermal oil boiler was  
repaired and put into operation upon class  
approval.  
ENVIRONMENT POLLUTION : None

*Board Decision No: 15 / D-07 / 2023*

*Date: 17 / 07 / 2023*

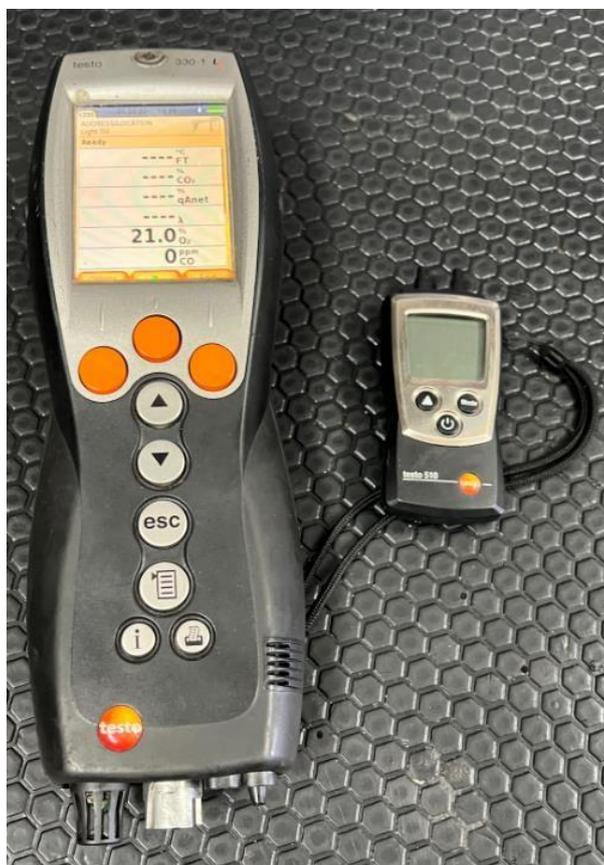
*Image 4 Flue Gas Meter*

the Engine Room and replaced the solenoid valve No: 4 which was brought from the ship's store. (Line Diagram 3) He did the necessary cleaning, measured the flue gas (Image 4), set the air/fuel ratio, returned the black smoke emitted out of the flue to normal, ignited the boiler many times with the existing 200 kg/h nozzle, operated it for a while, and observed that it was normal.

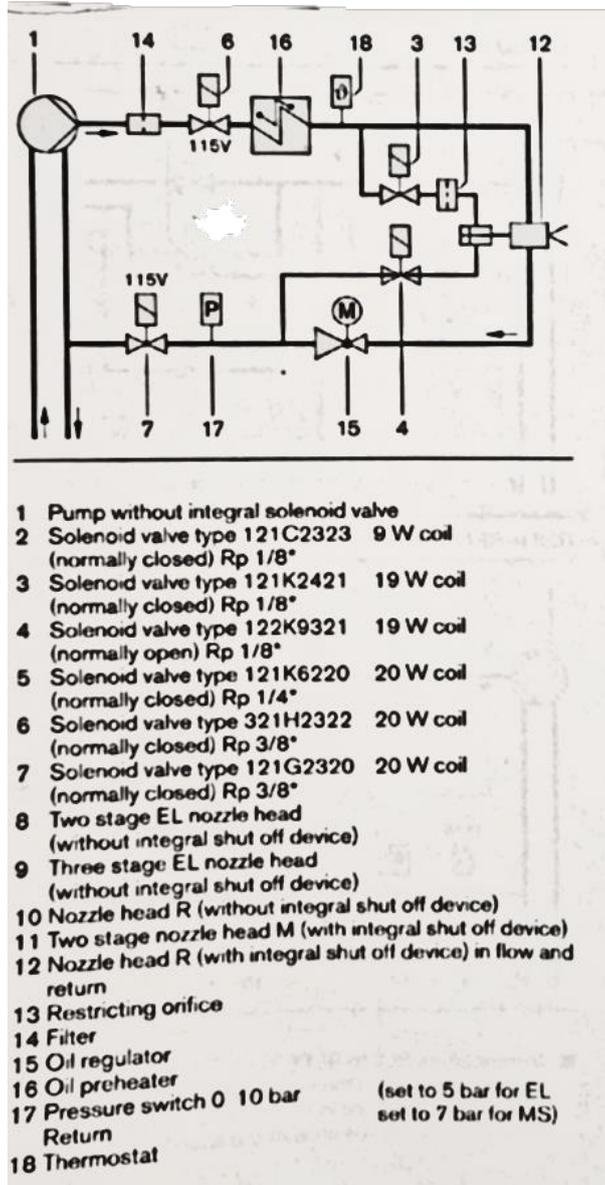
Line Diagram 3 Line Diagram of the Burner RMS9

Since the boilers of the Chemical Tanker M/T TORC failed to fire and operate properly in VLSFO, a service was called from the Boiler Maintenance-Repair Provider on 24/08/2022, as this is work that requires expertise due to technological reasons. The Boiler Maintenance Technician and his assistant, who arrived on board at noon on 28 August 2022 from the Boiler Maintenance Provider, repaired the firing failure of port side boiler No: 2 in the Boiler Room in
