# NIGERIAN MARITIME ADMINISTRATION AND SAFETY AGENCY

## Marine Safety Investigation Report on The Collision of *MSC CORUNA* with *MFT OLOKUN XII* Along Lagos Channel on 07<sup>th</sup> November, 2022

NIMASA-MAI-SIR-23-04

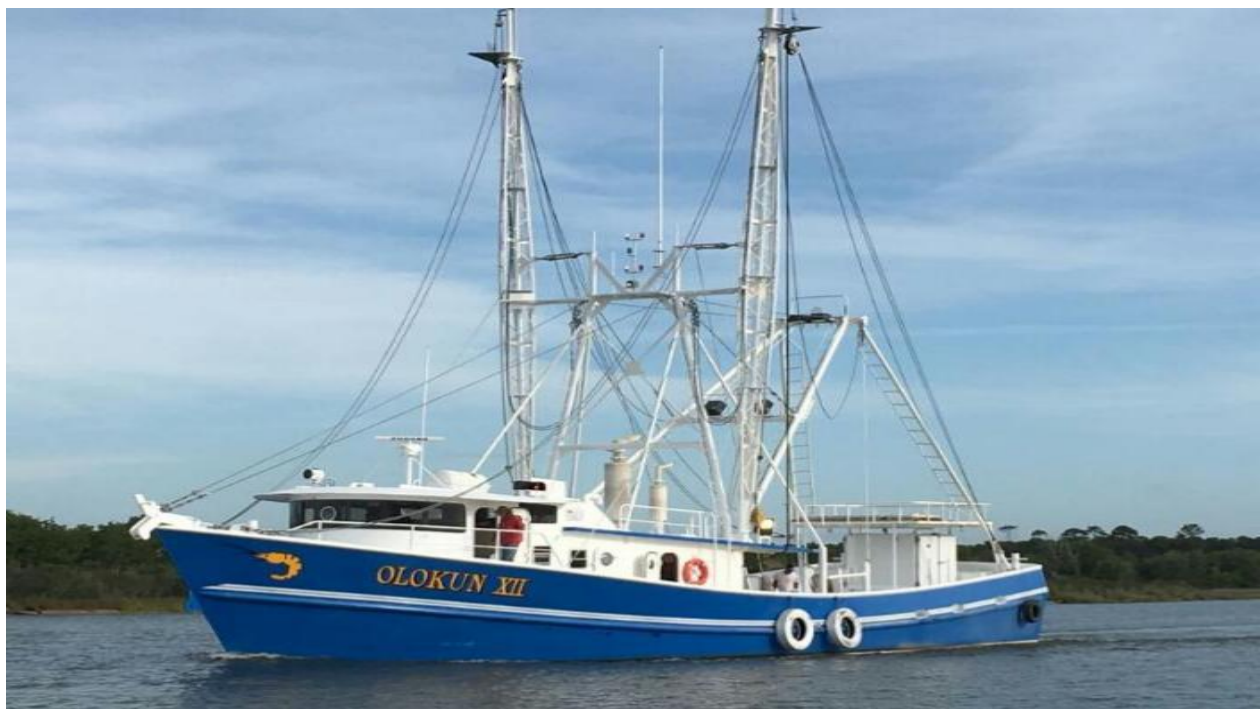
Picture 1: MFT OLOKUN XII

MFT OLOKUN XII is a 130MT steel welded, single screwed and diesel powered shrimper, built in the United States of America. The vessel had five transverse bulkheads. The main deck had a deckhouse at the forward, a mast and rigging amidships with work area on deck in the aft. She was built in 2017 and engaged in commercial fishing activities within the West African sub-region.

1. The Nigerian Maritime Administration is Recommended to :
  - ii. Liaise with the owners of *MFT OLOKUN XII* to establish the current location and determine the danger posed by the wreck to the safety of navigation and the environment, and to also commence the process of removal of the wreck in line with the provisions of the Nigerian Merchant Shipping Act, 2007.

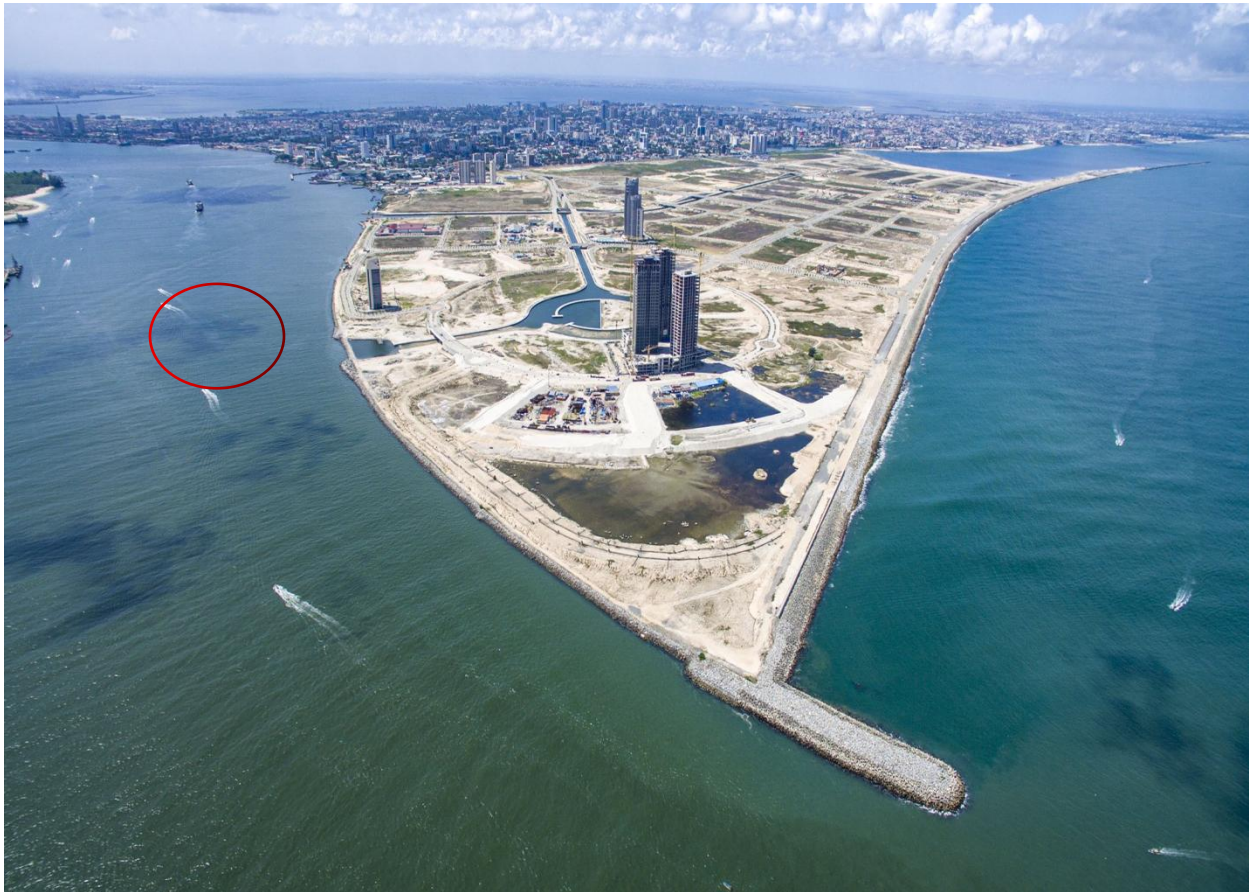
Picture 7: Lagos Channel (Source: Eko Atlantic City Website)

In view of the nature of the channel, and the effect of current, the Nigerian Ports Authority approved a speed limit of 7 – 8 knots for both in and outbound traffic in this location.
